**U.S. FOREST SERVICE  
NATIONAL STREAM AND AQUATIC ECOLOGY CENTER**

**August 16, 2016**

**ARMSTRONG CREEK RESTORATION: ASSESSMENT**

**Client:** Routt National Forest

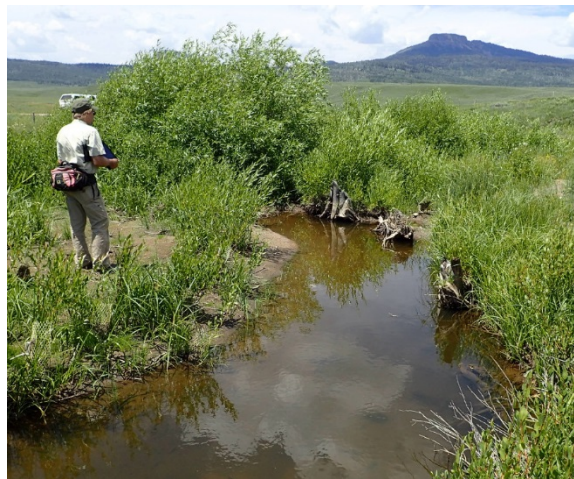
The portion of lower Armstrong Creek inspected during this visit was geomorphically stable (Figure 2, Figure 3), with well-developed riffle-pool bedforms. Portions of this reach were reportedly stabilized in place while another portion was re-channelized to pull the stream back from an eroding terrace. Introduced large wood, with rootwads, were present, as were active beaver dams. Several species of fish were observed including speckled dace, sculpin, and mountain sucker. Cutthroat trout abundance has reportedly increased in this restoration reach since implementation.

**Figure 2:** Lower Armstrong Creek channel, with pool and rootwads.

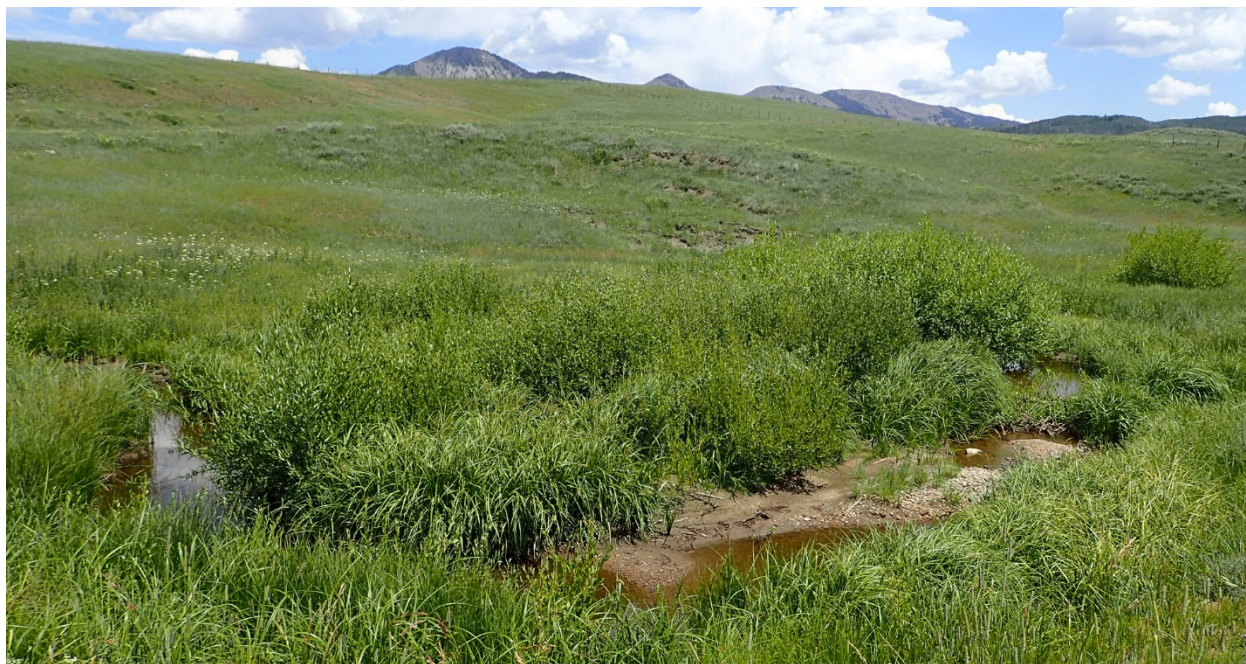
The riparian vegetation along this lower reach was dense and well-established along banks and near channel floodplain. The plantings of sedge plugs, sedge mats and willow appeared to have been very successful. There was also an abundance of what appeared to be smooth brome and Canada thistle along the visited reaches of lower Armstrong Creek.

**Figure 3:** Lower Armstrong Creek channel and riparian zone. Note the dense sedges (*Carex utriculata* and *C. aquatilis*) and bulrushes (*Scirpus microcarpus*) along the new channel and the natural colonization of bars in the channel.

An issue noted within lower Armstrong Creek is the presence of weeds. It is recommended that control measures be taken to counter the noted smooth brome and Canada thistle. Spot application of glyphosate (Roundup) would likely be an effective means of control. This would enhance the spread of native desirable riparian species. The formation of monospecific stands of Canada thistle should be avoided, as this would be detrimental to native riparian vegetation and the restoration efforts.

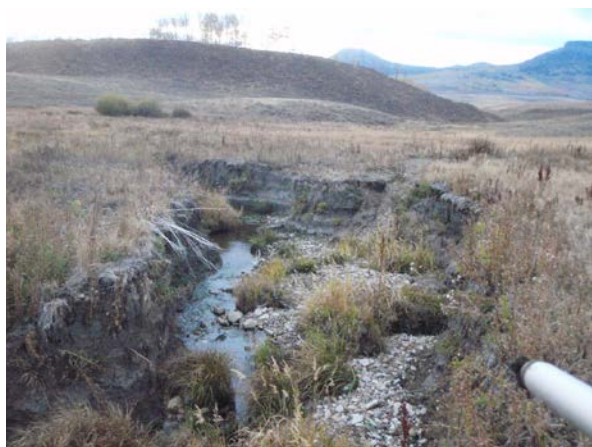
The upper Armstrong Creek restoration reach consists of three higher-gradient subreaches: an upper reach where the channel was stabilized and aquatic habitat was enhanced in place, a middle reach that was left as is (other than management), and a lower reach that was re-routed, the former gullied channel (Figure 4) partially filled, and a new channel and floodplain reconstructed and planted. An 8-foot high fence was installed in 2015 to exclude all three subreaches from livestock grazing and game browsing.

**Figure 4:** Gully formed from incision of the now abandoned and filled channel of upper Armstrong Creek (image from PowerPoint presentation provided by Henderson in 2013).

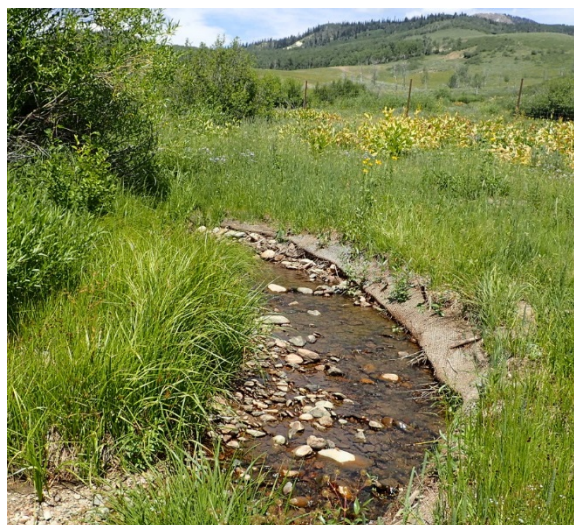
The upper subreach consisted of toe wood, coir soil wraps (Figure 5), and revegetation efforts to narrow the channel, strengthen banks, and decrease solar heating. The toe wood structures were constructed using aspen. A steep portion of this channel (reportedly 4.5%) had a series of rock cross vanes installed (Figure 6) to create drops and spill flow resistance, to dissipate energy. “Rock and roll” structures were also utilized (Figure 7), which were constructed of lodgepole pine. They appeared to be functioning well.

**Figure 5:** Upper subreach restoration, on upper Armstrong Creek.

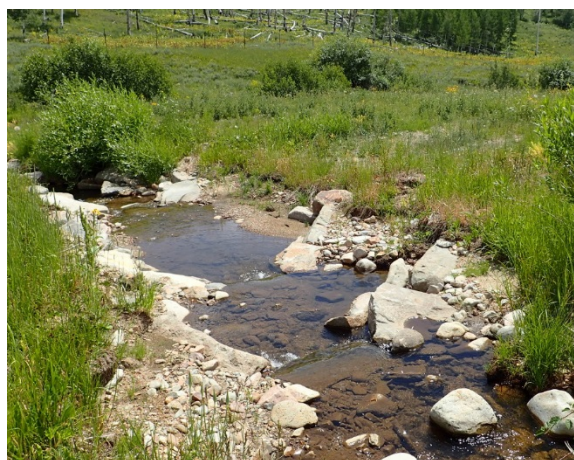
**Figure 6:** Rock cross vanes on upper Armstrong Creek.

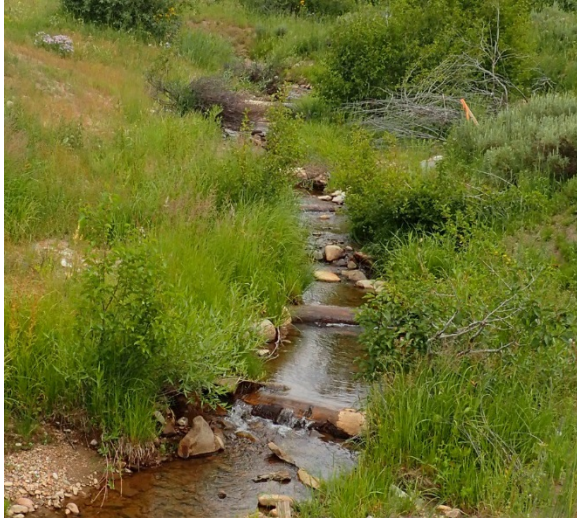
**Figure 7:** Rock and roll structures on upper Armstrong Creek.

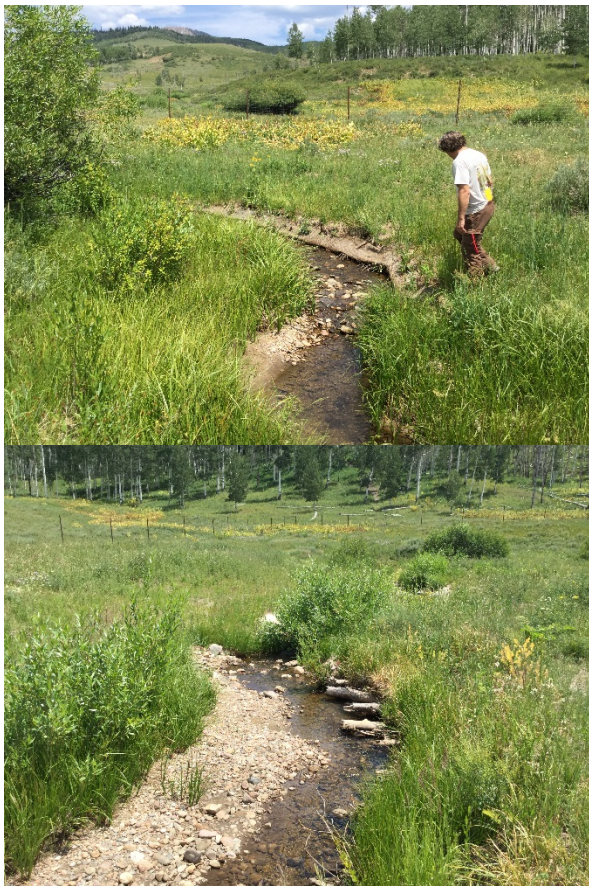
Overall, this upper subreach was generally stable, though erosion along some of the toe wood armored portions of the channel was observed (Figure 8). Considering the structures’ reported bank embeddedness, this erosion is not considered a problem to the structural stability and morphological condition of the channel. Some headcutting above the channel, from local drainage, was also observed, which will require

**Figure 8:** Undercut coir matting and toe wood armored banks on the upper restored reach of upper Armstrong Creek.

Upper Armstrong Creek has had less time for recovery since construction of the restoration project, though mixed results were observed. Generally, the upper reach is faring well, with relatively minor undercutting of coir-wrapped soil lifts and toe wood (Figure 8). This erosion does not appear to be fundamentally destabilizing, and may stabilize over time with root growth.

piping. Additionally, borrow material from a nearby source would be used to fill and regrade the pond areas (Figure 10) so that an increasing floodplain slope away from the channel results. This area would be then revegetated with sedges and willows, to provide long-term stability and ecological value. Additionally, with the mobilization of heavy machinery to the site, patching and revegetating other ongoing geomorphic adjustments should be performed, including the headcuts propagating across the floodplain surfaces, lost riffle bed material (Figure 11), resulting headcutting (Figure 13), and local erosion occurring downstream from the rock and roll structures (Figure 14) and the upstream coir and toe wood structures (Figure 8).

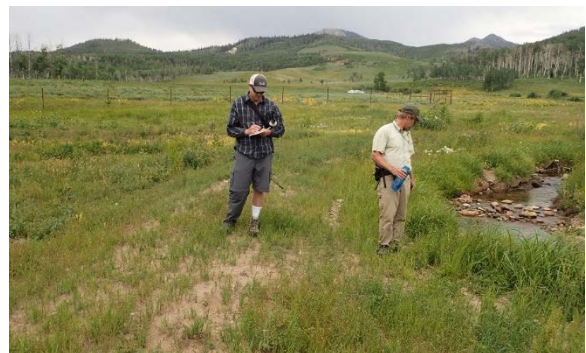
- The new channel and immediately adjacent floodplain surface appear to be perched above the floodplain and a series of small ponds were established where the incised channel existed prior to construction (Figure 10). Some headcutting of the plugs installed between the ponds, with resulting loss of water holding capability, was observed. This elevation difference may result in recapture of the stream channel.
- The earthen berms separating the new channel from the ponds and location of the previously-incised channel (Figure 9) are narrow and likely too dry for sedge establishment. Willow revegetation efforts were not utilized in these areas. Reportedly, these berms are designed to be overtopped with flows greater than the 5-year return interval.

**Figure 9:** Earthen berm, with new channel (right) and adjacent ponds and floodplain (left).

Additionally, it was noted that surprisingly few willows have survived from the plantings along this reach. Replanting would be advisable, particularly adjacent to grade control structures and the constructed berms (Figure 9).

The existing berms (Figure 9) could be partially reinforced through aggressive vegetative plantings (such as willow clumps). Raising the elevation of these berms to greater than the 5-year return interval flood should also be considered.

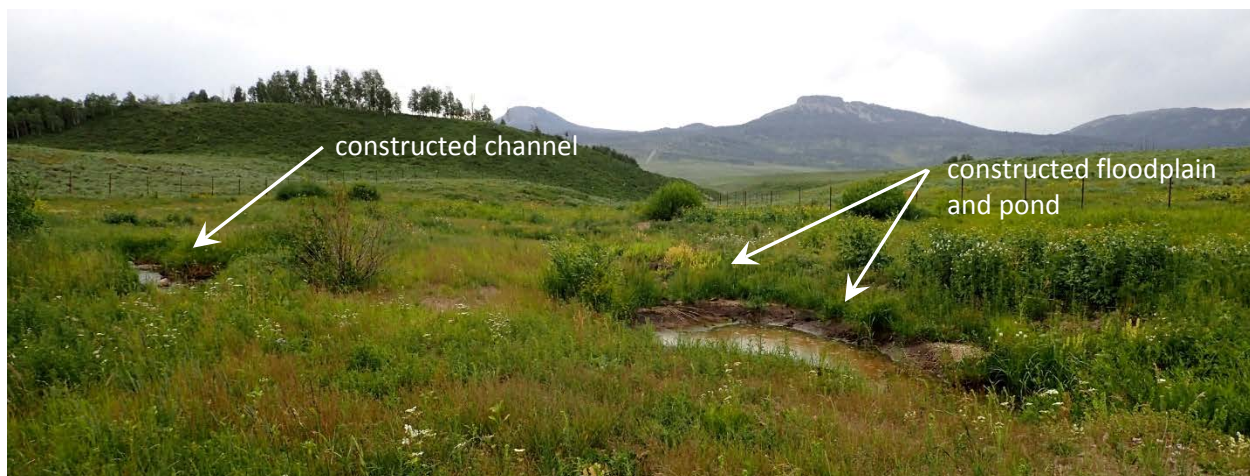
**Figure 10:** Perched constructed stream channel, with adjacent floodplain and ponds constructed where the incised channel was located prior to restoration.

- The grading of the valley bottom and constructed channel (Figure 10) is likely not sustainable, with the pond area (where the

former incised channel was located) and floodplain being at a lower grade than the channel. Fundamentally, floodplains slope up from a channel and adjacent bankfull surface. When the berms separating the channel from these pond areas are overtopped (>5-year return interval flood), there is high risk of this resulting in channel capture of the new channel by the old. This would result in a straightening, steepening, bypassing of the constructed grade-control structures, headcutting and incision, and the likely reformation of the pre-restoration gully (Figure 15).

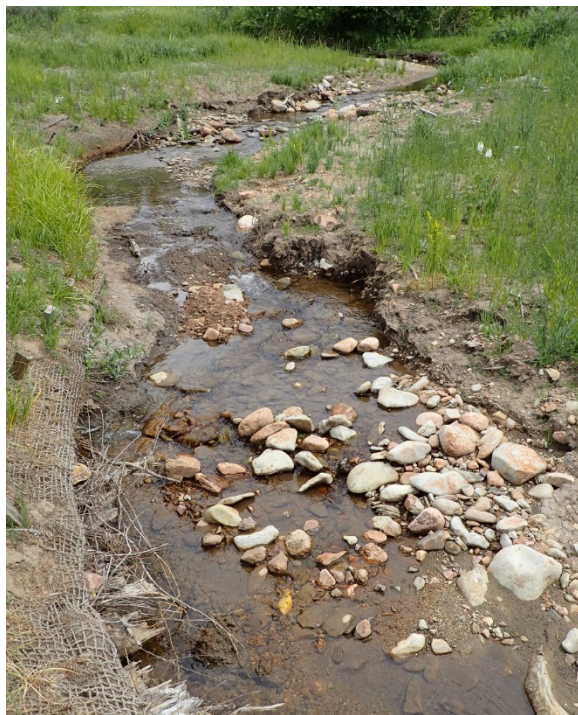
- The constructed gravel and cobble riffles shifted downstream into the excavated pools (Figure 11). This may be due to lack of embeddedness into the clay-dominated substrate.

**Figure 11:** Shifted riffle bed material.

- The rock grade control structures that are piping, scouring and being undermined (Figure 12) will likely fail, potentially this coming snowmelt season.
- The observed headcut (Figure 13) will likely continue migrating upstream.
- The shifting of coarse material placed on the clay material from riffles into the downstream pools (Figure 11), as well as a general lack of coarse material that could

serve to armor the fines that the channel is carved into and would provide better habitat for aquatic invertebrates and fish spawning habitat, is problematic and should be addressed.

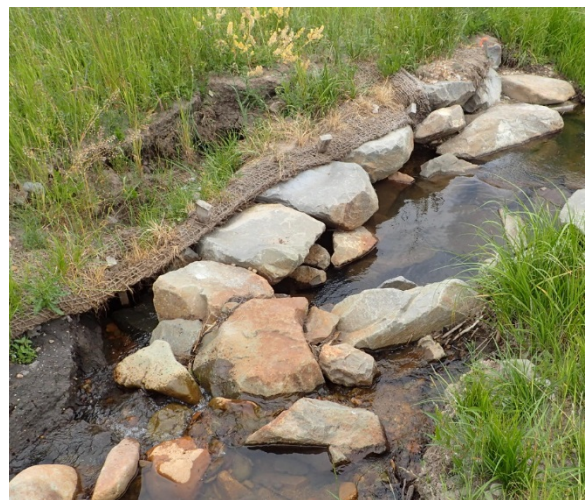
- Rock cross vanes installed to prevent incision have partially failed (Figure 12), with adjacent bank loss and piping through the structure. No geotextile material was installed along the upstream face of these structures.

**Figure 12:** Piping through left arm of cross vane, with adjacent bank failure.

The chinking approach for preventing piping through the rock grade control structures has not worked, resulting in piping and partial failures. Reconstruction of these cross vanes with geotextile fabric along the upstream edge should be more successful for preventing piping.

As with alternative 2, reconstruction of the cross vanes with geotextile fabric along the upstream edge should be more successful for preventing

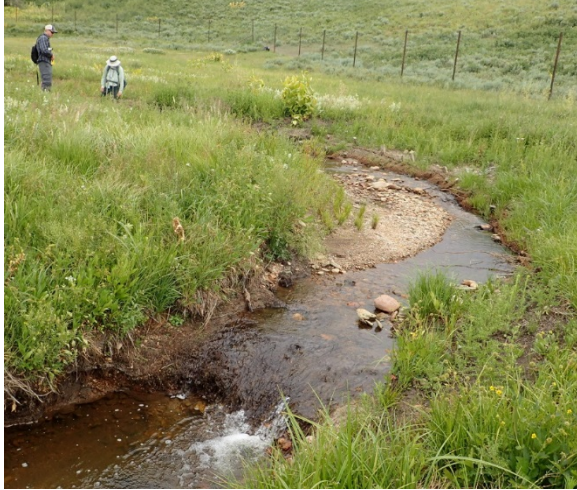
- An active headcut was observed within the channel at the site of a lost riffle (Figure 13). This location is just above the two most downstream cross vanes grade control structures (Figure 12).

**Figure 13:** Active headcut, at location of lost riffle.

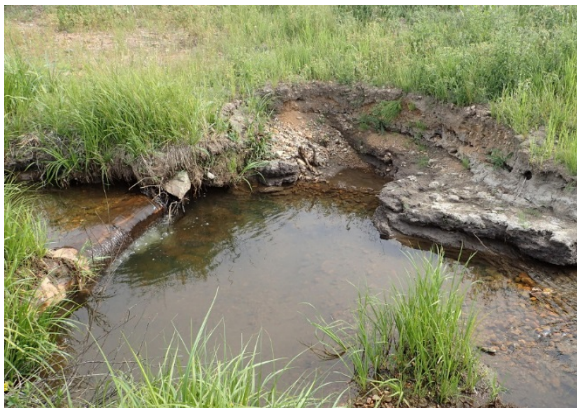
Downstream from the cross vanes, rock and roll structures were installed. These are generally faring well, though at least two were constructed improperly (downstream logs placed parallel, rather than stacked with a footer and header log). Also, some erosion was noted just downstream from some of the structures (Figure 14), though this erosion is likely not endangering the stability of the structures.

**Figure 14:** Erosion at downstream end of rock and roll structure.

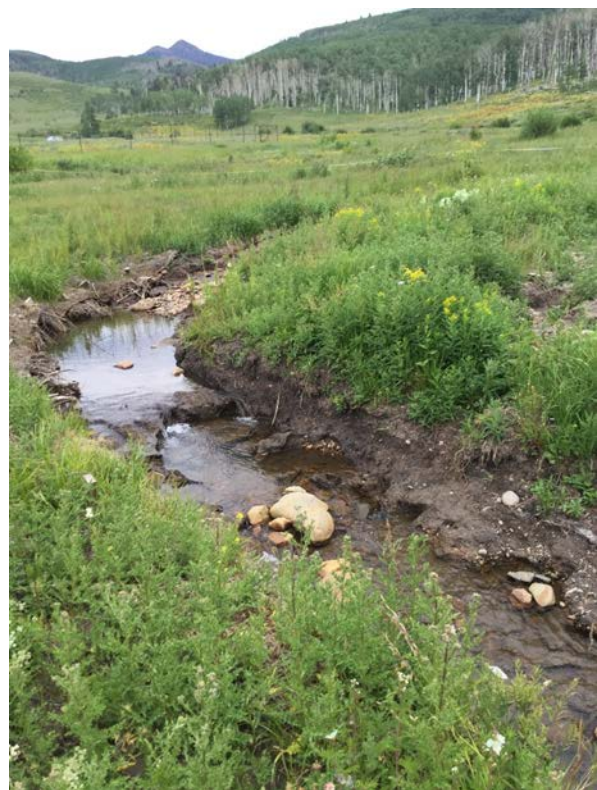
**Figure 15:** Pre-restoration condition of the lower subreach of upper Armstrong Creek.
