**U.S. FOREST SERVICE
NATIONAL STREAM AND AQUATIC ECOLOGY CENTER**

FIRST CREEK: STREAM RESTORATION ASSESSMENT

Client: Routt National Forest

Location: Headwaters of Elkhead Creek in California Park, Colorado

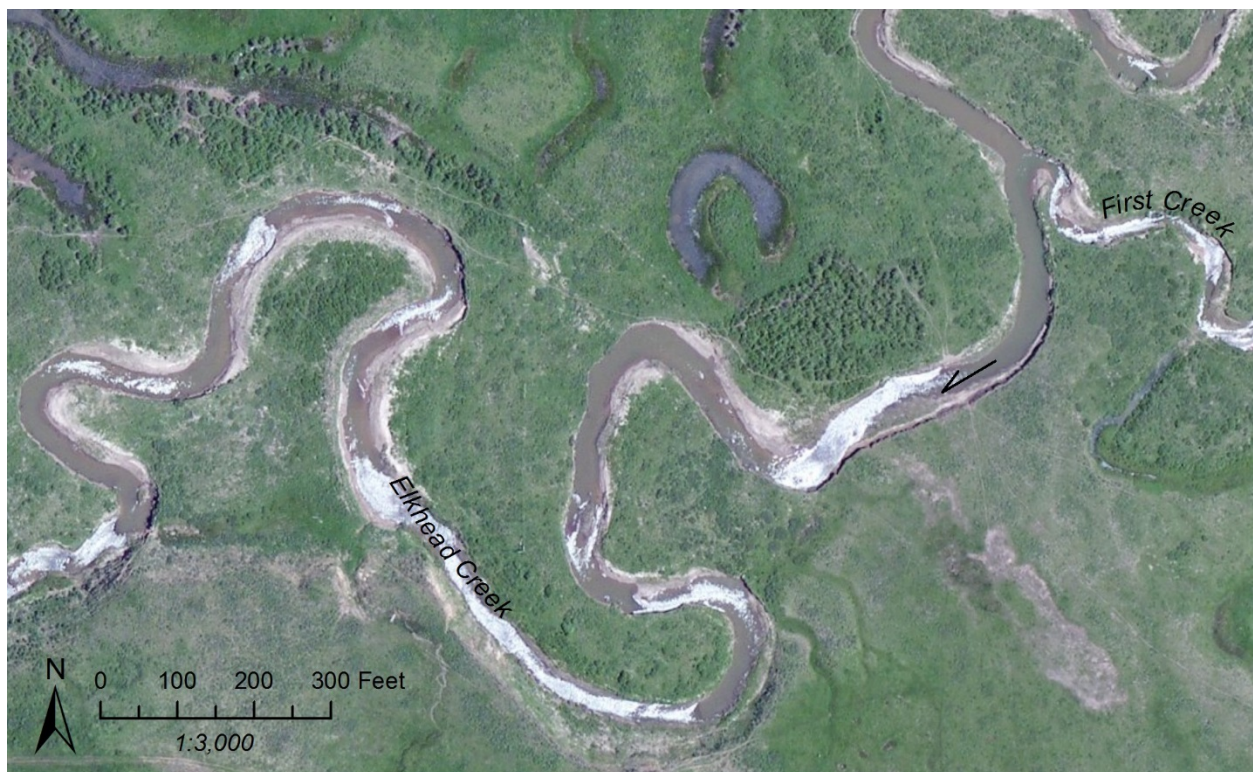
Elkhead Creek below the First Creek confluence (44.3 mi² catchment size; Figure 2) is incised, and appears to be in Channel Evolution Model (Schumm et al. 1984) stages 3 and 4 (Figure 3).

Figure 2: Elkhead Creek below the First Creek confluence. Aerial imagery dated 6/2010.

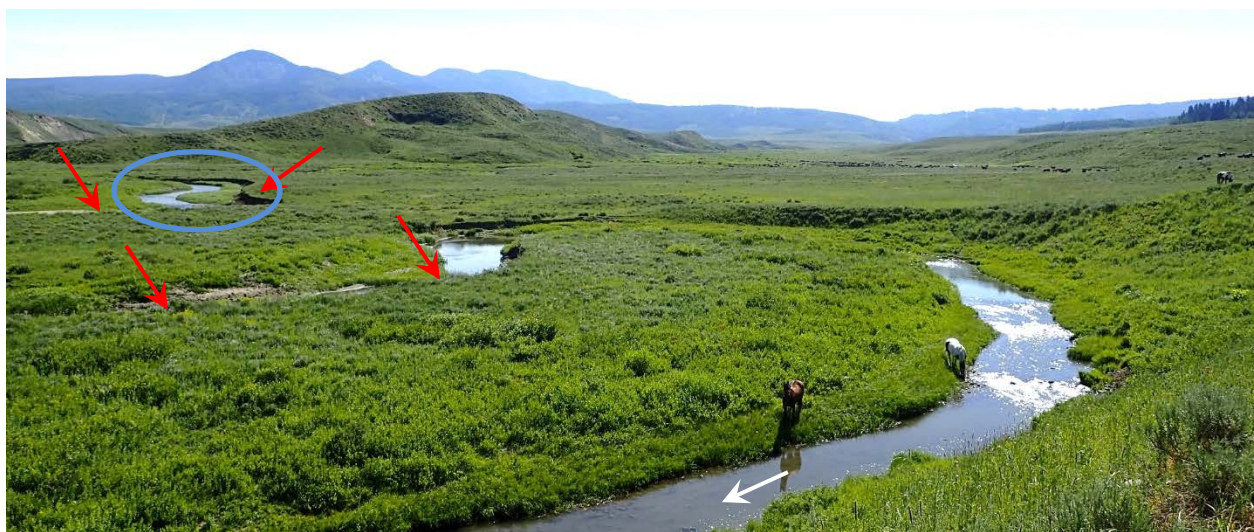
The Channel Evolution Model (CEM) is a valuable tool for understanding how channel form adjusts over space and time due to a disturbance that causes incision. At a specific location the channel evolves from an initial stable state (stage 1) through incision (stage 2), widening (stage 3), deposition and stabilization (stage 4), and once again stable (stage 5). Stages 2 and 3 are the most challenging stages of the evolution model for managers; this is the stage where sediment supply is highest and restoration options are limited. Over time, the incision moves upstream, forcing incision of the valley bottom on successive upstream reaches. With this reach of Elkhead Creek being in stage 3 within part of the observed reach, the stream appears to still be transitioning to a stable form (stages 4 and 5), with a sufficient floodplain width at the lower base level (oval, Figure 4).

Figure 4: Elkhead Creek, viewing upstream towards the First Creek confluence. The red arrows indicate cut banks eroding at a relatively-rapid rate as a new floodplain is established at the new base level. The blue oval indicates a reach that is transitioning from stage 3 to stage 4 in the channel evolution model.

With CEM stages of 3 and 4 being present on Elkhead Creek just below the First Creek confluence (Figure 5), and the majority of this channel in stage 3, conditions within Elkhead Creek are inherently unstable. The incised and laterally-constrained channel during annual high flows has, in consequence, higher shear stress ($\omega = \gamma hS$, due to deeper flow depths $[h]$ and, potentially, meander cutoffs that increase the slope $[S]$), higher unit stream power ($\omega = \gamma QS/w$, due to substantially narrowed floodplain widths $[w]$ and, potentially, meander cutoffs), and increased sediment conveyance capacity. During high flows continued relatively-high erosion rates will occur, resulting in additional floodplain widening, a reduction in unit stream power and shear stress, and the CEM stage 4 (and eventually 5) evolution states. With this channel evolution, the stream should stabilize at the lower base level, though additional disturbances that induce further incision is also a possibility.

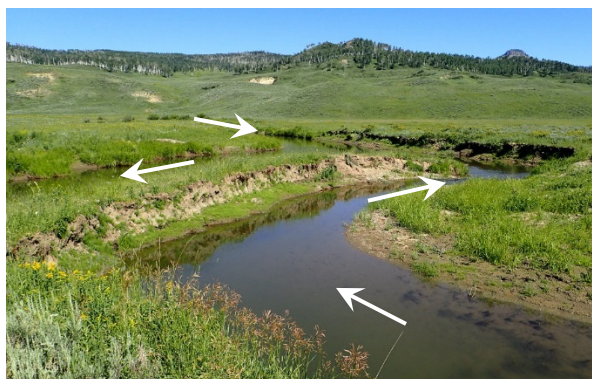
First Creek just above the confluence with Elkhead Creek (Figure 8) is incised about 2 feet, and has a substantial meander cutoffs present (compare 1970 to 2010 imagery in Figure 8), with sinuosity within the extent of this figure dropping from 1.74 (1970) to 1.61 (2010). The confluence has an upstream orientation (Figure 5), though erosion of the cutbank on First Creek just upstream of the confluence will soon correct this transient state. It was observed that additional potential cutoffs are possible in the near term, with apparently greater-than-average cutbank erosion rates. Like Elkhead Creek, First Creek throughout its lower extent appears to be in CEM stages 3 and 4 (Figure 6). Some meander bends are actively eroding to the point of threatening avulsions and, consequently, additional incision.

Figure 5: First Creek at the Elkhead Creek Confluence. The white arrows indicate the flow directions.

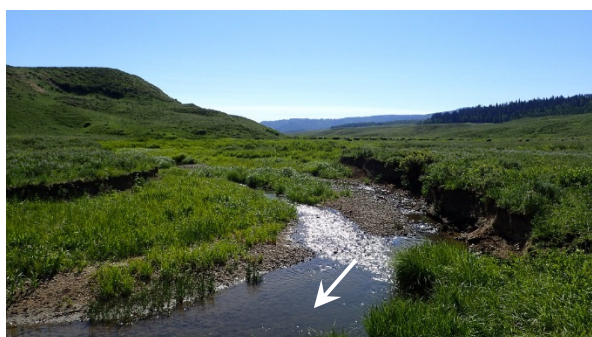
Figure 6: First Creek, incised about 2 feet in Channel Evolution Model stage 3.

Incision of First Creek near the confluence (Figure 6) is due to a drop in the base level of Elkhead Creek. The resulting First Creek channel is CEM stages 3 and 4, with some reaches showing substantial floodplain width at the lower base level (CEM 4) and many other reaches showing overly-narrowed, channelized reaches (CEM 3) that are actively eroding cutbanks (Figure 15). Like Elkhead Creek below the confluence, the

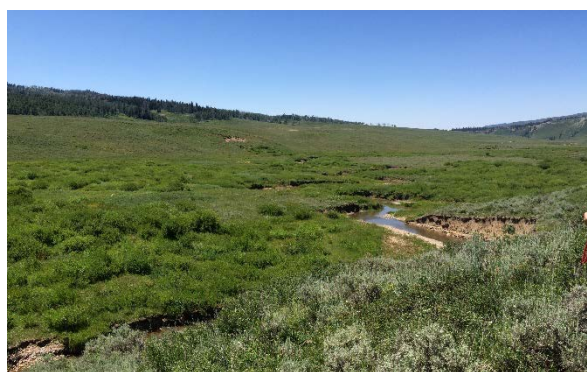
A host of native plant species dominate First Creek, including those mentioned above. Particularly striking was the diversity and extent of willow-dominated riparian vegetation, indicating that whatever incision has occurred has not been sufficient to lower water tables to a depth that would adversely affect shallow-rooted willow communities. Contributions of groundwater from extra-stream sources also serve to support such valley-bottom willow communities. Note seeps along valley margins in Figure 7.

Figure 7: Note springs and seeps well above the active channel of First Creek. These indicate that groundwater is likely contributing to First Creek and supplying extra-stream sources of water for phreatophytic vegetation.

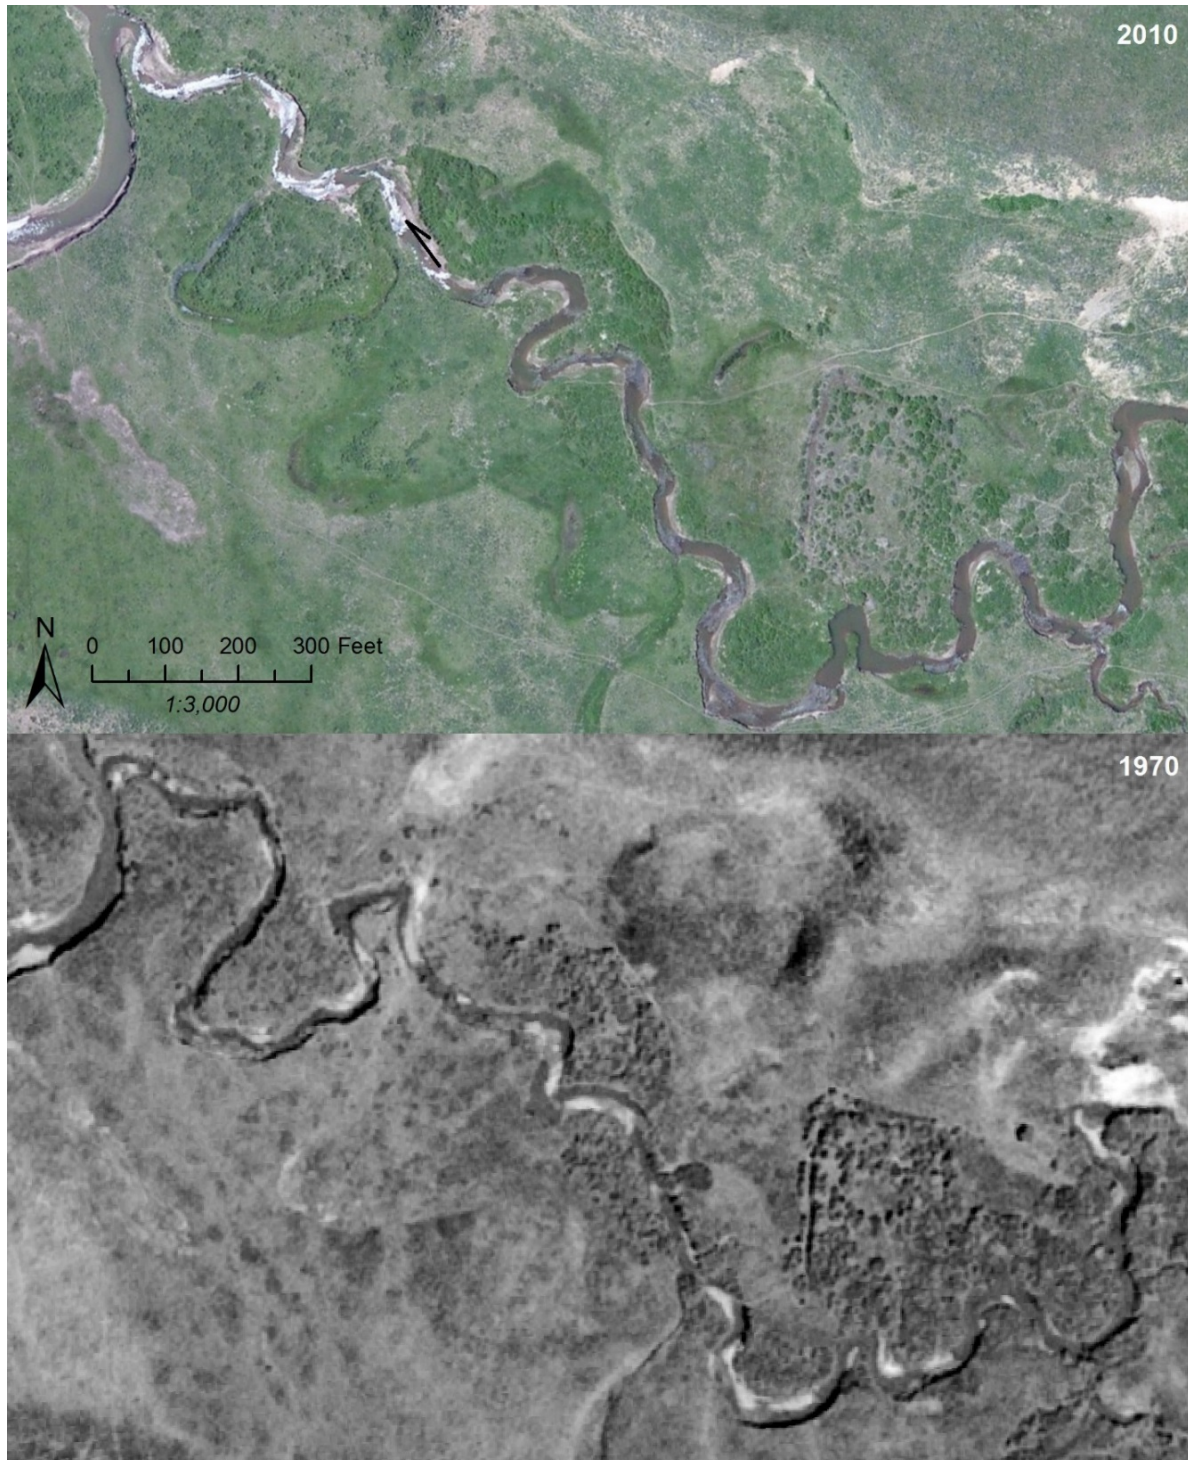
Figure 8: Lower First Creek, with aerial imagery from 2010 (upper) and 1970 (lower).

The influence of the Elkhead Creek incision upon First Creek likely decreases in influence as one proceeds further upstream. Instead, observed incision upstream may be instead dominated by local meander cutoffs increasing slope, unit stream power and shear stress, and sediment transport capacity. For example, a large meander cutoff near the confluence is evident in the aerial photo comparison between 2010 and 1970 (Figure 8).

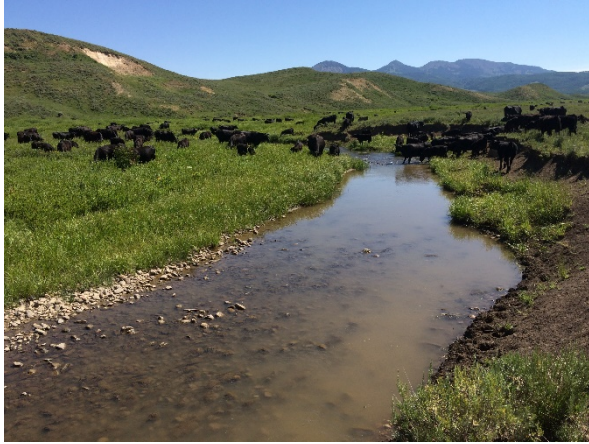
At the time of our field visit, cattle were dense and grazing in the channel and on its banks (Figure 9). Bank erosion resulting from livestock grazing was also evident. Defecation into the channel has likely contributed to the green algae, which was prominent in the channel.

Figure 9: Livestock grazing in and around the channel and on the floodplain of the lower reaches of First Creek. Note the turbidity in the foreground. Also note the patches of vegetation. These rhizomatous species would likely colonize and stabilize such channel margins if livestock and elk grazing were reduced or discontinued. This would likely occur without any manual seeding or planting.

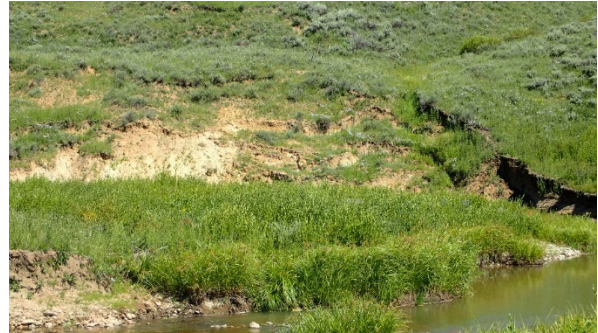
Along some reaches, high terraces and hillslopes were observed to be actively eroding by the stream (Figure 10). Along with the many existing rapidly-eroding cut banks, these hillslopes are primary sources of fine sediment to the channel.

Figure 10: High, unstable bank and hillslope eroding into the active stream channel.

The local restoration team (Rick, Liz, Brian) expressed concern regarding sediment loading from erosion of high (Mancos shale) banks and unstable hillslopes immediately adjacent to the stream channel (Figure 10). This makes sense considering the detrimental impacts of fine sediment on spawning gravels for cutthroat trout. However, it has been hypothesized that the apparent brook trout extirpation from California Park is in large part due to this turbidity and suspended sediment load. From this perspective, this fine sediment may not necessarily be a detriment to the restoration goals. Further, suspension and transport of these Mancos shale banks is likely an historic phenomenon to which the local cutthroat populations are adapted.

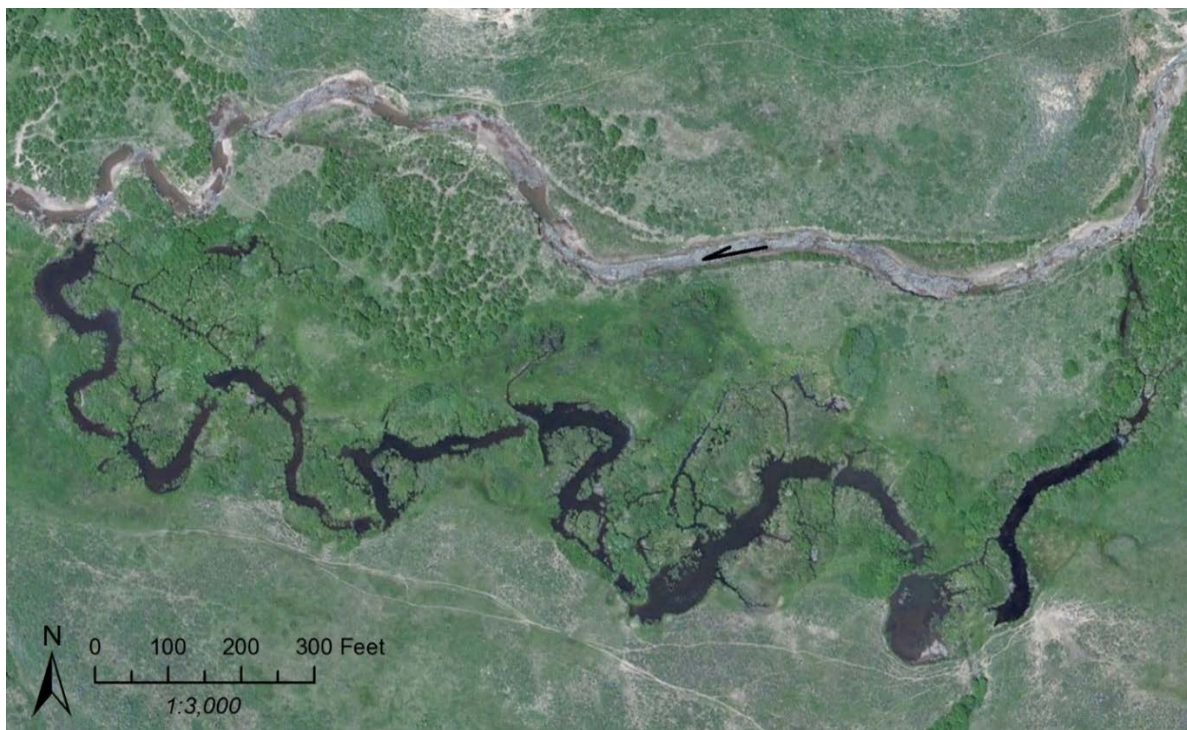
An abandoned channel has been proposed to be reconnected with the primary stream channel (Figure 11). Sinuosity of this reach has decreased

Figure 11: Proposed channel reconnection reach.

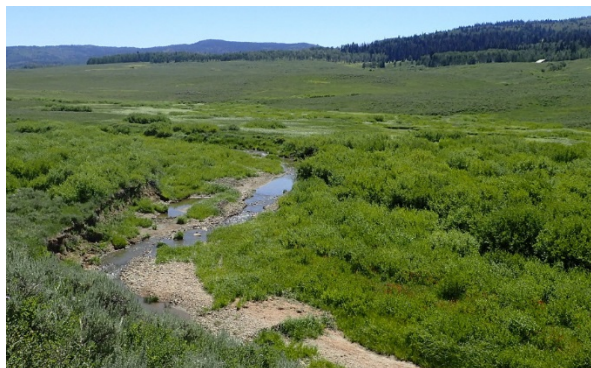
from 2.2 to 1.2; the once substantially-meandering channel on the south side of the valley has been replaced by a relatively-strait and incised channel on the north side of the valley (Figure 12). This new channel and associated floodplain has recruited a substantial amount of riparian vegetation, though has a fairly channelized and homogenous cross sectional and longitudinal form. This cutoff occurred sometime prior to 1970, according to historical aerial imagery.

Figure 12: Relatively-strait cutoff channel on north side of the First Creek valley.

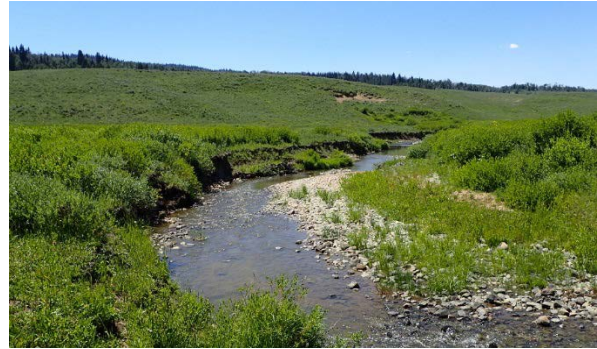
Incision both upstream and downstream (Figure 13) of the proposed channel reconnection is evident. Linking the bed grade of the new channel, at its lower base level, and the old channel and floodplain may be problematic in any restoration effort within this reach.

Figure 13: Just downstream from the proposed channel reconnection, with 2 to 3 feet of incision.

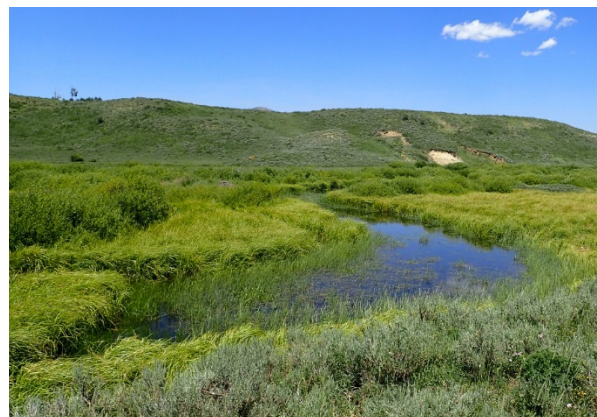
The abandoned channel is functioning well as a wetland (Figure 14), with a surface source for water from a small tributary (southeast corner of Figure 11) and potentially additional sources of water from a spring along the adjacent hillslope. The tributary has introduced sediment as a small fan, which has filled a portion of the abandoned channel. This wetland is considered a valuable resource and should be highlighted for protection. Threats to the long-term stability of this feature include breaching of the natural levees that retain the water by a large flood in the primary, incised conveyance channel, as well as failure of grade control for any restoration efforts that seeks to reconnect this abandoned channel to the primary channel.

Figure 14: Current wetland within abandoned channel proposed for reconnection.

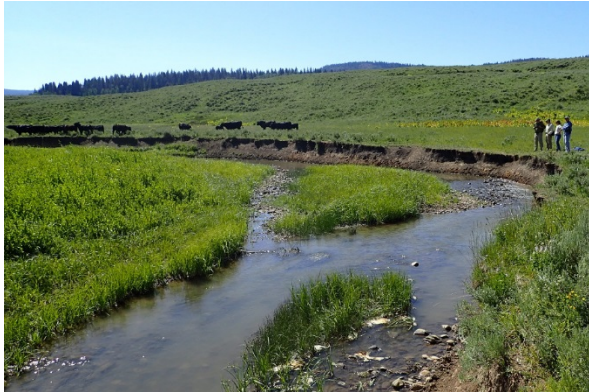
Figure 15: Typical cutbank with high erosion rates.

This alternative would consist of the constructed exclosures of alternative 2 plus protection of strategic cutbanks that threaten to cut off meander bends, reducing the possibility for additional localized incision. This protection could consist of only planted vegetation (sedge plugs, willow poles and bundles, willow clumps), or vegetated plantings in combination with flow deflection structures (such as bank vanes), toe armoring (such as toe wood), or wood jams. However, a drawback of this approach is that existing oxbow-associated wetlands may be lost with channel migration. Once the vegetation has recovered beaver dam construction may eventually raise the channel grade, though this process would take years or decades. The beaver dams could be reinforced through poles installed in existing dams, to provide better resistance to floods. Beaver dam analogs could also be constructed.
