**U.S. FOREST SERVICE
NATIONAL STREAM AND AQUATIC ECOLOGY CENTER**

September 17, 2015

GOVERNMENT CREEK: STREAM RESTORATION ASSESSMENT

Location: Government Creek, in Government Park, Utah

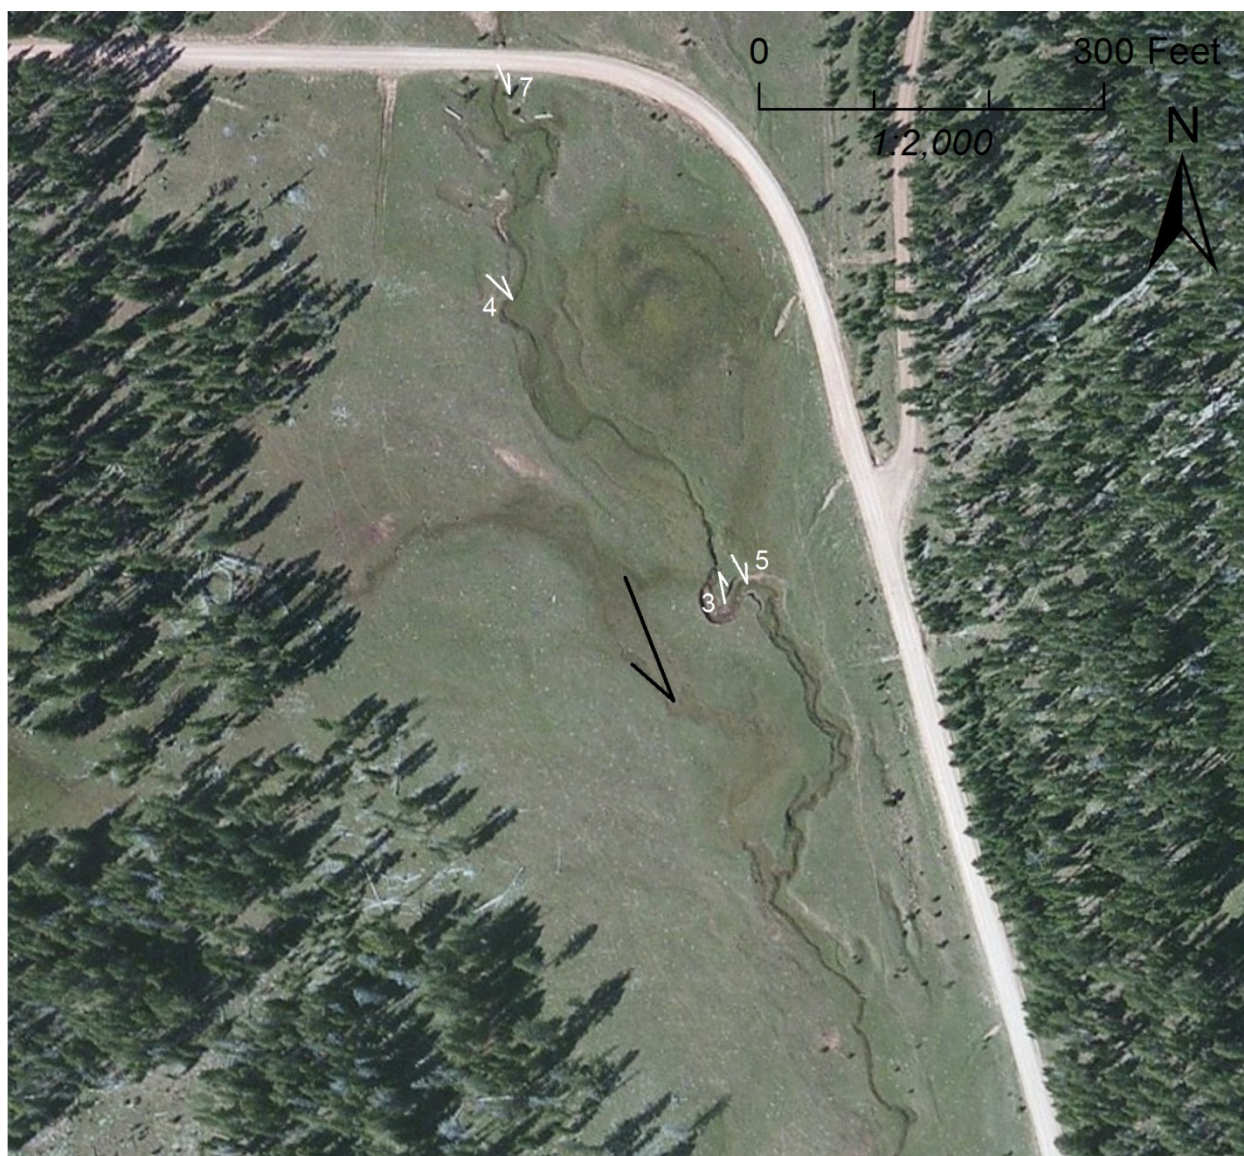
Downstream of the road crossing (Figure 2) a wet meadow currently exists but is terminated by a headcut (Figure 3). This headcut appears to be actively moving upstream, successively drying up portions of the wet meadow from downstream to upstream. Upstream of the headcut (Figure 4) the

Figure 2: Government Creek downstream of road crossing, with a wet meadow terminated by headcut development (9/11/2014).

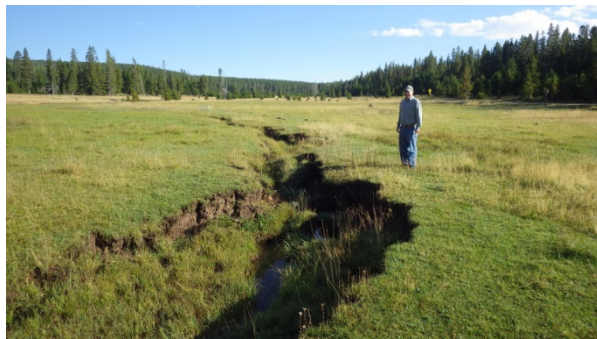
Figure 3: Headcut termination of wet meadow.

Historic aerial imagery was obtained for 1949, 1953, 1959, 1965, 1976, and 1993. Figure 16 provides imagery from 1959. Using this 1959 image, as well as the 1953 image, an average headcut propagation rate of the primary headcut of concern (Figure 3) is 4 to 5 feet/year. If this rate has been more or less consistent, then this particular headcut initiation may have started in the 1870s, 1880's, or 1890's.

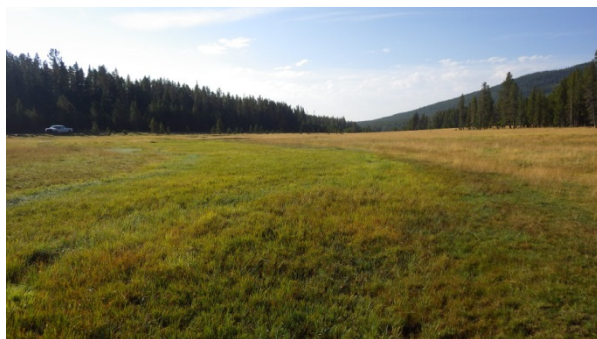
wet meadow appears to be healthy, with a prevalence of water sedge and beak sedge present. Very few willows were observed along the valley bottom. The width of the riparian-obligate vegetation in this meadow typically varies from 35 to 55 feet inside what appears to be a previously incised channel. Before this earlier incision occurred, the wet meadow may have been substantially wider than present. Other wet meadow areas exist outside of this primary channel, expanding the width to 200 feet. This area is visible in the aerial imagery (Figure 2). Much of this wetland area will dry as the headcut continues to move upstream and the local water table drops. Side springs, where present, can reduce the wetland area loss, as is the case to the immediate west of the current active headcut along this reach (Figure 2).

Figure 4: Wet meadow upstream of the headcut.

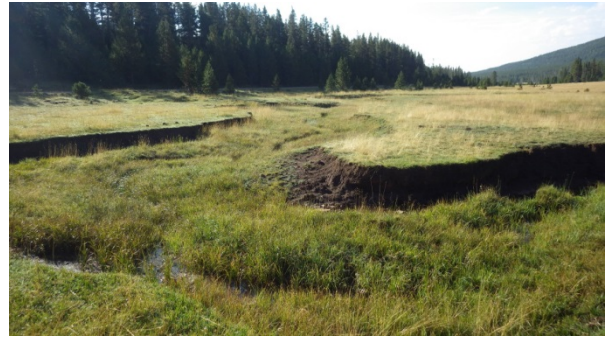
Figure 5 illustrates the channel evolution of Government Creek after the incision, with widening, a lower water table elevation, and a much narrower riparian width (typically 15 to 20 feet). This lowered riparian area has an abundance of sedge present. This feature would be considered stage IV in the channel evolution model (Schumm et al. 1984; Figure 6).

Figure 5: Downstream of headcut, with narrow wetland features evident at the lower water table elevation.

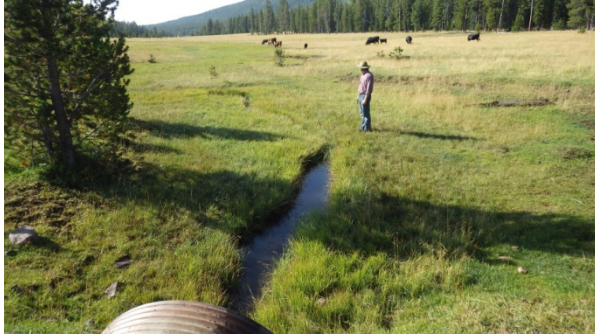
Figure 7 illustrates the existing wet meadow as viewed from the road crossing. Grazing cattle are also shown. The channel is very narrow, relatively deep, and has a sinuosity of 1.5 within this reach. It is an E-type stream in the Rosgen classification system. This sinuosity being in the low end of what is typically expected in this stream type may be due to the previous period of incision.

The road crossing of Government Creek has a single-culvert. This culvert's invert appears to be well placed for the current condition. The single culvert may cause periodic scour immediately downstream during larger flow events.

Figure 7: Wet meadow and cattle grazing, as viewed from road crossing at the culvert, looking downstream.

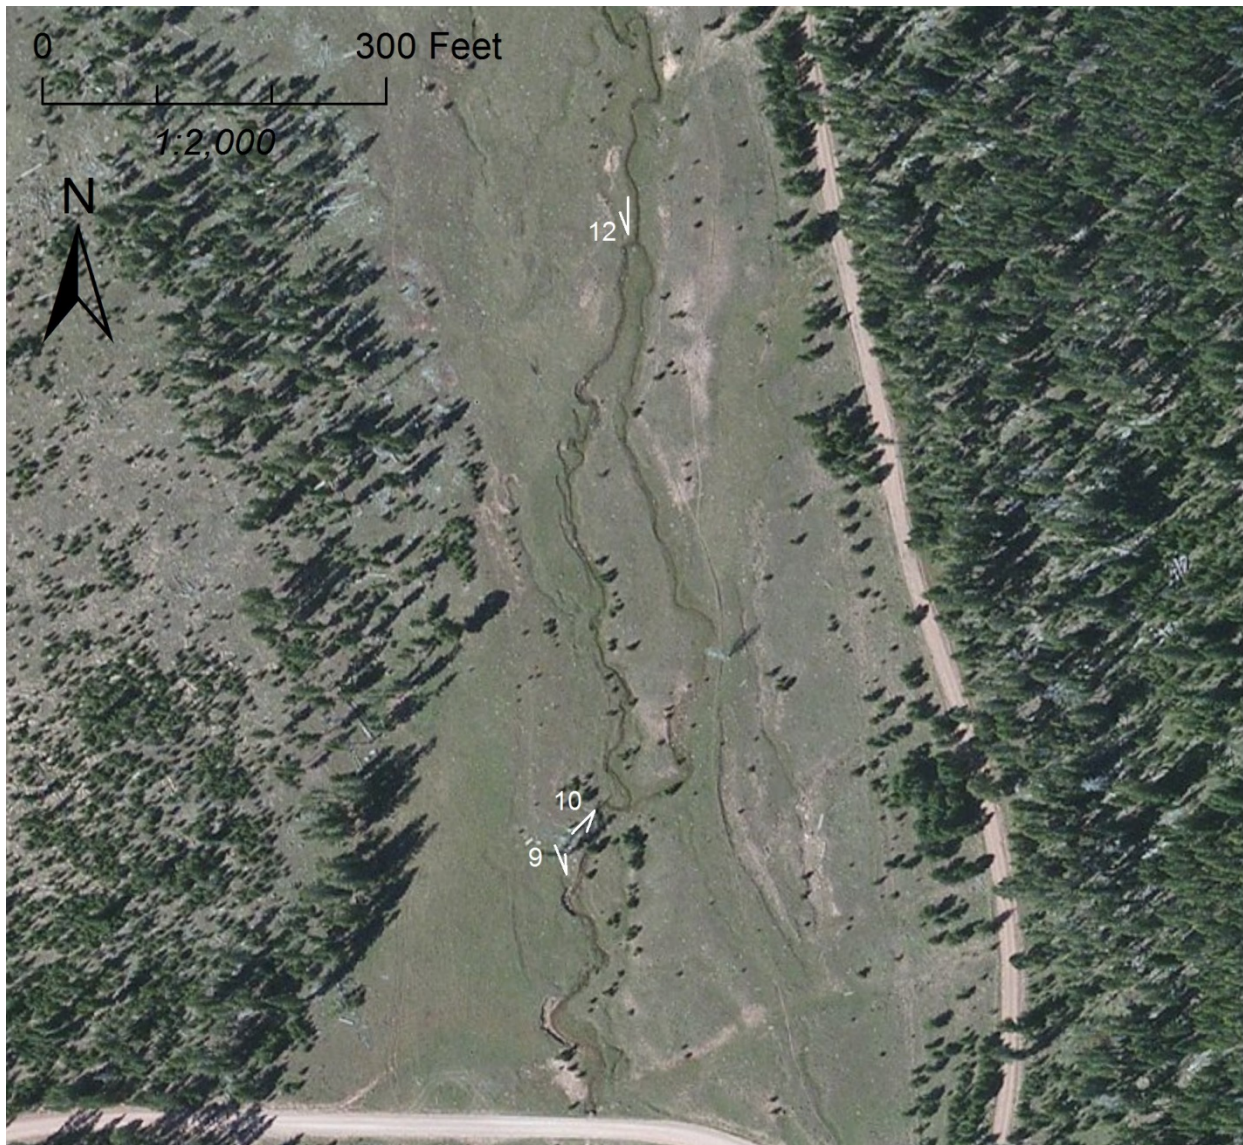
Upstream of the road stream and valley condition are illustrated in the aerial imagery presented in Figures 8 and 11. This reach appears to be steeper

than the downstream reach. A previous period of incision is evident, with tendrils of incised riparian zones bounded by upland terraces across the valley width. Additionally, a contemporary series of small headcuts is occurring, dropping water table levels and drying parts of the wet meadow.

Figure 8: Government Creek upstream of road crossing (9/11/2014).

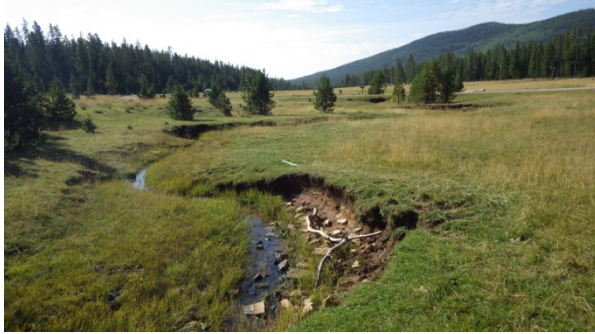
Figure 9 shows a relatively newly incised channel, with a raw cutbank and some active bank erosion, as well as deposition and sedge growth. The riparian zone has been reduced to about 15 feet in width, down likely an order of magnitude compared to pre-settlement conditions.

Figure 9: Incision just downstream of a headcut.

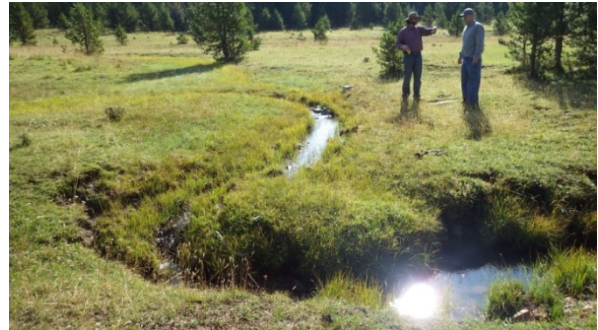
Figure 10 shows the active headcut just upstream of Figure 9. Upstream of this headcut the water table rises and riparian width increases. While this headcut is propagating upstream, it is moving

at a rate slow enough so that the new floodplain surface downstream is being deposited and colonized by sedges without a substantial gap in form and vegetative protection. Further upstream,

Figure 10: An active headcut.

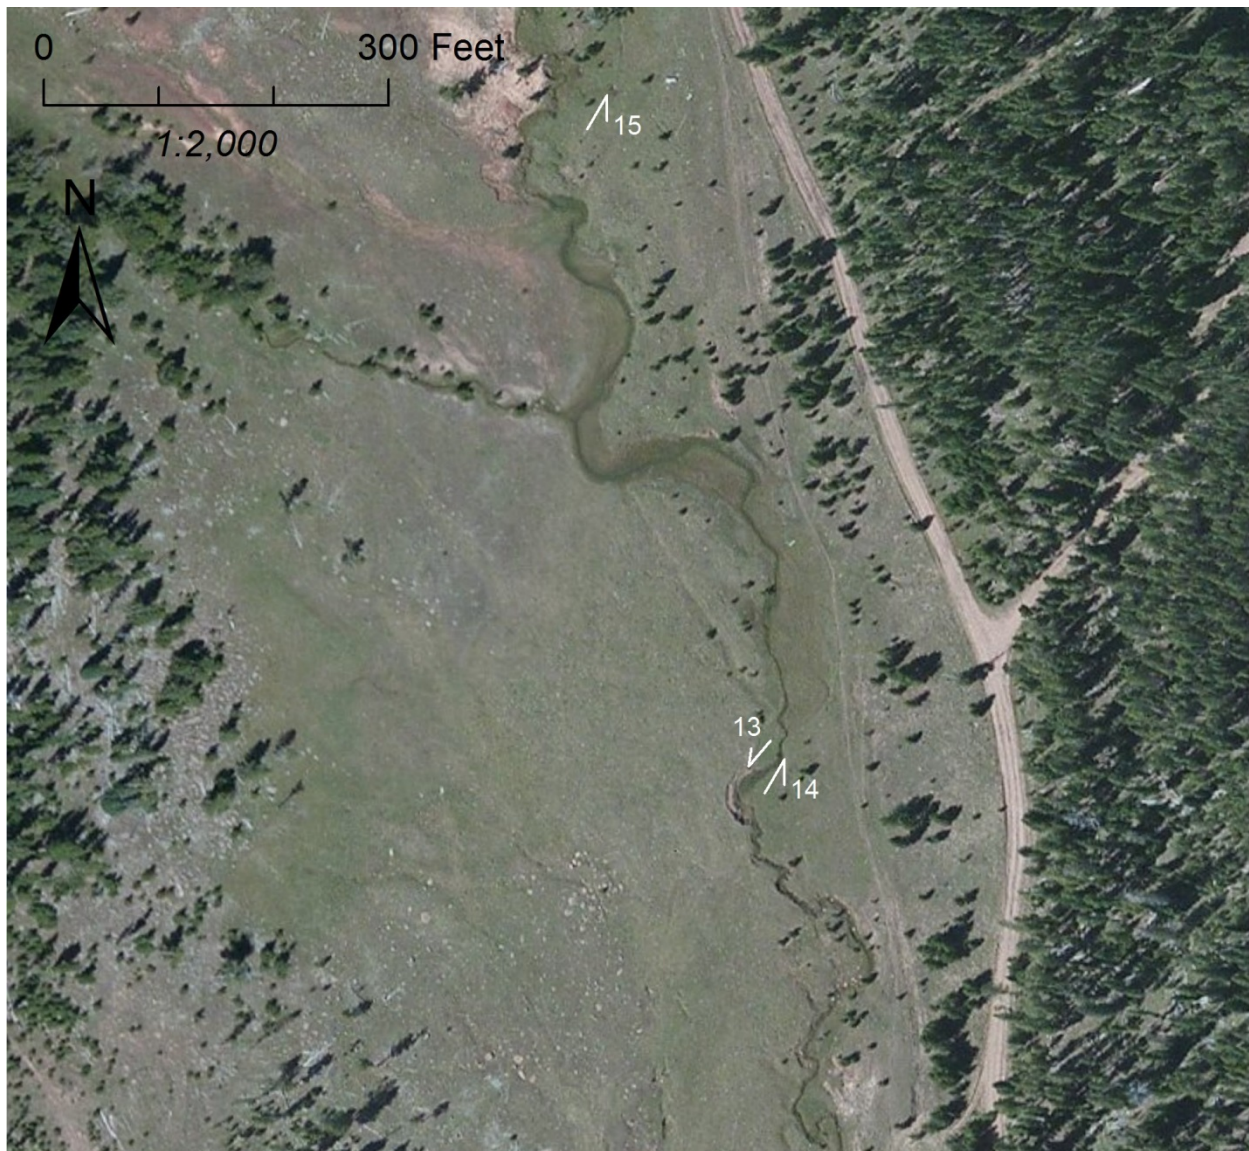
Figure 11: Government Creek upstream of the extent shown in Figure 8 (9/11/2014).

Continuing upstream (Figure 11), the pattern repeats, with an incised channel (Figure 13) with a lowered water table, redeveloped floodplain, raw cut banks, and narrowed riparian zone. Just upstream of this incised zone (Figure 14), the riparian zone is again wider, with a higher water table. This pattern repeats numerous times over the extent shown in Figures 8 and 11.

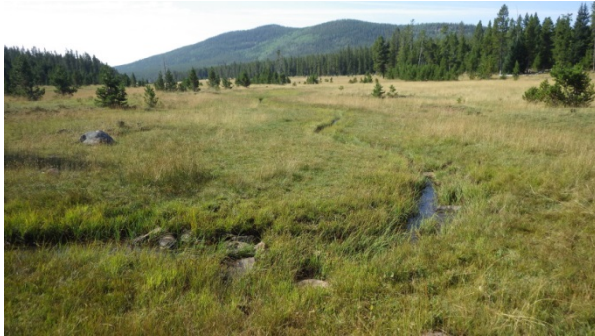
the meadow widens and returns to an E-type form (Figure 12).

Figure 12: Wet meadow, upstream of a headcut.

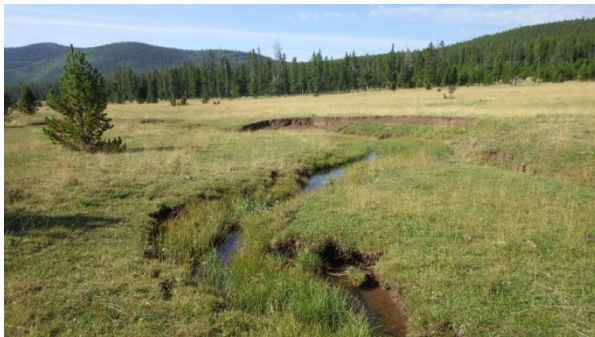
Figure 13: Another incised channel, just downstream of an active headcut.

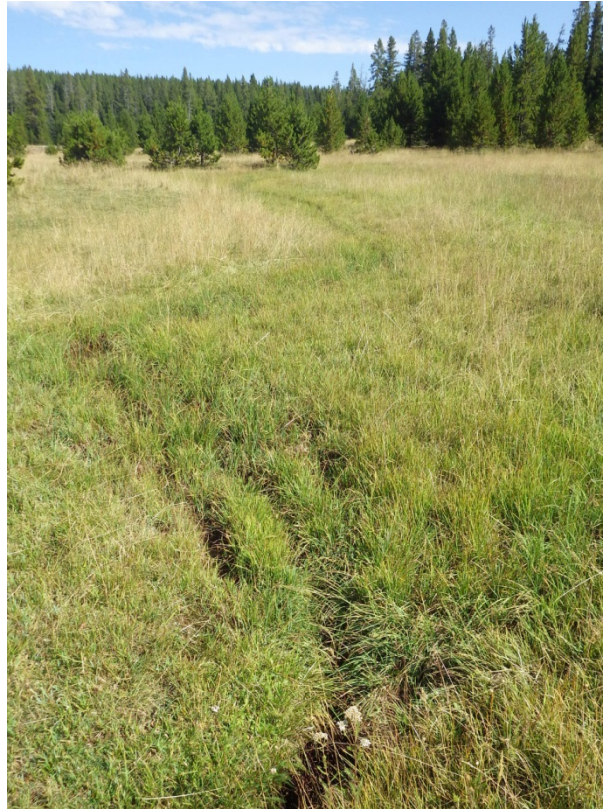
Figure 14: Just upstream of another active headcut.

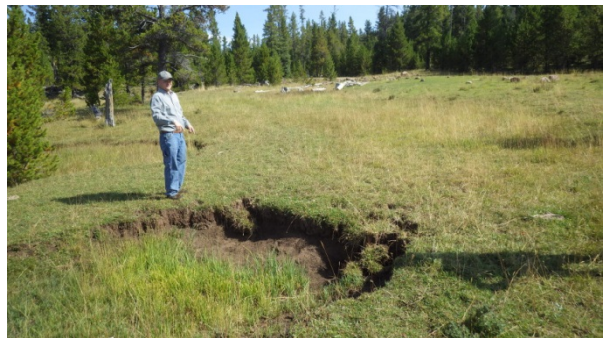
Due to increased flashiness caused by the bare and less permeable roadway surface, headcuts have been forming at some locations downstream of culverts draining the roadway (Figure 15). Not all of the culverts draining the roadway have headcuts formed downstream, but a number of them do.

Figure 15: Active headcutting downstream of a roadway culvert.

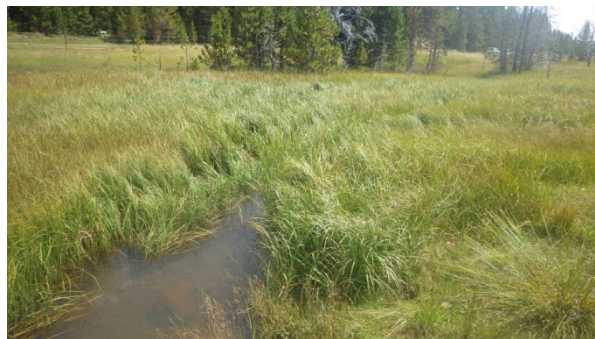
To understand the meadow condition potential with livestock exclusion, an existing exclusion at the lower end of Government Park can be used as a reference of a reach along the path to recovery 9 years after exclusion (Figures 17 to 19). Note the contrast between Figure 18 and Figure 19, just upstream and downstream of the fenceline, respectively. The implementation of a full restoration alternative can likely provide a condition similar to what is shown in Figures 17 and 18.

Figure 17: Typical channel and riparian zone condition of Government Creek within the grazing exclusion.

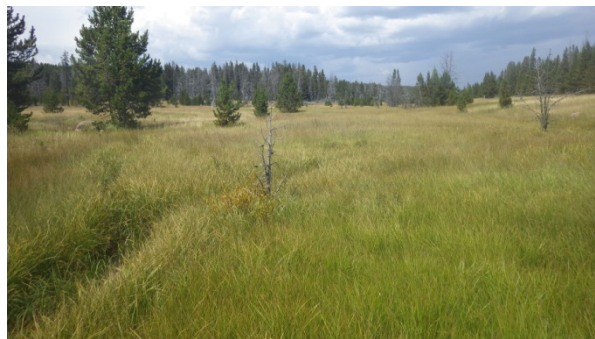
Figure 18: Condition of the riparian zone of Government Creek just inside the exclusion fence.

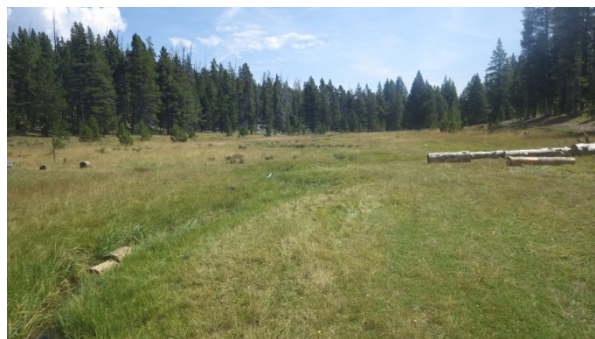
Figure 19: Condition of the riparian zone of Government Creek just outside the exclusion fence.
