**U.S. FOREST SERVICE  
NATIONAL STREAM AND AQUATIC ECOLOGY CENTER**

**November 30, 2016**

**UPPER MILK CREEK: STREAM CONDITION and RESTORATION POTENTIAL**

**Client:** White River National Forest

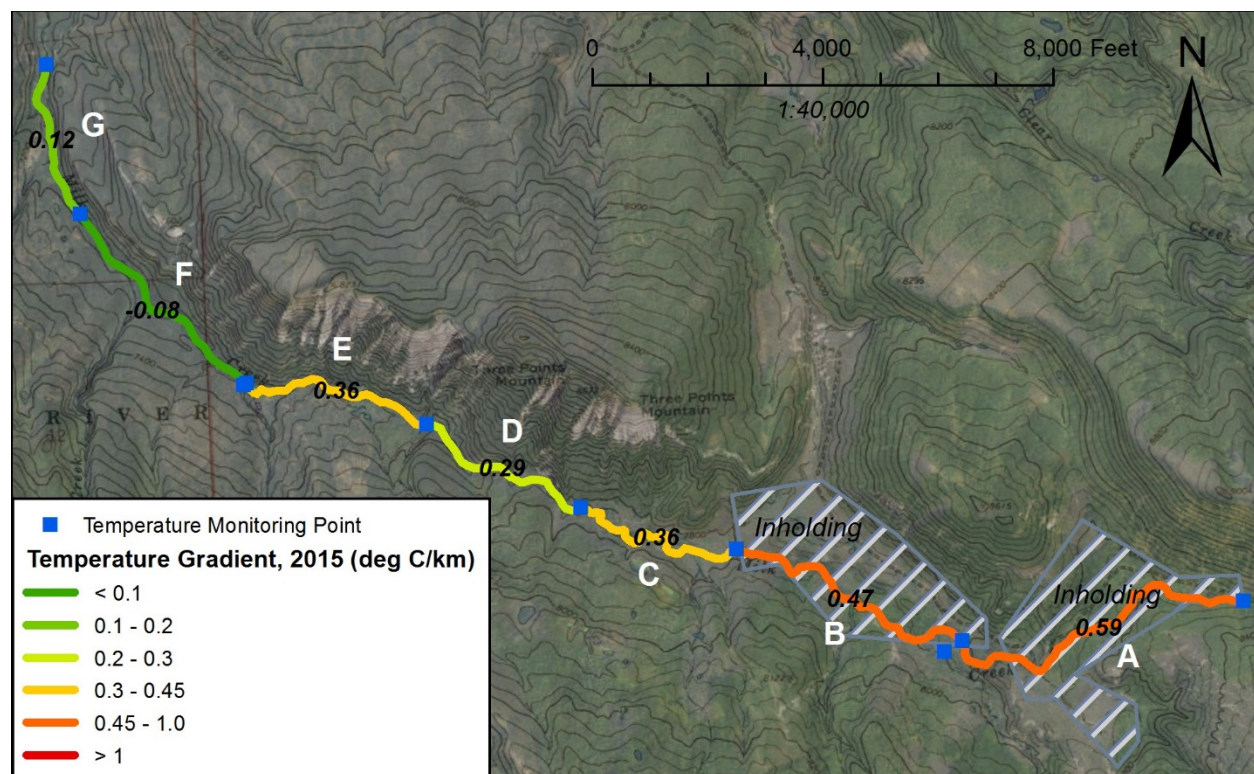
**Figure 2:** Stream reach designations and average July temperature increase gradients (degrees C per km of stream length) of the primary Colorado River cutthroat trout reaches, on National Forest and inholdings. The flow direction is from right to left.

Reach C (Figure 3) is a 3600 ft (1100 m) reach between the inholdings and a shift to a narrower valley form. It is relatively low gradient, with an average channel slope of 0.020 ft/ft. It had a temperature gradient of 0.36 C/km in July of 2015 (Figure 2). This reach is tied for the third-highest rate of July heating in 2015, though lower than the two upstream reaches that are within inholdings (reaches A and B). This lower-

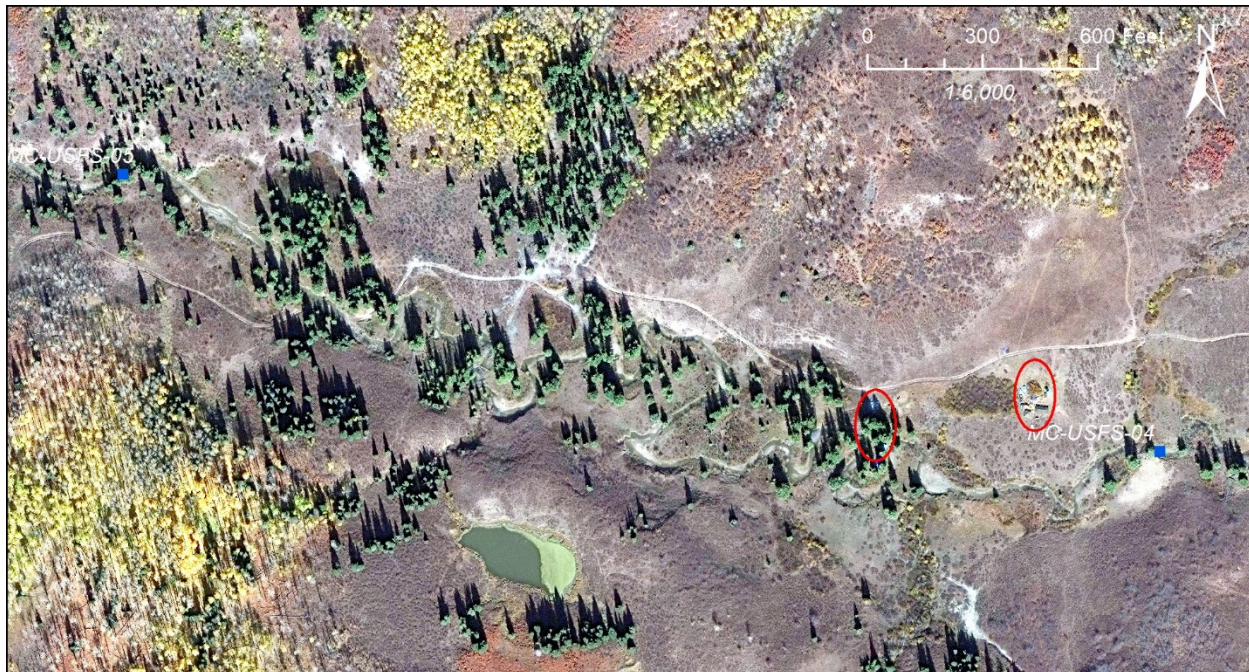
**Figure 3:** Reach C (10/13/2016). The red ovals highlight hunting camps present at the time of the field visit on 10/18. Image: DigitalGlobe.

This reach is substantially impacted by hunters that set up relatively-elaborate camps during the hunting season. Two camps present at the time of the site visit are highlighted by red ovals (Figure 3). The camp on the left was setup immediately adjacent to Milk Creek, without a buffer.

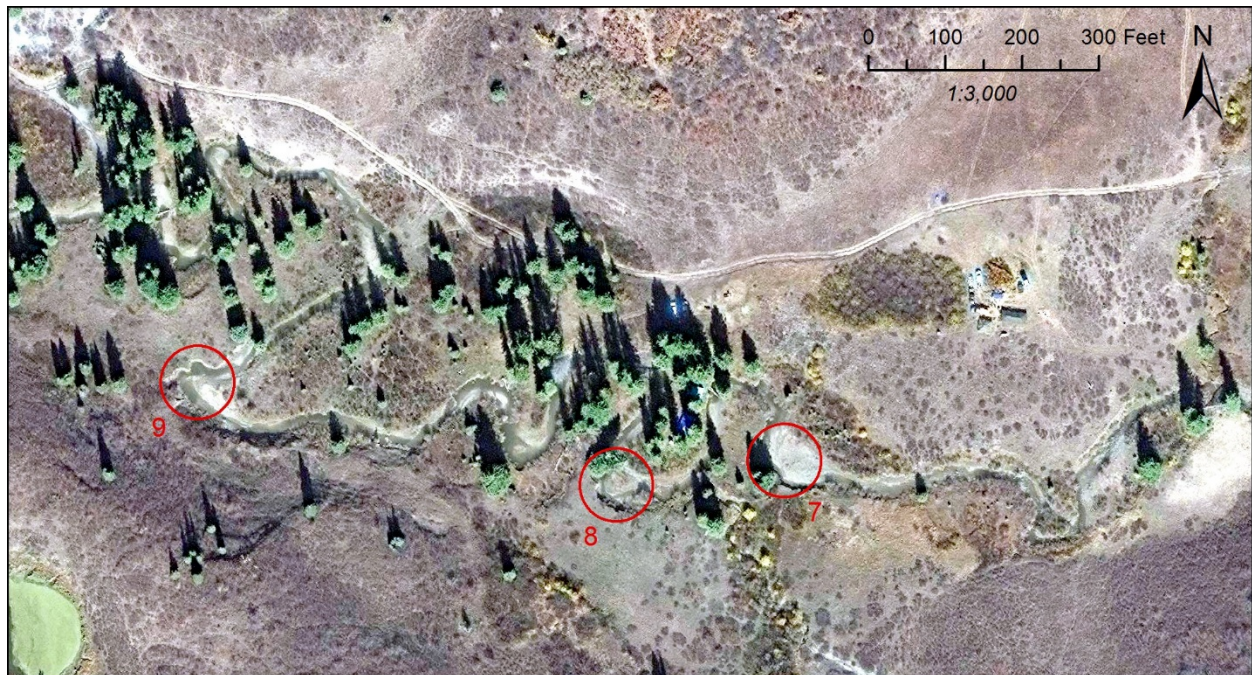
**Figure 4:** Aerial image detail of upstream portion of reach C (10/13/2016). Note the shadows and limited shading by tree canopy. The red numbered circles indicate streambank erosion locations of possible concern, with the numbers indicating the figures. Flow direction is from right to left.

Reach C has a very limited amount of tree canopy shading the channel, as is evident in Figure 4. Note the low areal coverage of shade from the existing trees. Alders and willows are generally present along the channel banks and in portions of the active floodplain, though this woody vegetation provides much less effective canopy for channel shading. Cottonwoods have minimal presence along this reach, with only a few relatively-young narrowleaf observed. On the downstream Milk Creek Ranch reach, livestock exclusion is resulting in the development of new cottonwoods stands from the remnant population of mature trees.

The lack of consistent shading of the channel within by spruce and cottonwoods (Figure 4) is considered a fundamental impairment. The lack of canopy and shade directly impacts stream temperature through solar radiation increasing water temperature, leading to higher rates of temperature increase in the downstream direction (Figure 2). Restoration action to dramatically increase the population of canopy-providing trees is likely warranted. Management changes and direct restoration may likely be needed for vegetation along this reach. A comprehensive assessment of vegetative condition and livestock and game utilization may be advisable, to have greater understanding of status and trends. Tom Probert has recommended the following as options: White River Stream Monitoring Protocol; a greenline assessment (Winward 2000); or the National Riparian Vegetation Monitoring Core Protocol.

An aggressive program of narrowleaf cottonwood plantings could eventually constitute a cottonwood gallery that would provide shade and reduce the rate of temperature increase within this reach. This activity could also counteract the negative impacts of climate change to this core conservation population of cutthroat trout. These plantings would need to be protected from browsing from beaver, sheep, deer, and elk. Additionally, the trout population would likely benefit from an increased beaver population. Assessment of the vegetative condition and livestock and game utilization may likely be needed to develop a plan for increasing willow extent, for increasing the beaver populations. Willow plantings may also be needed in areas. Additional willows along streambanks could narrow the channel at overly-wide locations, reducing solar radiation heating of the stream during low flow.

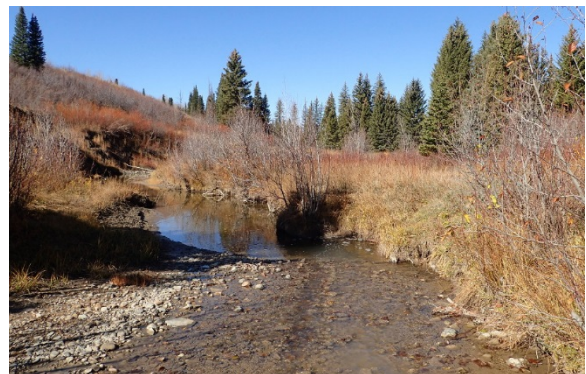
This stream reach varies in connectivity with its floodplain, with a few remnant portions of the channel directly connected to its historic and wide floodplain surface within a meadow, and numerous other portions of the reach that appear to be incised and disconnected with its former floodplain (Figure 5). These latter subreaches typically still have floodplains, though they are

**Figure 5:** Incised portion of reach C, with poor connectivity with the former floodplain and meadow.

Currently, the channel is predominantly incised between 1 to 3 feet and is frequently disconnected from its former floodplain, which was likely a wet meadow. This incision is due to past disturbances or the loss of beaver dam building activities, and is considered an impairment. The incised channel during annual high flows has, in consequence, higher shear stress ( $\omega = \gamma h S$ , due to deeper flow depths [ $h$ ]), higher unit stream power ( $\omega = \gamma Q S / w$ , due to substantially narrowed floodplain widths [ $w$ ]), and increased sediment conveyance capacity. However, while this condition is considered impaired, mechanical restoration through reconnection of the channel with its former floodplain is not recommended for consideration due to the reasonable extent of existing riparian vegetation, large amount of needed borrow material, difficult access for heavy machinery, and the existing population of cutthroat trout present within this reach. Instead, beaver dam building activities throughout this reach could be encouraged, which can reestablish channel-floodplain connectivity while also providing deep pools for cutthroat refugia from summer heat and winter ice.

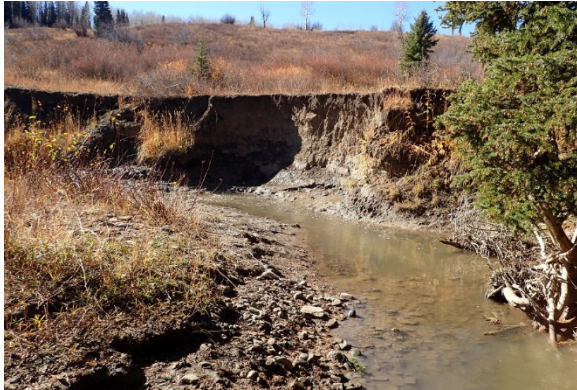
Relatively-high rates of streambank erosion is occurring along a few portions of reach C. These eroding banks are along both the valley margins (Figure 6) and within more central portions of the valley bottom as downstream meander migration.

**Figure 6:** High eroding channel bank along the valley margin.

Generally, the high, eroding banks along the valley margins (Figure 6) are not a concern other than with respect to their fine sediment contribution to the channel and potential impacts to cutthroat trout spawning. However, three locations where faster than typical lateral and downstream meander migration is occurring (Figures 7 to 9) may have repercussions to the channel form by cutting off meanders, decreasing sinuosity, and increasing local channel slope. This increased slope leads to higher stream power and shear stress, and can lead to additional incision and loss of floodplain connectivity, lowering of groundwater table levels, and associated loss of riparian vegetation extent. This can in turn lead to impairment to beaver communities that can eventually reverse the incision that has already occurred. Generally, the rates of erosion are not of imminent concern, but they are steadily progressing, and the erosion rate during a large flood could be dramatically higher. Action is warranted to reduce the erosion rate and prevent meander cutoffs.

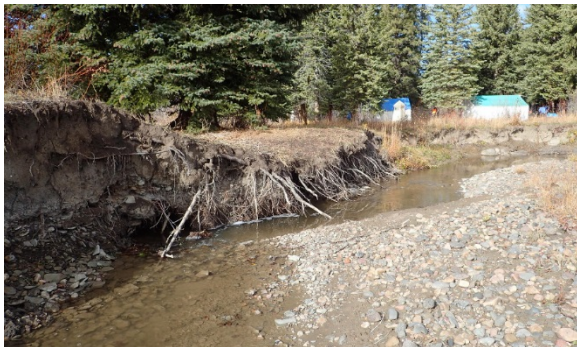
The three observed locations where it appears that relatively-high rates of streambank erosion is occurring and could lead to meander cutoffs are illustrated in Figures 7 to 9. The locations are

indicated in Figure 4 by the red circles, with the numbers referring to the figure numbers. Aerial imagery was utilized to measure the average rate of bank erosion at these three sites (1993 compared to 2016). The measured average bank erosion rates are indicated in the figure captions. However, these rates can be greatly exceeded during future large floods.

**Figure 7:** Active bank erosion and downstream meander migration. A hunting camp is shown in the background. Average erosion rate (1993 to 2016): 1.8 ft/year. The location is indicated in Figure 4.

This alternative would include actions from alternatives 2 and 3 but would also include the engineered installation of bank stabilization structures to narrow the channel in such locations as the downstream subreach (Figure 11), and to reduce the bank erosion rates associated with meander migration (Figure 4) that will likely lead to meander cutoffs, higher local gradients, and additional channel incision. This alternative would require fairly difficult mobilization of construction equipment and materials.

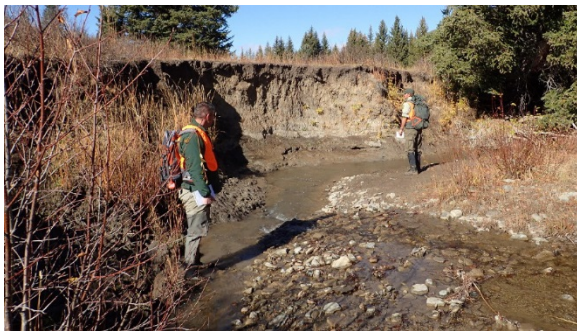
**Figure 8:** Active bank erosion and downstream meander migration. Average erosion rate (1993 to 2016): 0.6 ft/year. The location is indicated in Figure 4.

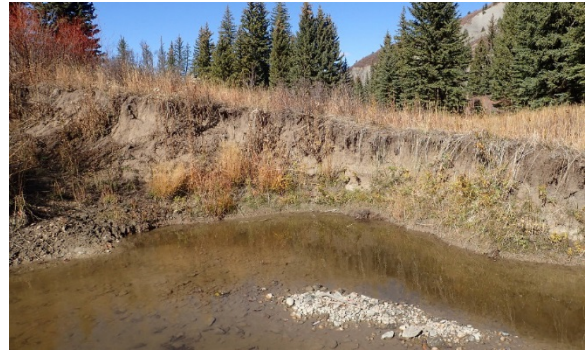
**Figure 9:** Active bank erosion and downstream meander migration. Average erosion rate (1993 to 2016): 1.8 ft/year. The location is indicated in Figure 4.

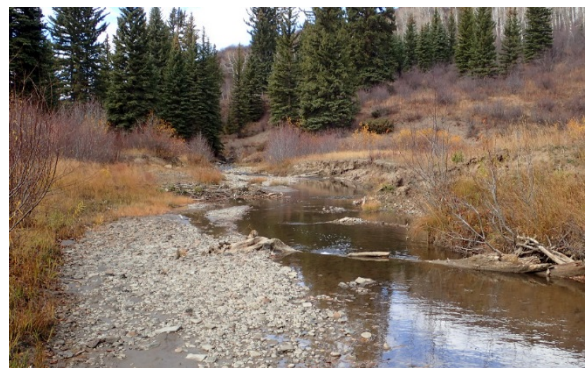
Work performed downstream on Milk Creek, on the Milk Creek Ranch, has indicated that the bankfull channel width in well-vegetated reaches can be as narrow as 22 to 24 feet. Generally, reach C has bankfull channel widths that are not excessive but, in places, the channel is overly wide. This is especially the case towards the downstream limit of reach C (Figure 10). As shown by historic aerial imagery (Figure 11), the current straight form of the downstream limit of reach C is a recent development. It appears that a more complex channel existed in 1993, though the upper portion of this reach was still relatively straight.

**Figure 10:** Overly-wide portion of reach C.

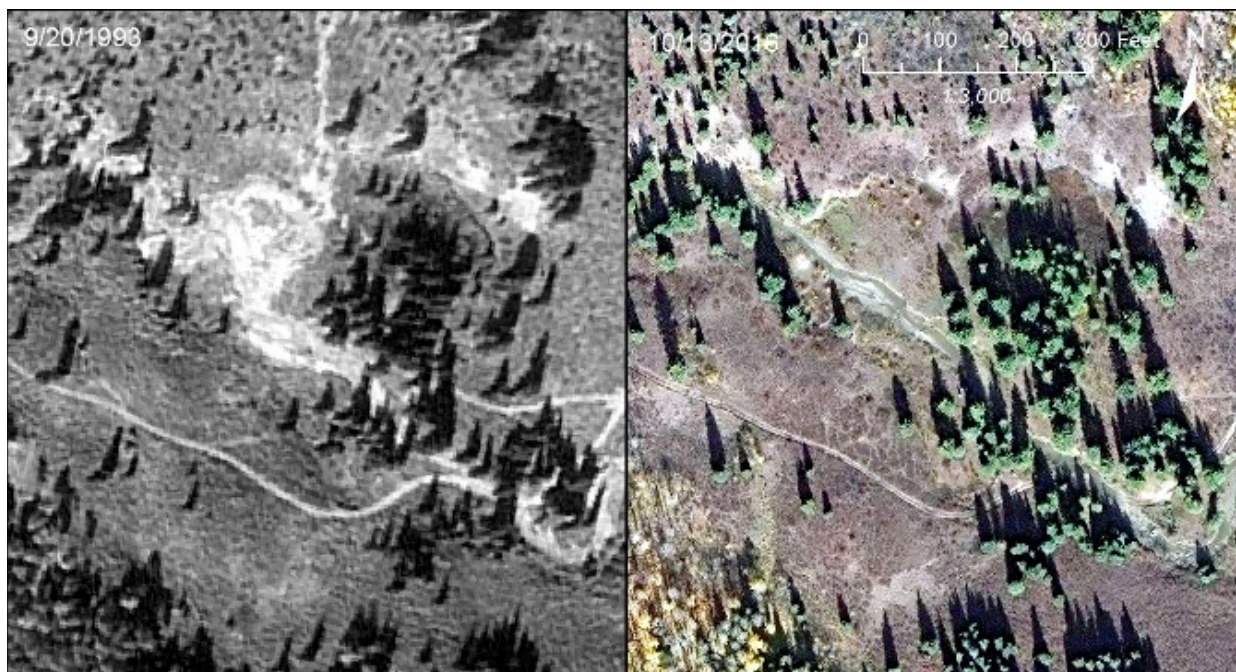
**Figure 11:** Aerial imagery of the downstream portion of reach C, from 1993 (left) and 2016 (right). This reach has decreased in complexity, with a current straightened form with excessive channel widths.

Reach C generally has reasonable bankfull channel widths and frequently has relatively-narrow low flow channels, though overly-wide conditions are prevalent towards the downstream limit and, in places, the low flow channel is overly wide. An overly-wide low flow channel results in excessive solar heating during critical

post-snowmelt summer periods. The noted downstream reach (Figure 11), which has been simplified over the last 23 years, could be a candidate for engineered manipulation. However, mobilization of heavy machinery to this reach could be challenging. An alternative to consider is the introduction of large wood, with attached rootwads, to increase complexity within this subreach.

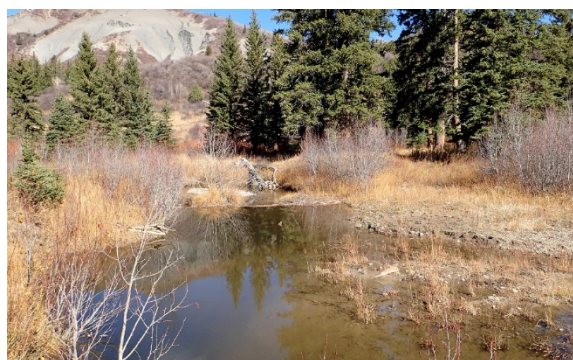
Alders along the channel banks are common throughout this reach (Figure 12). Willows are also present, with some portions of the reach having dense stands (Figure 13), while other portions having sparse coverage (Figure 12). A few narrowleaf cottonwoods (*Populus angustifolia*) were also observed, though they are young and sparsely present throughout the reach. Weeds were also observed, including houndstongue (*Cynoglossum officinale*) and plumeless thistle (*Carduus acanthoides*).

Beaver activity was observed within this reach, including browsing, burrowing, and the building of small dams. In places, the beaver population may be a bit excessive for the current willow population.

Sheep grazing occurs on this reach, with this livestock appearing to be negatively impacting the riparian vegetation. The willows are being browsed, likely from sheep, deer, and elk. A comprehensive assessment of livestock and game utilization may be advisable.

**Figure 12:** Low beaver dam and impoundment, with alders along the channel banks and a sparse willow population.

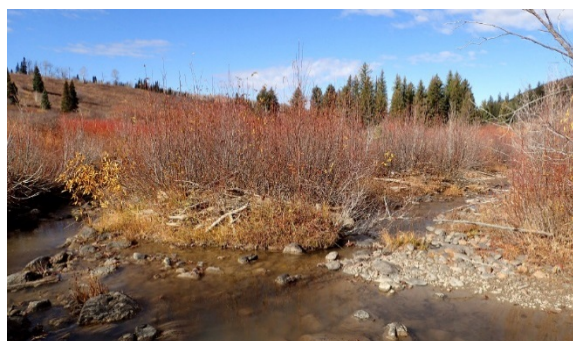
**Figure 13:** Dense willow stands along the Milk Creek channel, on the upper portion of reach C.

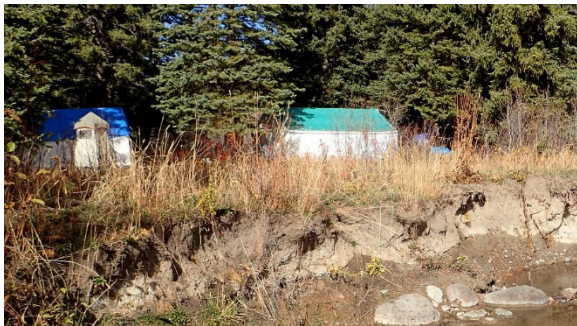
**Figure 14:** Hunting camp along the banks of Milk Creek reach C.

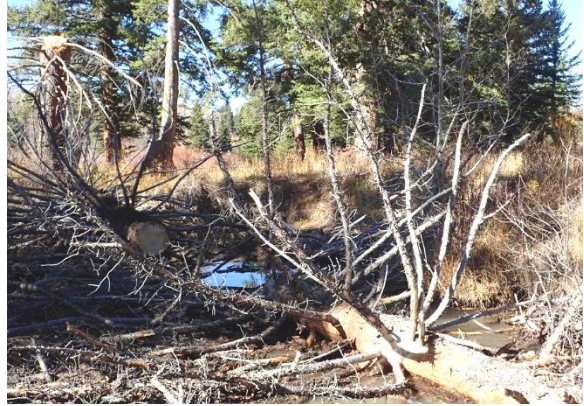
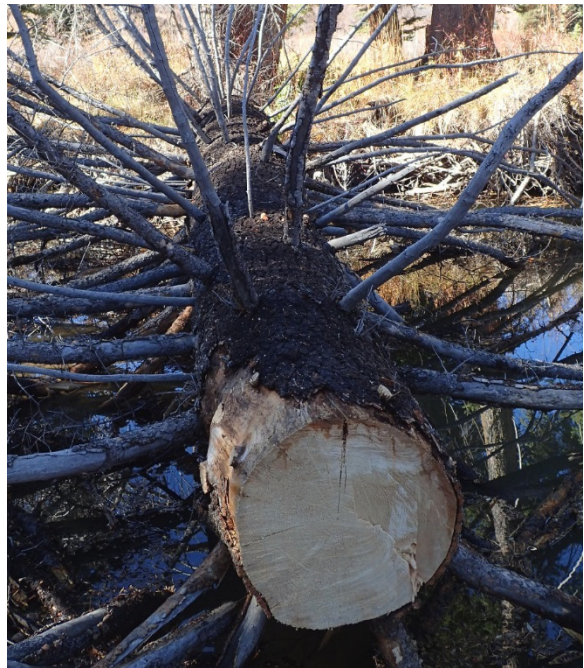
**Figure 15:** Relatively large (about 18" diameter) instream wood harvested as firewood for nearby hunting camps.

Large wood is present to an extent within reach C and are contributing to pool development. However, the recruitment potential within this reach is limited and wood is being actively removed for firewood collection by hunting camps. These campers are untraditional with respect to other Forest users since they set up sites for weeks at a time, have high demand for firewood due to multiple burning needs (wood stoves and fire pits), and have chainsaws and axes for harvesting larger wood sizes. Direct harvesting of wood from stream channels needs to be curtailed for the sake of the cutthroat trout population. Additionally, the introduction of large wood (with rootwads) should be considered. Windthrow emulations (Figure 18) may be most feasible and effective. It's very feasible for a skidder to negotiate the access road to the site.

In addition to the vegetation plantings and management activities of alternative 2, to increase the willow and cottonwood populations, this alternative would harvest local trees (with rootwads) for strategic placement in the channel. This large wood introduction could increase the channel complexity, reduce the rate of meander migration and cutoffs (Figure 4), provide cover, and add to the pool frequency, depth and extent, and increase bed material size variability. This alternative would also counteract the negative

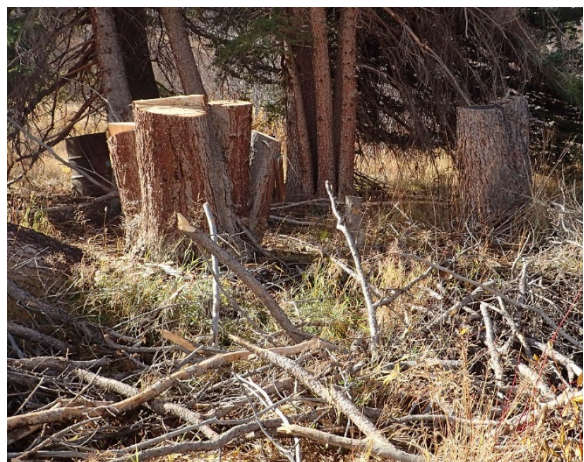
**Figure 16:** Firewood harvesting for nearby hunting camps.
