**U.S. FOREST SERVICE
NATIONAL STREAM AND AQUATIC ECOLOGY CENTER**

PICKEL MEADOW: STREAM CONDITION and RESTORATION POTENTIAL

Client: Humboldt-Toiyabe National Forest

Location: Pickel Meadow, West Walker River, Mono County, California

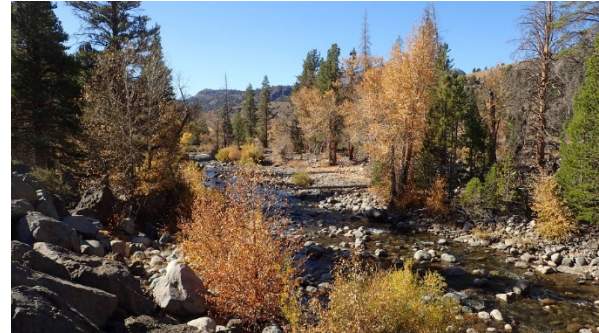
The upper part of **reach 1** (Figure 5, Figure 6) is dominated by boulder-size material, in both the channel as well as the floodplain and terrace surfaces. Cobbles and gravels are also present. The large bed material may have been deposited during the flood of January 1997, as well as during previous (undocumented) large floods. The upper portion of this reach is bounded by trees, with shrubs also present. Sporadic large wood deposited within the floodplain was noted, though no material was observed in the channel. Thin to nonexistent soils were noted on the floodplain and terrace surfaces. Impact scars on trees were noted likely from the 1997 flood.

Figure 5: Upper portion of reach 1 (viewing downstream), with streamside shrubs and trees present. Thin floodplain and terrace soils were observed over deposited alluvium.

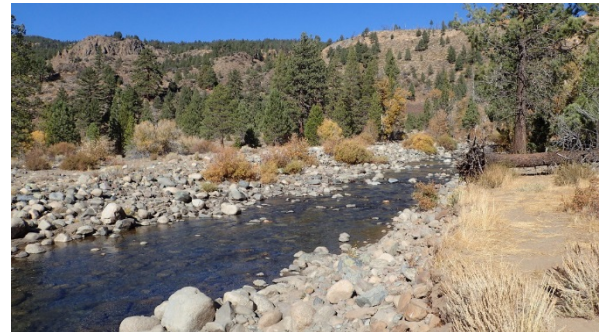
Figure 6: Upper portion of reach 1 as it is transitioning from the presence to absence of trees (viewing upstream). Thin floodplain and terrace soils were observed on the right bank (as viewed downstream).

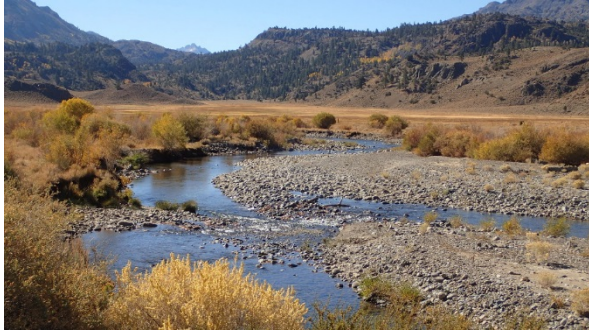
In the middle to lower part of reach 1 (Figure 7), the stream shows instability that appears to be associated with a terrace on the left bank, with more xeric to mesic conditions and with higher and less stable banks, as well as a response to the continued transition from the higher gradient canyon reach to lower-gradient meadow reach. This transition promotes sediment deposition. Cobble-size material appears to be dominant.

Figure 7: Middle to lower portion of reach 1 (viewing downstream), with a terrace on the left bank and meadow on the right bank.

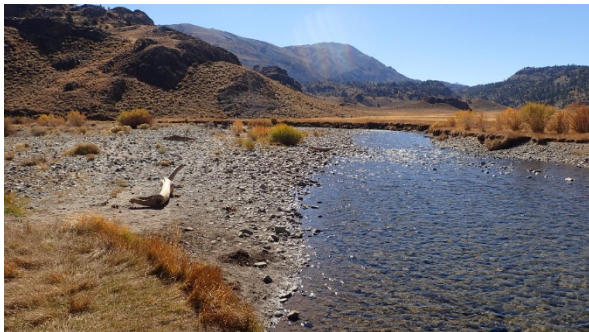
The downstream end of reach 1 (Figure 8) has a wide wet meadow present on the right bank, with the confluence of a small stream (Poore Creek) that feeds this meadow. The West Walker River is mildly incised (~1 ft) compared to this meadow surface, but still has 300 ft of active floodplain width present (Appendix A, X-S 2). The high left

Figure 8: Lower limit of reach 1, with an expansive meadow present on the right (West) bank.

bank along the lower portion of reach 1 continues to this point. This terrace is 5 ft above the bankfull water surface at the lower limit of reach 1.

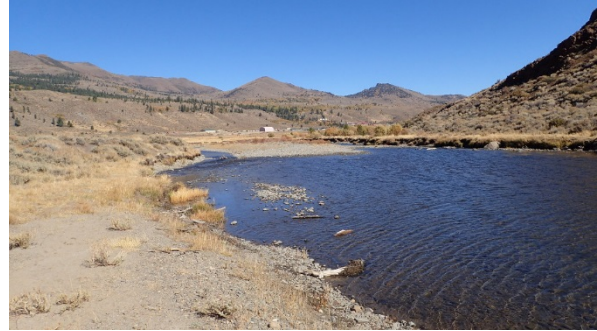
Proceeding downstream through **reach 2** (Figure 9, Figure 10), the bed material appears to shift from cobble to gravel dominated size material. The largest extent of Pickel Meadow is on the left side of the West Walker River in this reach, with the surface of the meadow adjacent to the current floodplain functioning as a terrace that is 3 to 4 ft above the bankfull elevations. High banks are also present in places on the right (south) bank (Figure 11). However, the current active floodplain is wide, with up to at least 900 ft widths (Appendix A, X-S 3, 4, &5). Minimal willows are present along this reach and no in channel large wood was observed. Minimal pool development was also observed.

Figure 9: Reach 2 (viewing downstream).

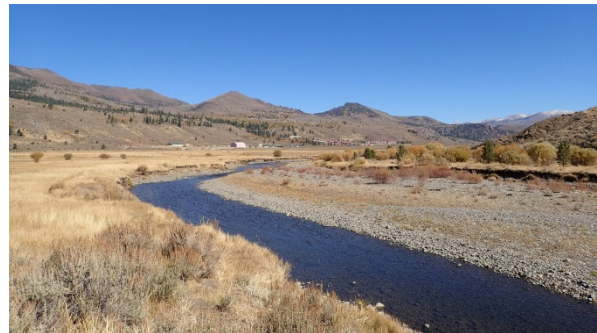
Figure 10: Reach 2 (viewing downstream).

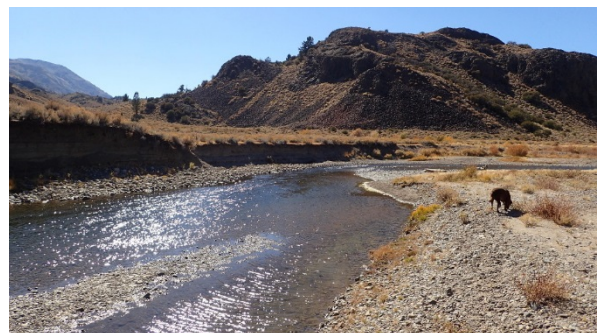
The terraces and current and former meadow surfaces along reach 2 show a mix of vegetation types, from hydric, to mesic, to xeric. This is likely due to these surfaces being various elevations above the low flow (dry season) water surface (up to 9 ft).

Figure 11: Reach 2 (viewing upstream), with high banks on the right side of the channel (as viewed downstream; south).

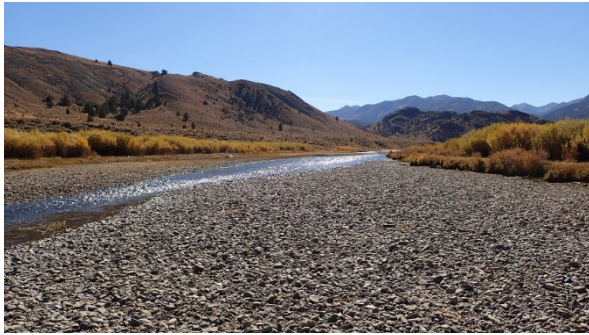
Reach 3 (Figure 12, Figure 13) is semi confined by high terraces (15 to 40 ft above the current floodplain surface). An active floodplain exists within this confinement; it varies in width from about 500 to 800 ft (see Appendix A, X-S 6 for an example). An extensive stand of mature willows is present within this reach, primarily on left (north) bank. Sedges are also widely present. Side channels were also observed within the floodplain of reach 3 (Figure 13), with groundwater connectivity noted.

Mature willows were heavily browsed to about 4 ft; deer appear to be having a high impact here and may pose problems for vegetation recovery during restoration.

Figure 12: Gravel bar, mature willows, and wide floodplain of reach 3, viewing upstream.

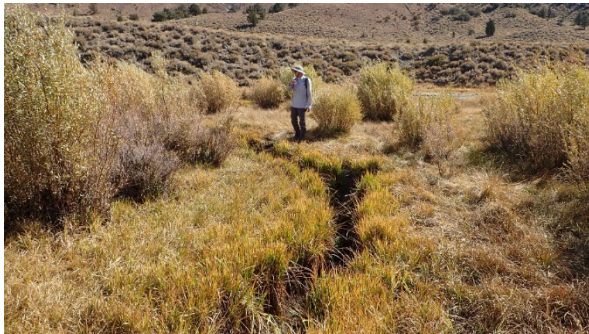
Figure 13: Side channel and willows on north bank of reach 3.

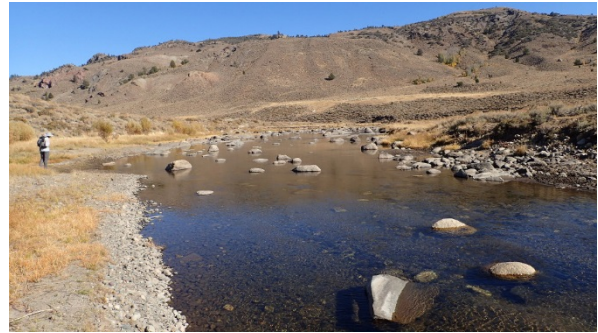
Reach 4 (Figure 14, Figure 15) is generally unconfined, with an extensive meadow existing along Silver Creek near the confluence. Unlike the reach 2 portion of Pickel Meadow, the lower portions of this meadow appear to be still connected as active floodplain surfaces of the West Walker River (Appendix A, X-S 8). Fewer willows are present along this reach than in reach 3. Underwater exposed clay lenses, which provide some cover, were observed near the upstream limit of reach 4 (Figure 16).

Figure 14: West Walker River in reach 4, viewing downstream.

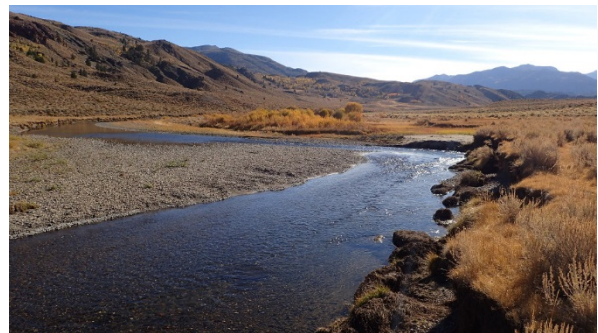
Figure 15: Lower portion of reach 4, viewing upstream.

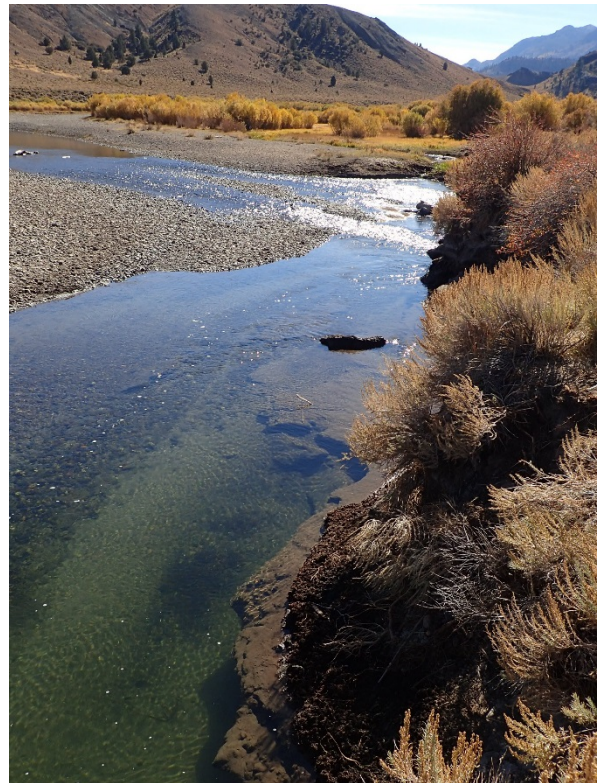
Figure 16: Underwater clay lenses in reach 4 that provide some fish cover (viewing upstream).

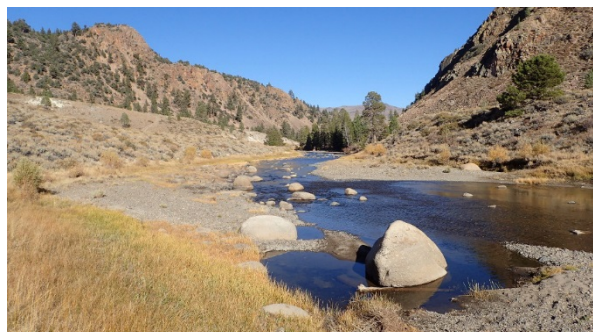
Reach 5 (Figure 17) is confined by high terraces (15 to 55 ft high), though active floodplains are still present (Appendix A, X-S 9). Larger bed material sizes (up to boulder sized) are present within portions of this reach.

Figure 17: Reach 5, viewing downstream.

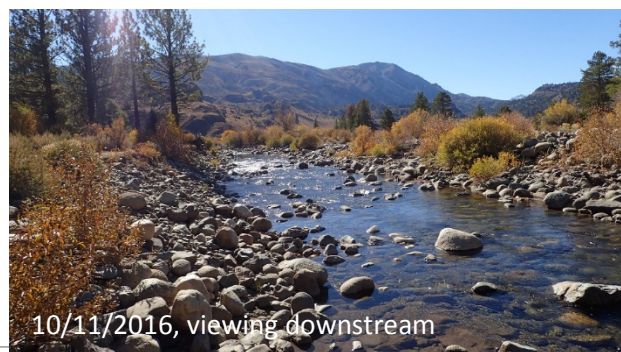
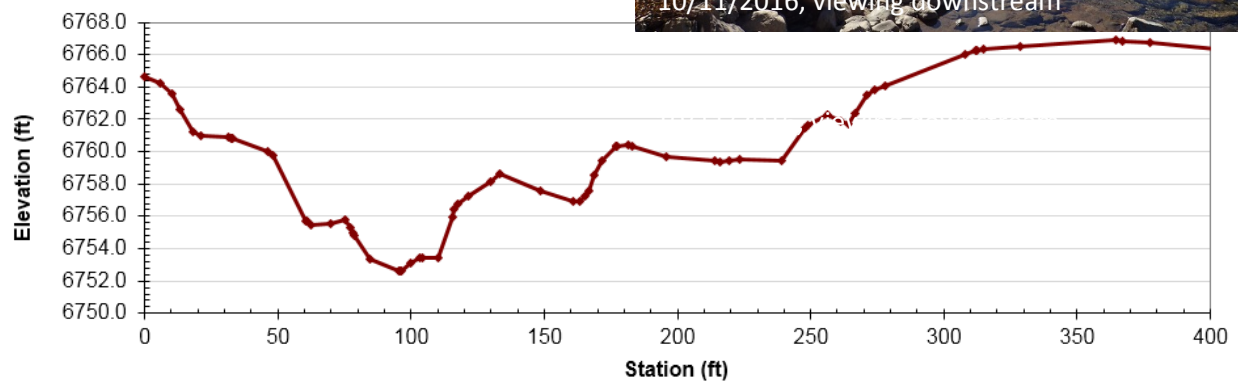
X-S 1

Stream is incised, without reasonable bankfull indicators

Large bed material is present within this transition from canyon to meadow on a constrained alluvial fan

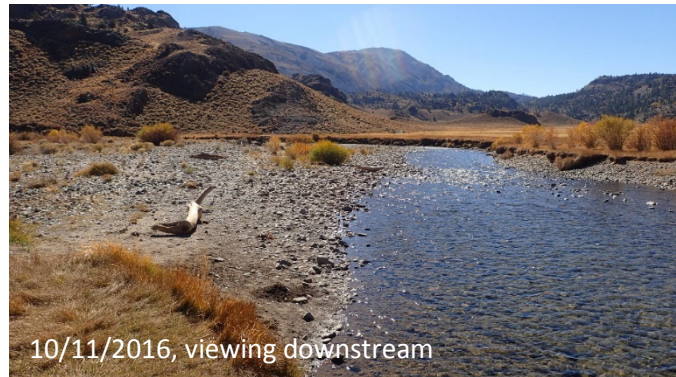
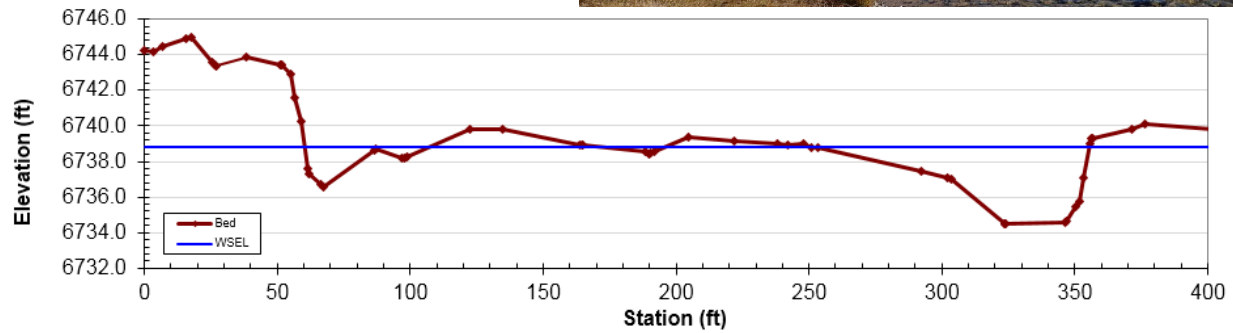
X-S 2

Active floodplain is 300 ft wide

$Q_{bnk} = \sim 780$ cfs

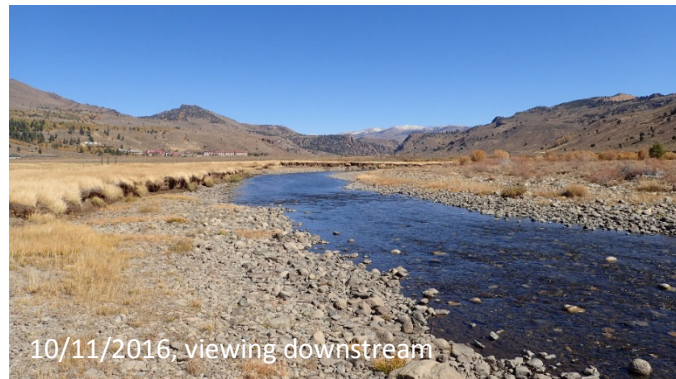
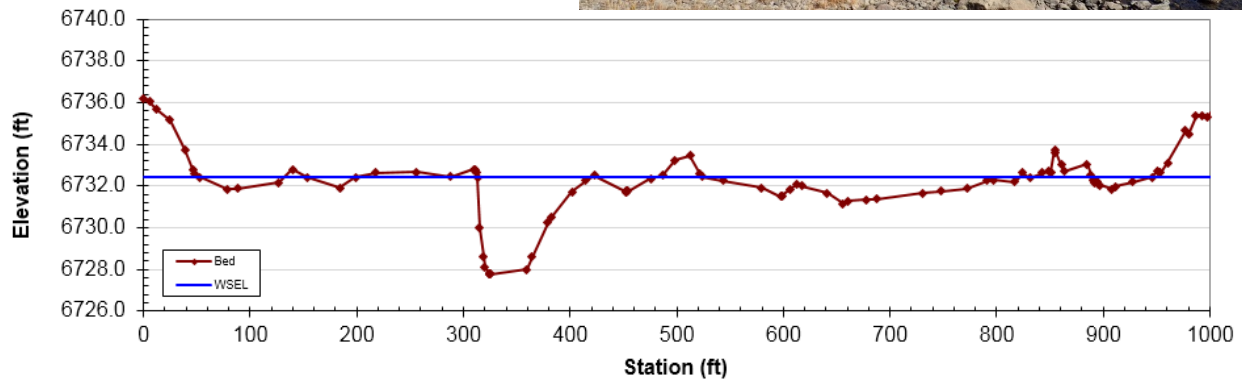
X-S 3

Active floodplain is 900 ft wide

$Q_{bnk} = \sim 880$ cfs

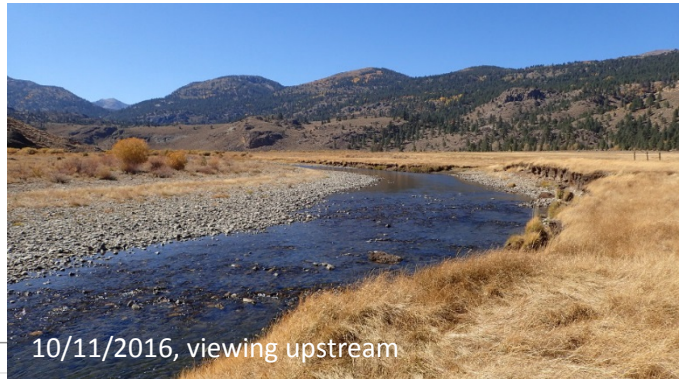
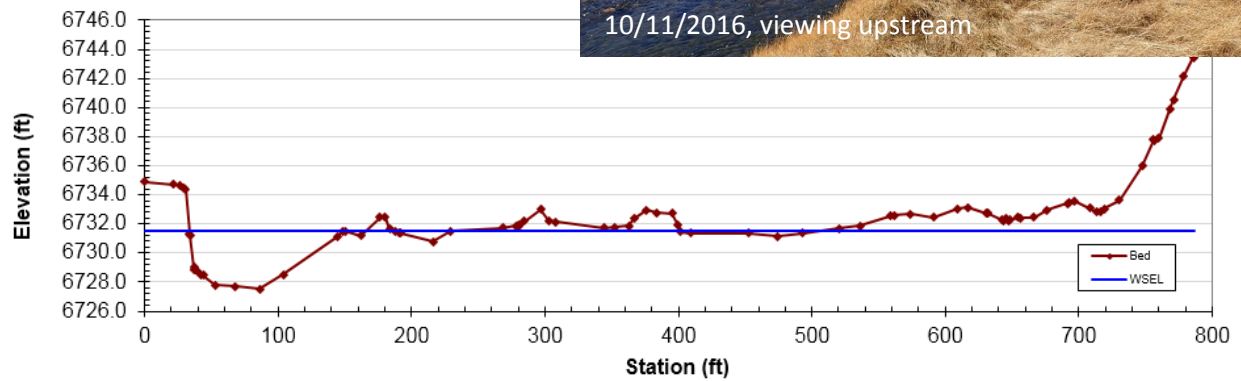
X-S 4

Active floodplain is 700 ft wide

$Q_{bnk} = \sim 720$ cfs

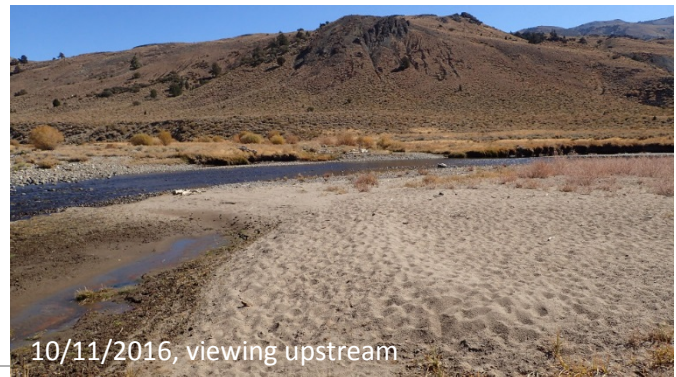
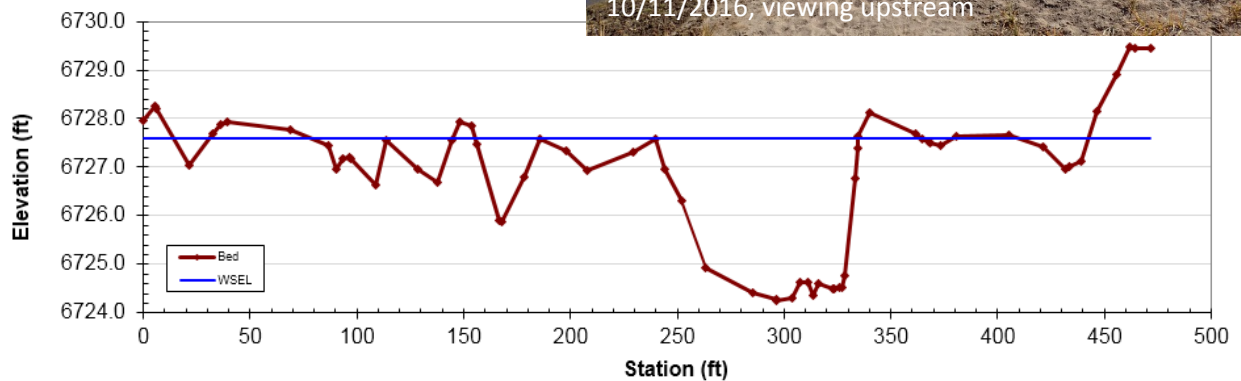
Floodplain is wide, with X-S 5 across only the primary channel and adjacent floodplain

$Q_{bnk} = \sim 790$ cfs

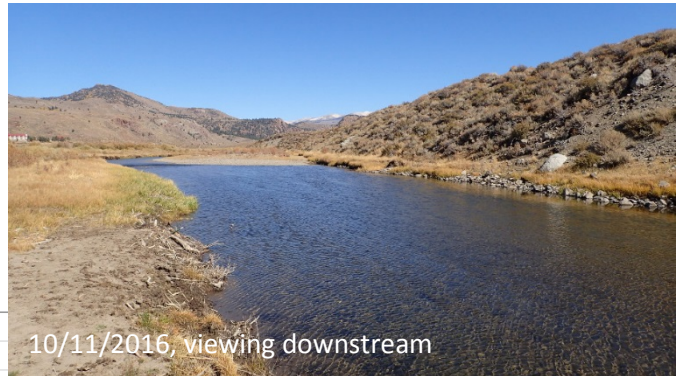
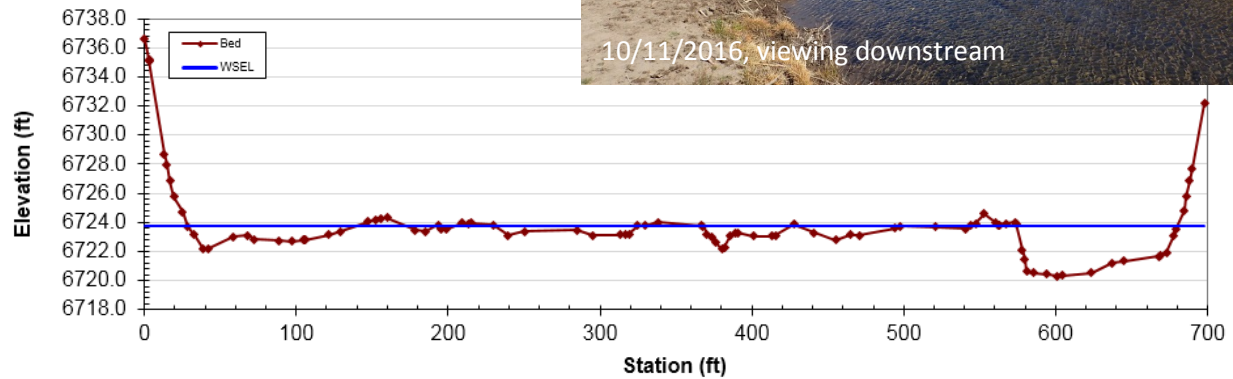
X-S 6

Active floodplain is 650 ft wide

$Q_{bnk} = \sim 750$ cfs

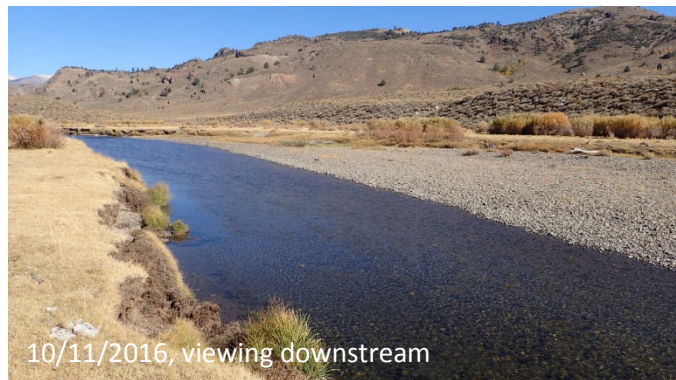
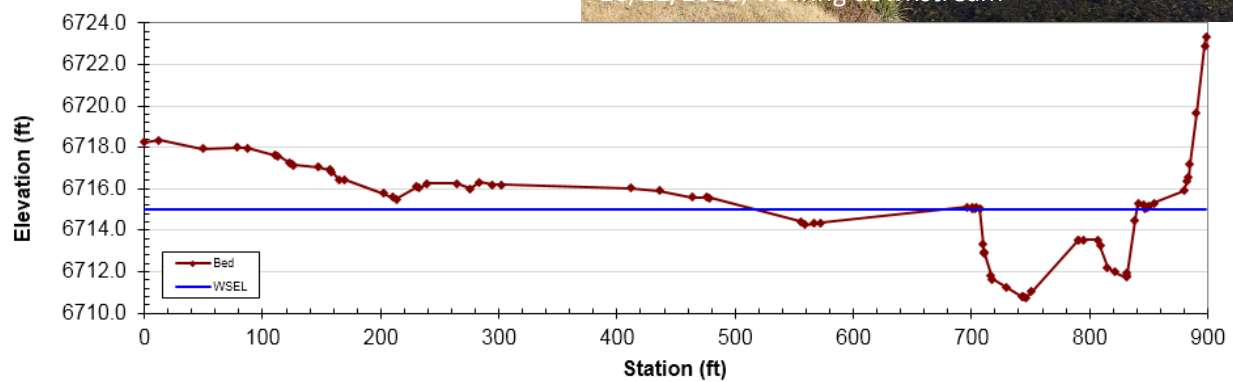
X-S 8

Floodplain slopes up to a smaller unconfined meadow system (reach 4)

$Q_{bnk} = \sim 1020$ cfs

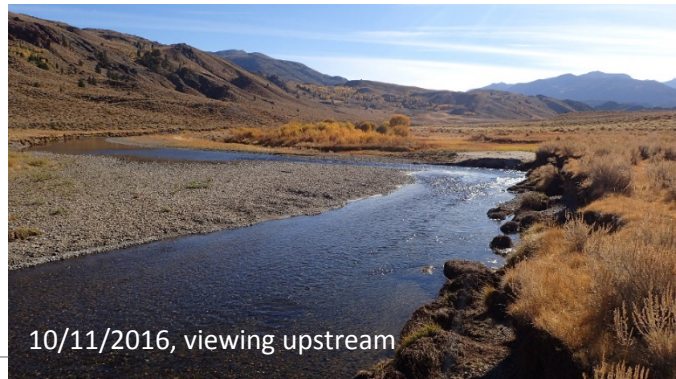
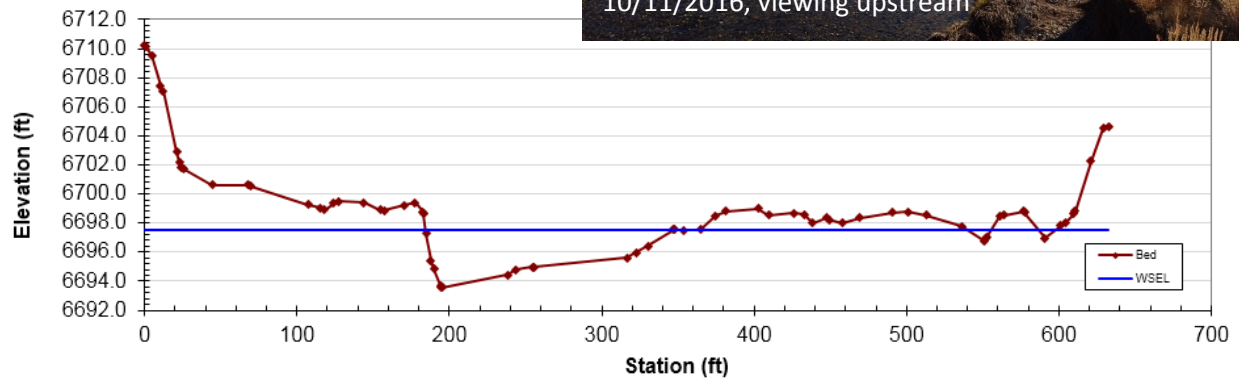
X-S 9

Left bank is a low terrace

$Q_{bnk} \approx 1110$ cfs
