**U.S. FOREST SERVICE
NATIONAL STREAM AND AQUATIC ECOLOGY CENTER**

RIO SAN ANTONIO: STREAM CONDITION and RESTORATION POTENTIAL

Client: Carson National Forest, Tres Piedras Ranger District

Location: Rio San Antonio watershed, Rio Arriba County, New Mexico

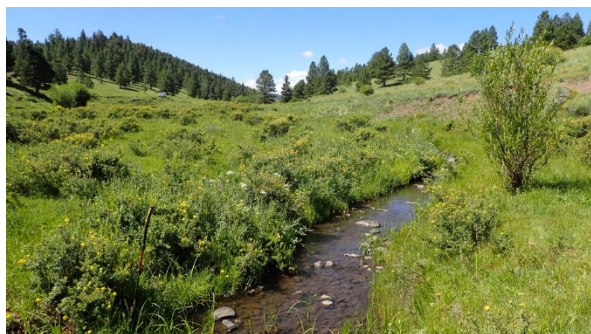
Figure 2: Reach of Canada Tio Grande with less vegetation cover.

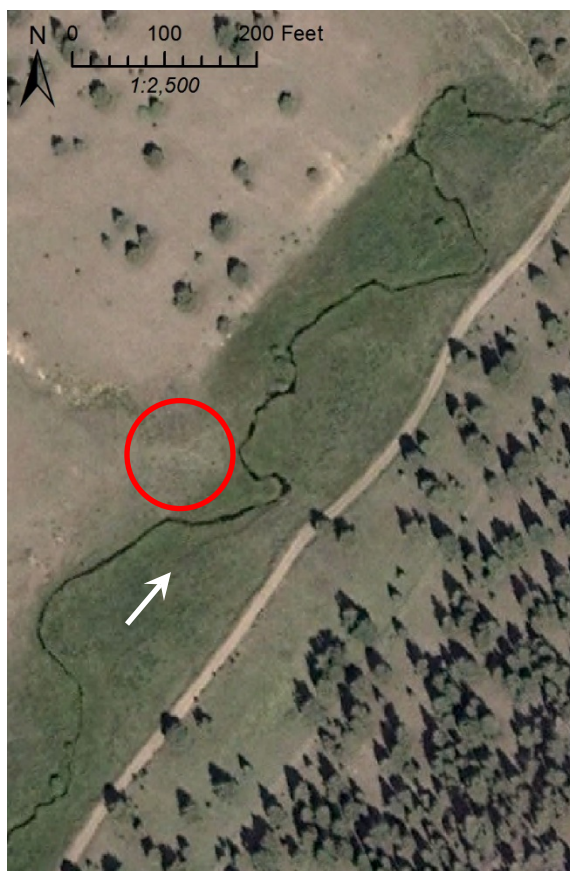
Figure 4: Canada Tio Grande example reach with less riparian vegetation present (10/4/2016). An alluvial fan is also present (red circle).

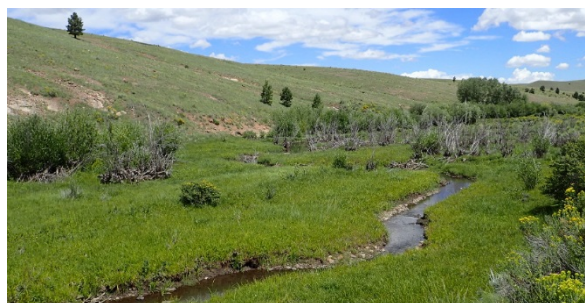
Figure 5: Decadent willows on Canada Tio Grande.

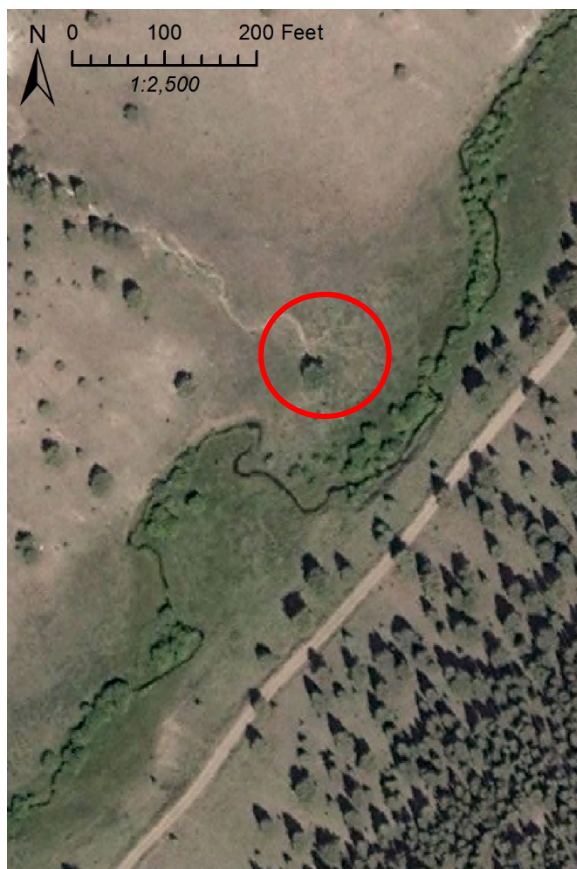
Alluvial fans from side drainages are present, influencing the fluvial geomorphology of the stream (Figure 6). In some locations these fans are pushing the channel to the far side of the valley bottom. Abandoned relic channels were noted in places, which could be utilized in restoration activities. Beaver activity was noted in at least one location, where a dam had failed prior to the field visit and had not yet been reconstructed. A maintained beaver dam and impoundment was noted in the September 2016 imagery (Appendix A).

Figure 6: Canada Tio Grande (10/4/2016), example reach with more riparian vegetation present. A tributary alluvial fan (red circle) is also present.

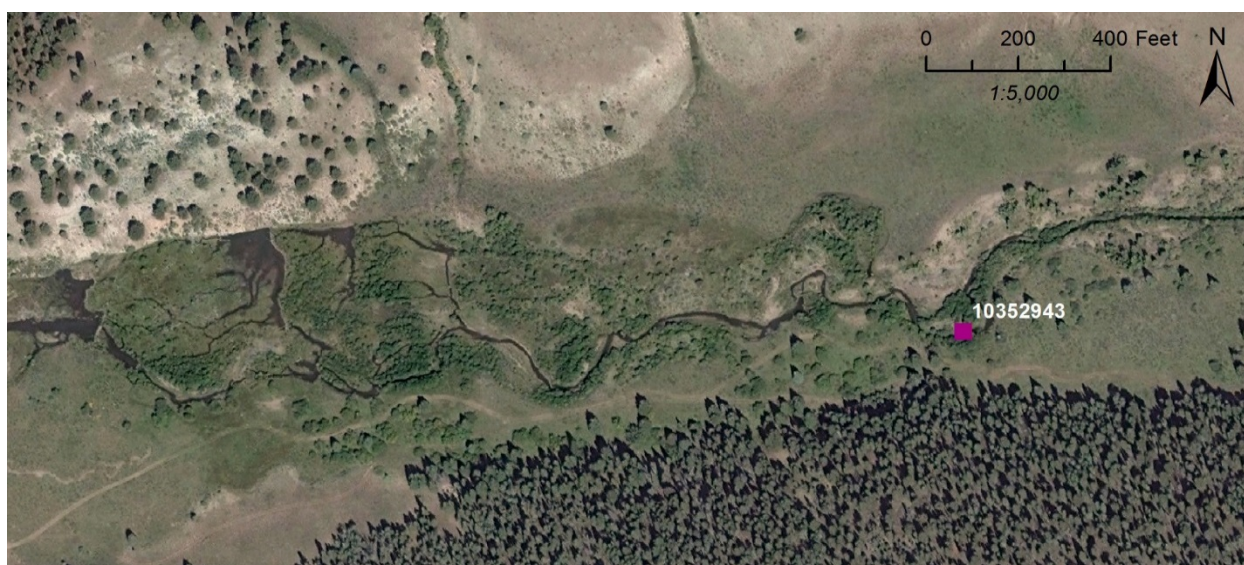
Figure 7: Lower Rio San Antonio proposed restoration reach (2016-10-4), downstream (just above private lands). Beaver activity is evident, with numerous currently-maintained ponds. Temperature monitoring at noted point (ID 10352943) in 2013.

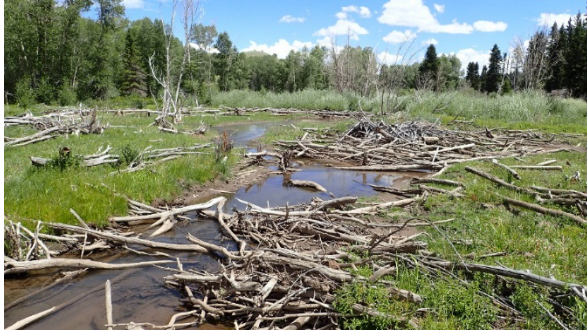
recently inundated areas where dams have not been recently maintained (Figure 9) have a prevalence of dead willows and alders present (presumably due to inundation), though alder and willow recruitment was observed in these areas. Generally, in disturbed reaches substantial vegetation recovery was noted (Figure 10).

Figure 9: Beaver dam-impacted reach on lower Rio San Antonio.

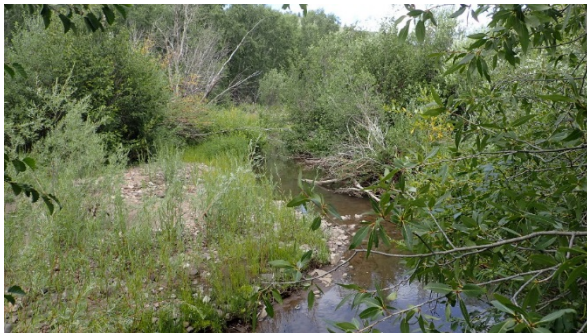
Figure 10: Vegetation recovery on lower Rio San Antonio.

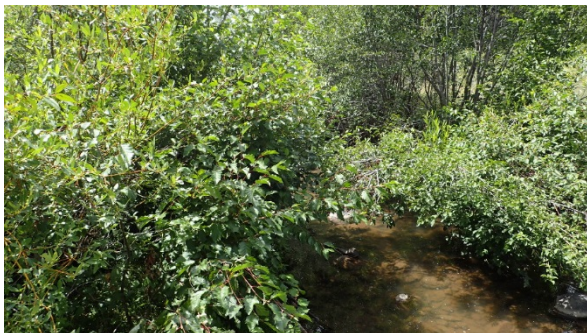
Figure 11: Well vegetated incised reach on lower Rio San Antonio.

In some areas the channel appears to be incised, with up to 18 inches or so of incision and resulting disconnections from its former floodplain. However, these reaches have generally recovered

with a narrower but well vegetated floodplain (Figure 11) that provides cover for fish and solar radiation (reducing temperature increases). This vegetation at the incised grade is also providing substantial amounts of bank stabilization and fine sediment load reduction (compared to unvegetated surfaces).

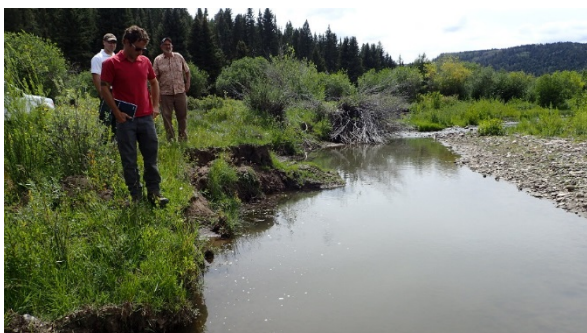
Figure 12: Unstable streambanks on lower Rio San Antonio.

At some locations, more substantial erosion-induced disturbance was observed (Figure 12). Such reaches are overwidened and are receiving excessive solar radiation, potentially leading to increased water temperatures.

However, some locations of more substantial erosion, less vegetation cover and bank stabilization, and overly-widened channels were observed (Figure 12). These reaches may be candidates for more extensive restoration practices, such as the installation of toe wood and

In addition to fencing, a few reaches may benefit from more active restoration. Such restoration may consist of the installation of toe wood and bankfull benches and log bank vanes (to narrow the channel for reduced solar radiation and heating), and the introduction of additional large wood to the channel. Additional on-the-ground inspection is necessary to further evaluate this potential need. Additionally, beaver dam analogs could be considered where ground water table elevations are depressed compared to relic floodplain elevations, to restore riparian conditions and encourage additional beaver activity.

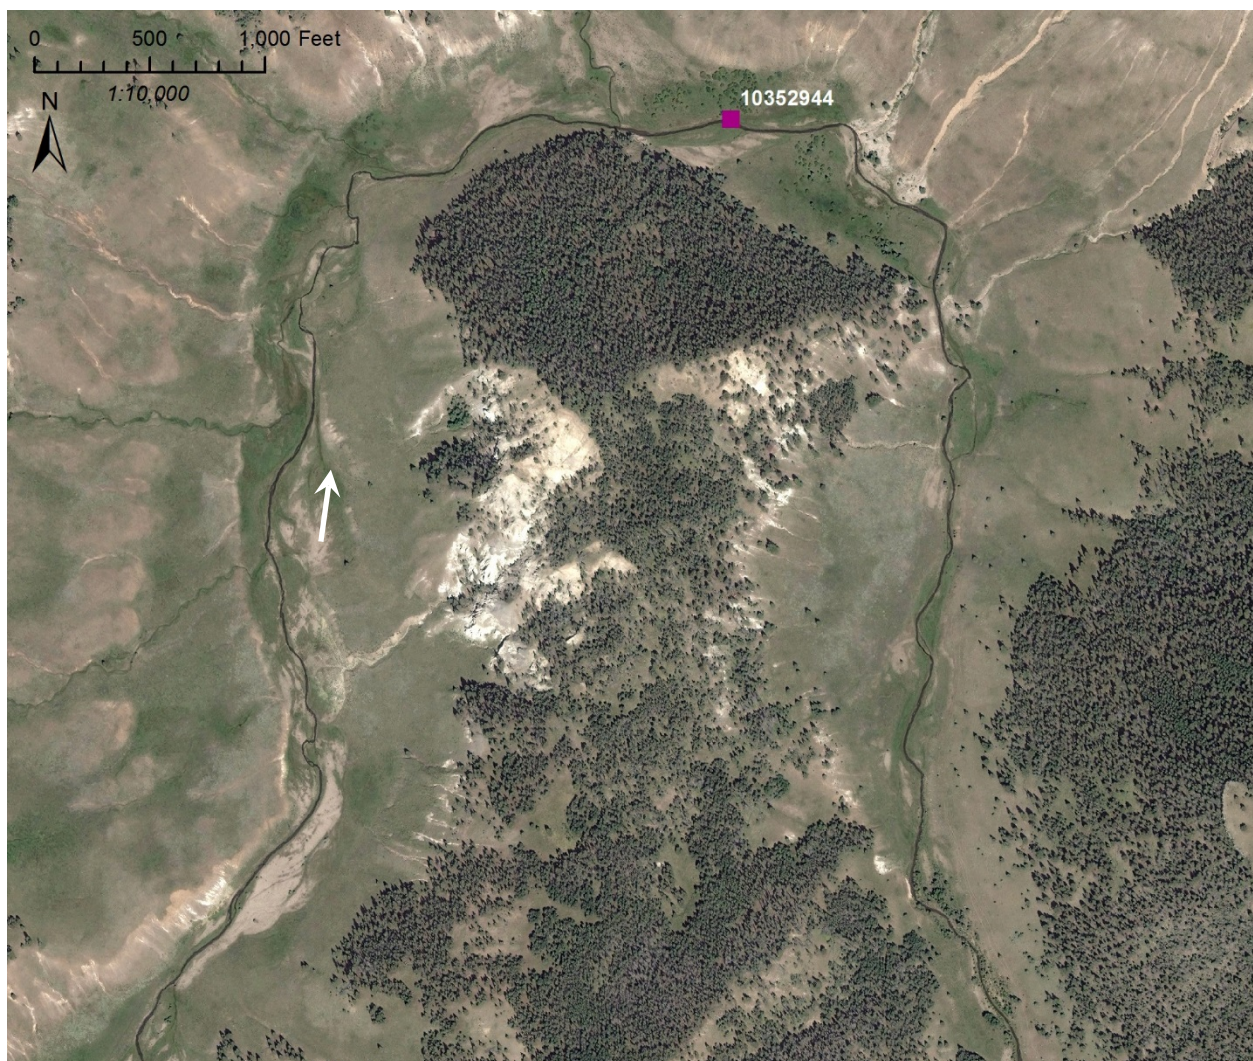
Figure 13: Upper Rio San Antonio proposed restoration reach (2016-10-4), downstream.

Numerous small alluvial fans are present along this reach (Figure 13), from small and a moderate-sized tributary (Canon Largo). Erosion of the terraces that are former floodplain surfaces that were abandoned with incision are evident, as is erosion of higher terrace surfaces, including portions of alluvial fans.

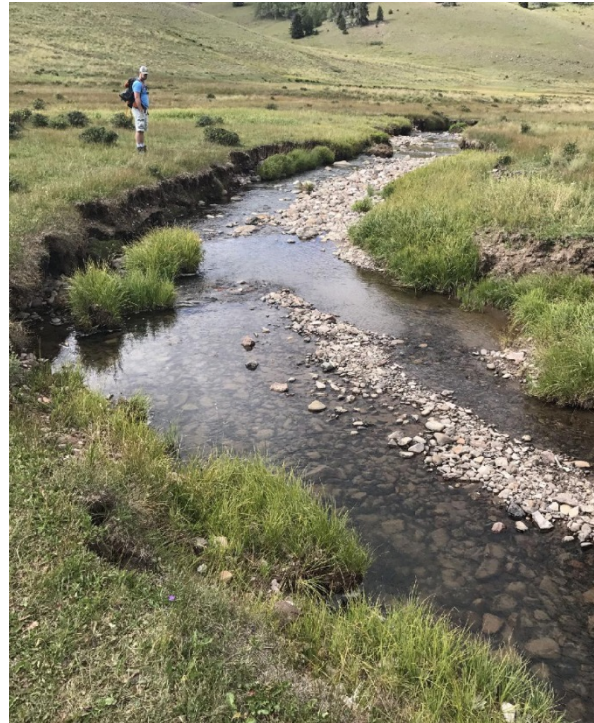
This reach is incised at a number of locations (Figure 16), with developed and vegetated bankfull benches frequently established at a lower grade (Figure 17). The riparian vegetation is impaired, with very heavy browsing of willows that is minimizing abundance and condition.

Figure 16: Incised stream channel, with limited riparian vegetation due to browsing (photo by Michael Gatlin).

In any case, an essential component of any restoration strategy is to reduce browsing of the woody vegetation, allowing shade and cover to develop. This would likely consist of both a cottonwood canopy as well as willows and alders. Exclusion fences will be required, with some of these enclosures likely needing to be greater than 0.1 acres.

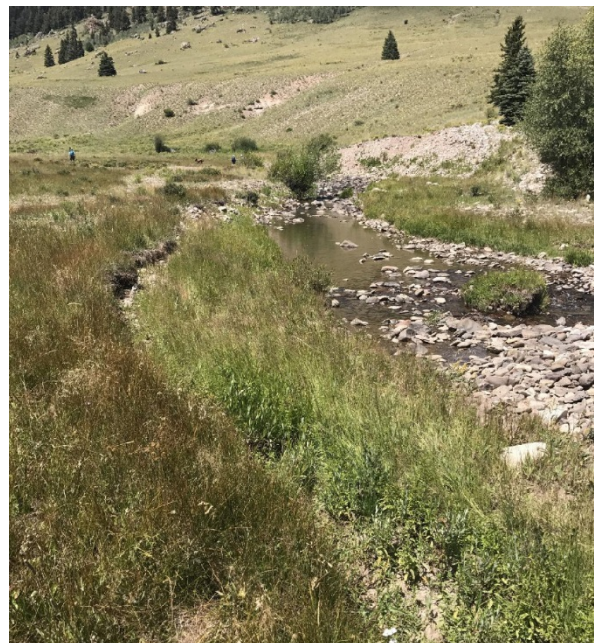
Figure 17: Inset floodplain development, with bankfull bench (photo by Michael Gatlin).
