**U.S. FOREST SERVICE
NATIONAL STREAM and AQUATIC ECOLOGY CENTER**

TULAROSA RIVER at NFSR-233: SITE VISIT and RECOMMENDATIONS

Client: Gila National Forest, Reserve Ranger District

Location: NFSR-233 crossing of the Tularosa River, Catron County, New Mexico

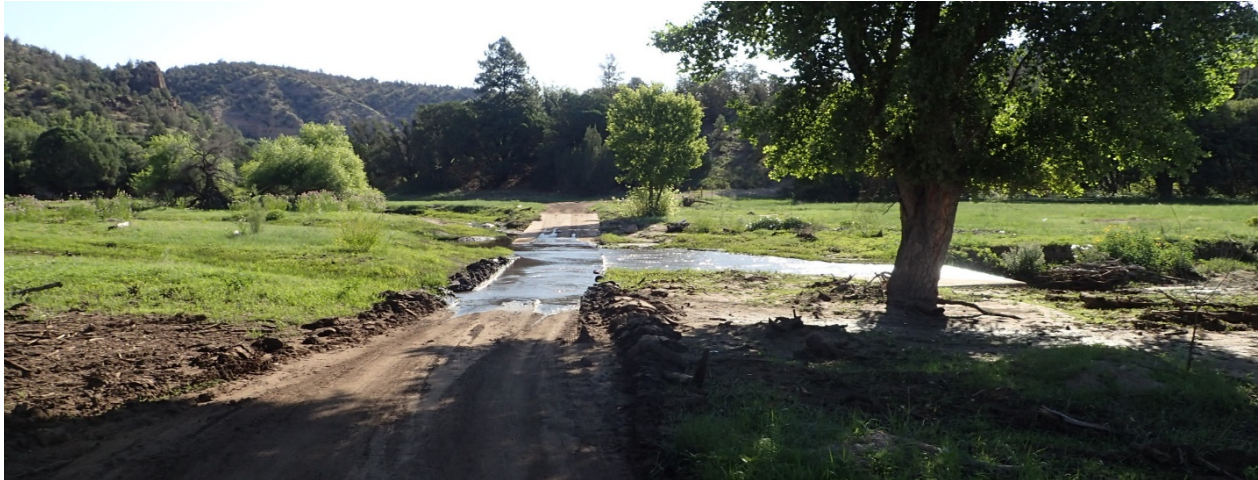
The NFSR-233 crossing of the Tularosa River consists of a concrete low water crossing (Figure 2) that spans a bit more than half of the valley width (Figure 3) at an angle to the valley profile. The 2009 addition of a concrete apron just downstream had the intent of increasing aquatic

Figure 2: National Forest System Road 233 crossing of the Tularosa River (flowing left to right), with concrete crossing, downstream concrete apron, and upstream wetlands.

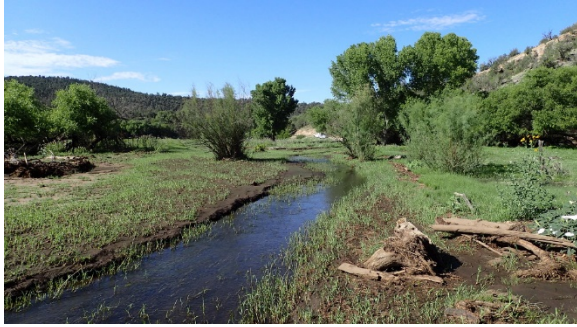
organism passage for the loach minnow; it is unknown if this feature was effective in satisfying this objective. Immediately upstream of the crossing is a wetland, with a multi-thread channel (Figure 4, Figure A-1). Just downstream of the apron is a scour hole (Figure 5) with a depth of 4 to 6 feet (from apron surface). Large rocks have been placed along the edge of the apron, with the intent of arresting headcutting proceeding along the edge of the apron towards the crossing.

Figure 4: Wetlands upstream of the crossing.

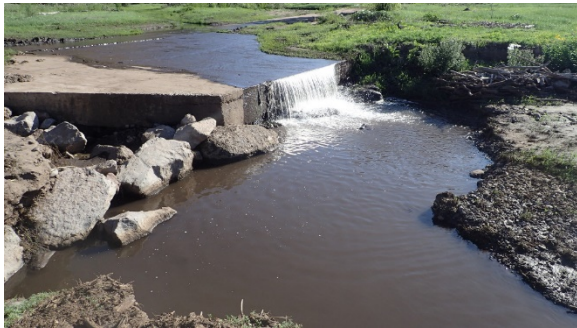
Figure 5: Scour at downstream limit of concrete apron. This is an aquatic organism passage barrier for the target species (loach minnow).

The drop at the edge of the apron (Figure 5) is an aquatic organism passage barrier to the loach minnow and will be a long-term point of instability due to associated high energy (a knickpoint). Such

scour is common downstream of low water crossings, likely due to flow acceleration across the smooth surface. Considering this, the apron likely made the problem worse by providing additional length for flow acceleration during high flow. The skewed orientation of the crossing is also a problem; a crossing perpendicular to the valley profile would be preferred. Additionally, channel incision downstream of the structure is resulting in groundwater table elevation reductions and increased geomorphic instability for a distance of about 1000 feet, which is negatively impacting riparian resources, including an adjacent spring system.

The concrete apron placed immediately downstream was added to assist with aquatic organism passage. It is unknown if this structure actually assisted with passage, though the scour downstream of the structure is now preventing passage, with this scour likely made more severe by the apron. Removal of the apron is recommended as a part of a restoration strategy at this crossing.

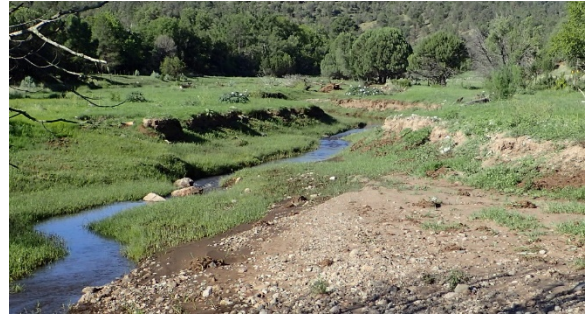
Downstream of the crossing the channel is incised for a distance of roughly 1000 feet (Figure 6, Figure 7), with this incision in a predominantly fine-grained material. Gravel-sized dominated material was observed on the channel bed. This incision decreases in the downstream direction until the channel appears to be more connected with its floodplain (Figure 8) in the vicinity of a National Forest boundary with downstream private lands. (Further downstream the channel appears to be once again incised, and may have been channelized.) The incision just downstream of the crossing has resulted in dropped groundwater table elevations immediately downstream of the apron, for at least a few hundred feet (Figure A-1). A spring is present 300 feet downstream of the crossing, on the left side – this incision may also be impairing this feature.

Figure 6: Incision downstream of the NFSR-233 crossing. Viewing downstream ~200 feet downstream of the crossing.

Regarding the downstream channel incision (Figure 6, Figure 7), this reach appears to be predominantly in channel evolution model stages 3 and 4 (Figure 10), with stage 2 immediately downstream of the crossing. The channel evolution model (Schumm et al. 1984) is a valuable tool for understanding the dynamics of stream disturbance and recovery processes. The method describes the movement of a headcut through a channel reach and the consequential evolution of the channel over time and space. This provides a framework for evaluating longitudinal response and restoration potential. At a specific location the channel evolves from an initial stable state (stage 1) through incision (stage 2), widening (stage 3), deposition and stabilization (stage 4), and once again stable (stage 5). Stages 2 and 3 are the most challenging stages of the evolution model for managers; this is the stage where instability and sediment supply is highest and restoration options are limited. Over time, the incision (at a knickpoint) moves upstream, forcing evolution of the valley bottom on successive upstream reaches.

Restoration of the downstream channel and floodplain is recommended. This restoration would consist of filling the high unit stream power channel with borrow material from a suitable source, to eliminate the knickpoint at the downstream limit of the crossing, reconnect the channel with its floodplain (reducing unit stream power), and raising groundwater levels to

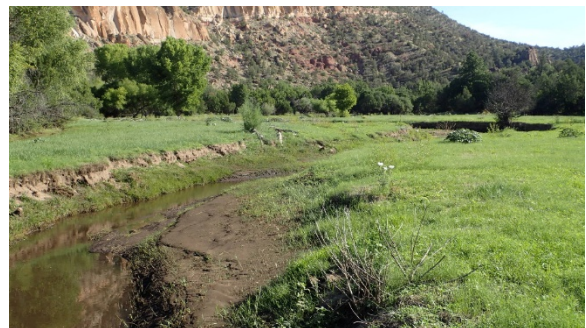
Figure 7: Incision downstream of the NFSR-233 crossing. Viewing upstream from ~600 feet downstream of the crossing.

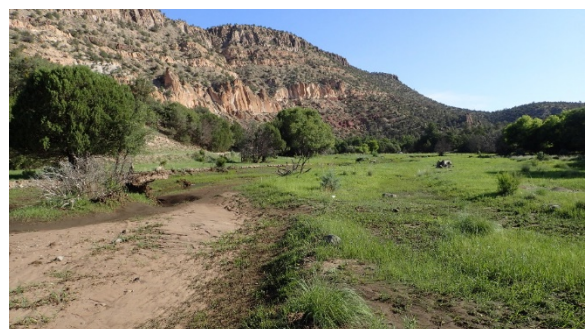
Figure 8: Tularosa River at downstream limit of the incision-dominated reach. Viewing upstream from ~1000 feet downstream of the crossing.

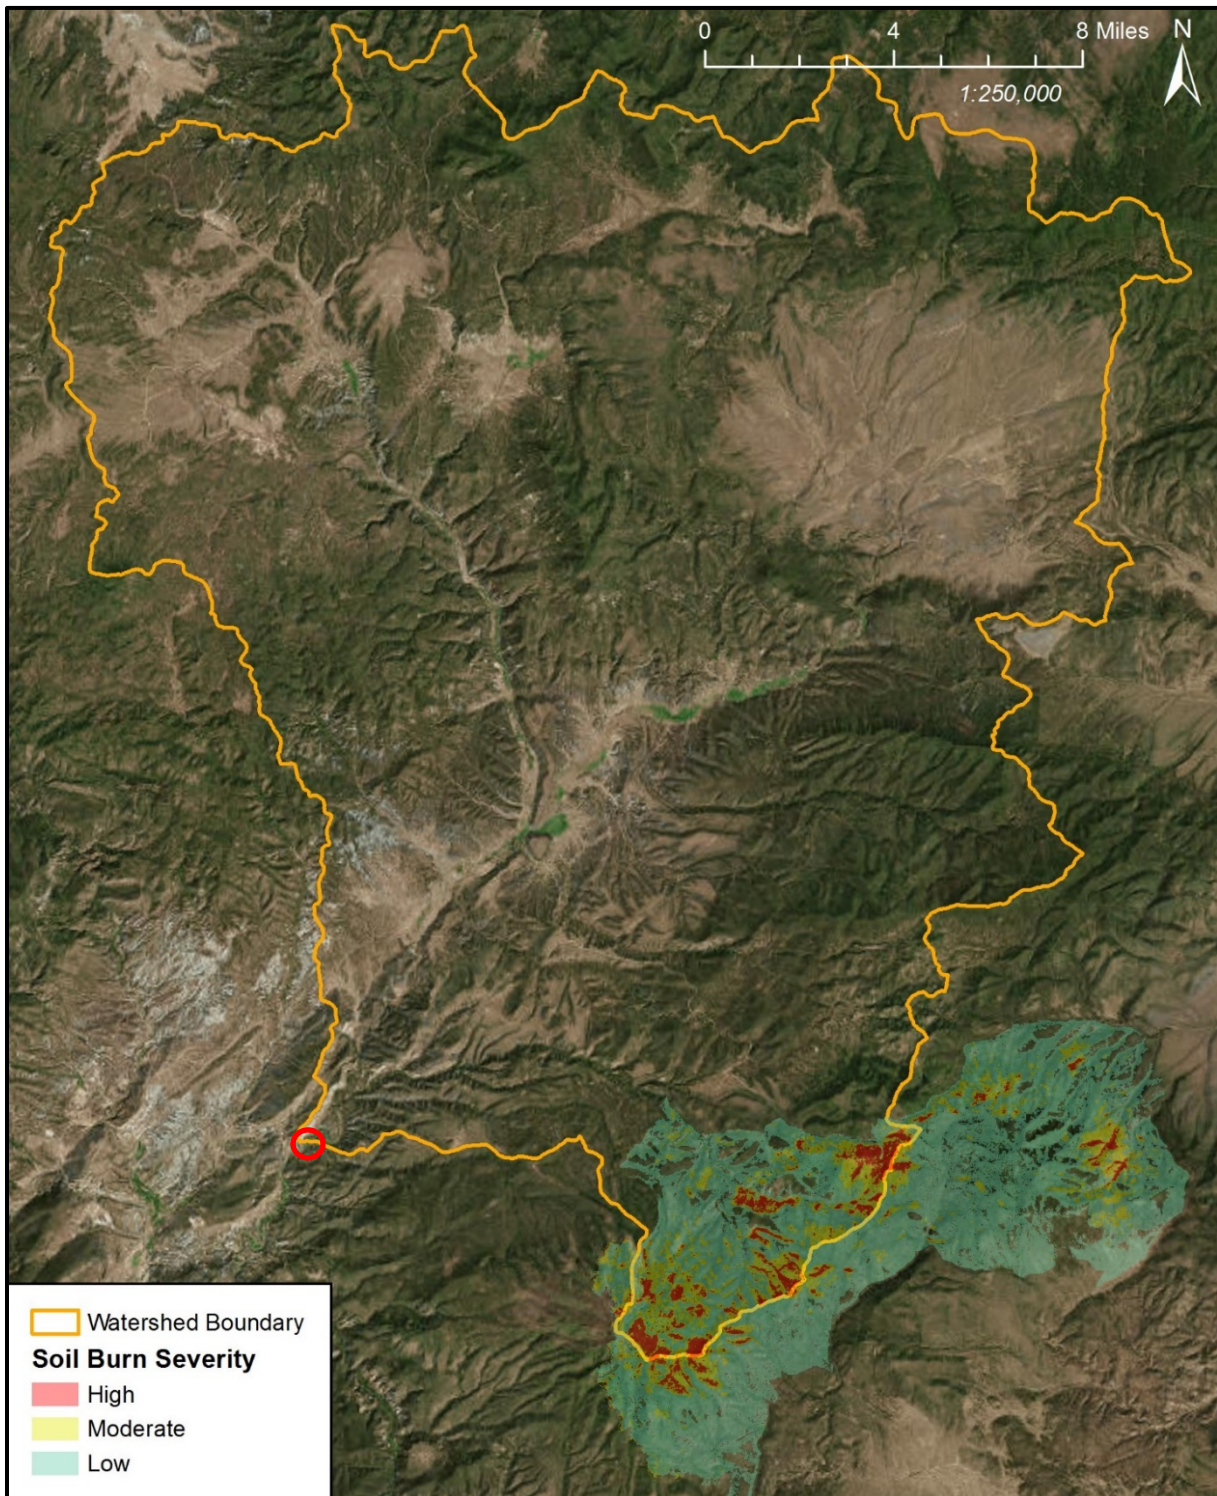
The Buzzard Fire burned in June of 2018, with an extent of 50,300 acres (Inciweb 2018). Most of the high and moderate soil burn severity areas are

within the Tularosa watershed (Figure 9), which has likely resulted in substantially increased flood flows downstream (in Deep Canyon), though this affect will likely be substantially reduced at the

Figure 9: Soil burn severity for the 2018 Buzzard Fire, with the watershed boundary delineation for the Tularosa River (406 mi²). The NFSR-233 crossing is circled.

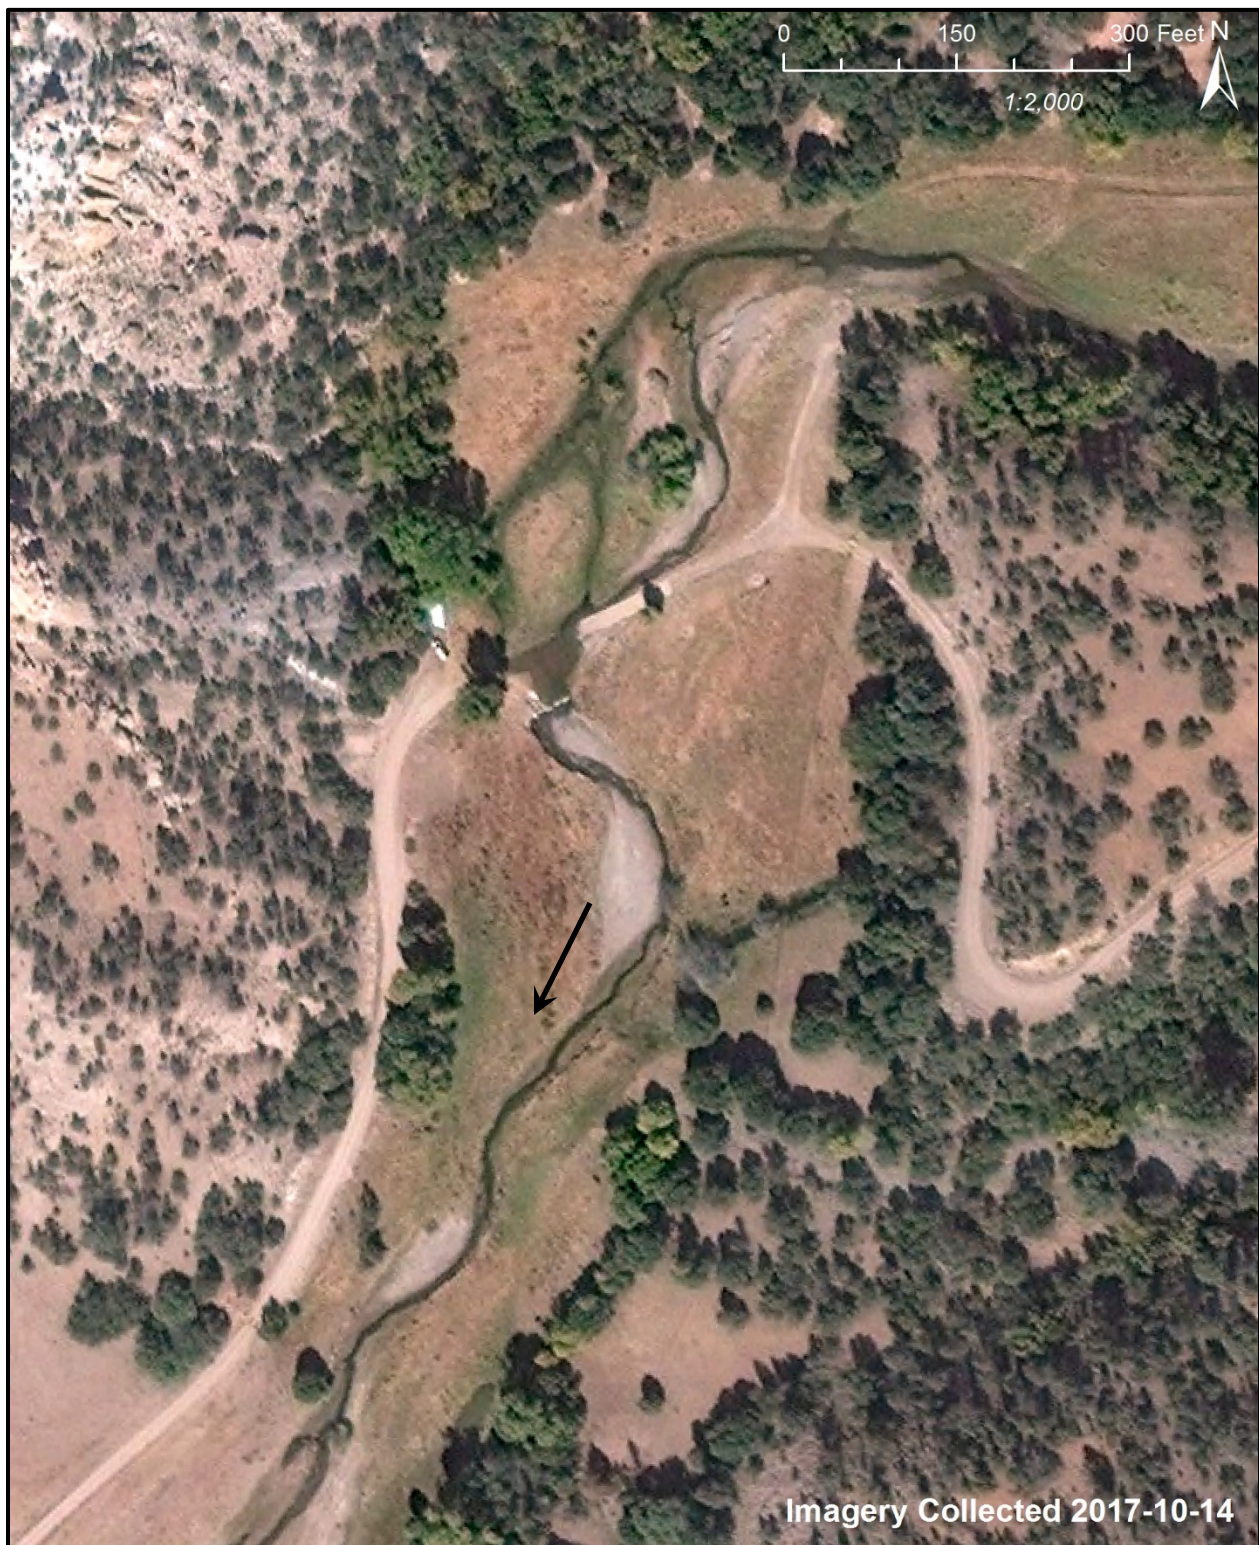
Upstream of the crossing the channel is multithread (Figure A-1), with one the threads eroding against the edge of the concrete crossing at the left edge of the structure. Historic aerial imagery (Figures A-1 to A-3) indicates that this multithread pattern has existed for some time since the hardened crossing was installed, but did not exist prior to the installation, when this upper

Figure A-1: Tularosa River at NFSR-233 (2017-10-14).

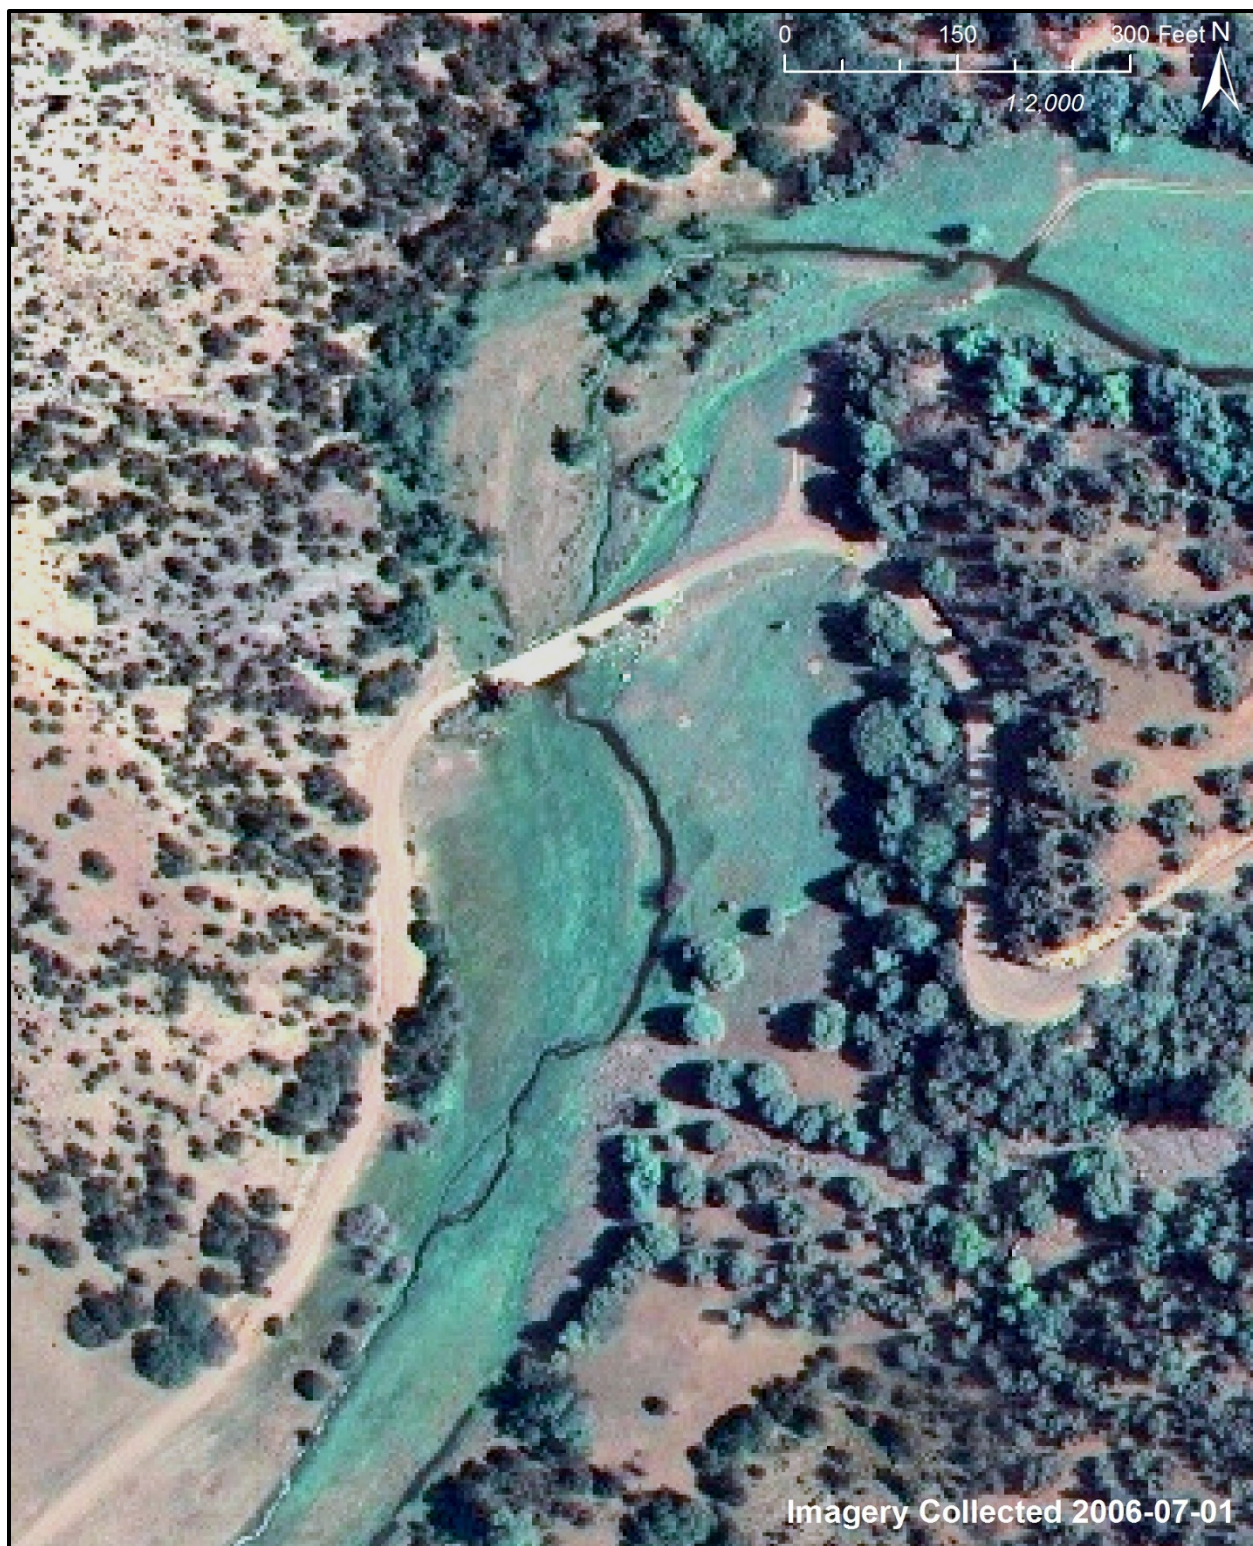
reach was single thread (Figure A-4). The downstream reach appears to have been predominantly single thread throughout the available historic record. Incision downstream of the structure was present since at least 2006 (Figure A-3), before the apron installation, though appears to have gotten substantially worse in recent years.

Figure A-3: Tularosa River at NFSR-233 (2006-07-01).

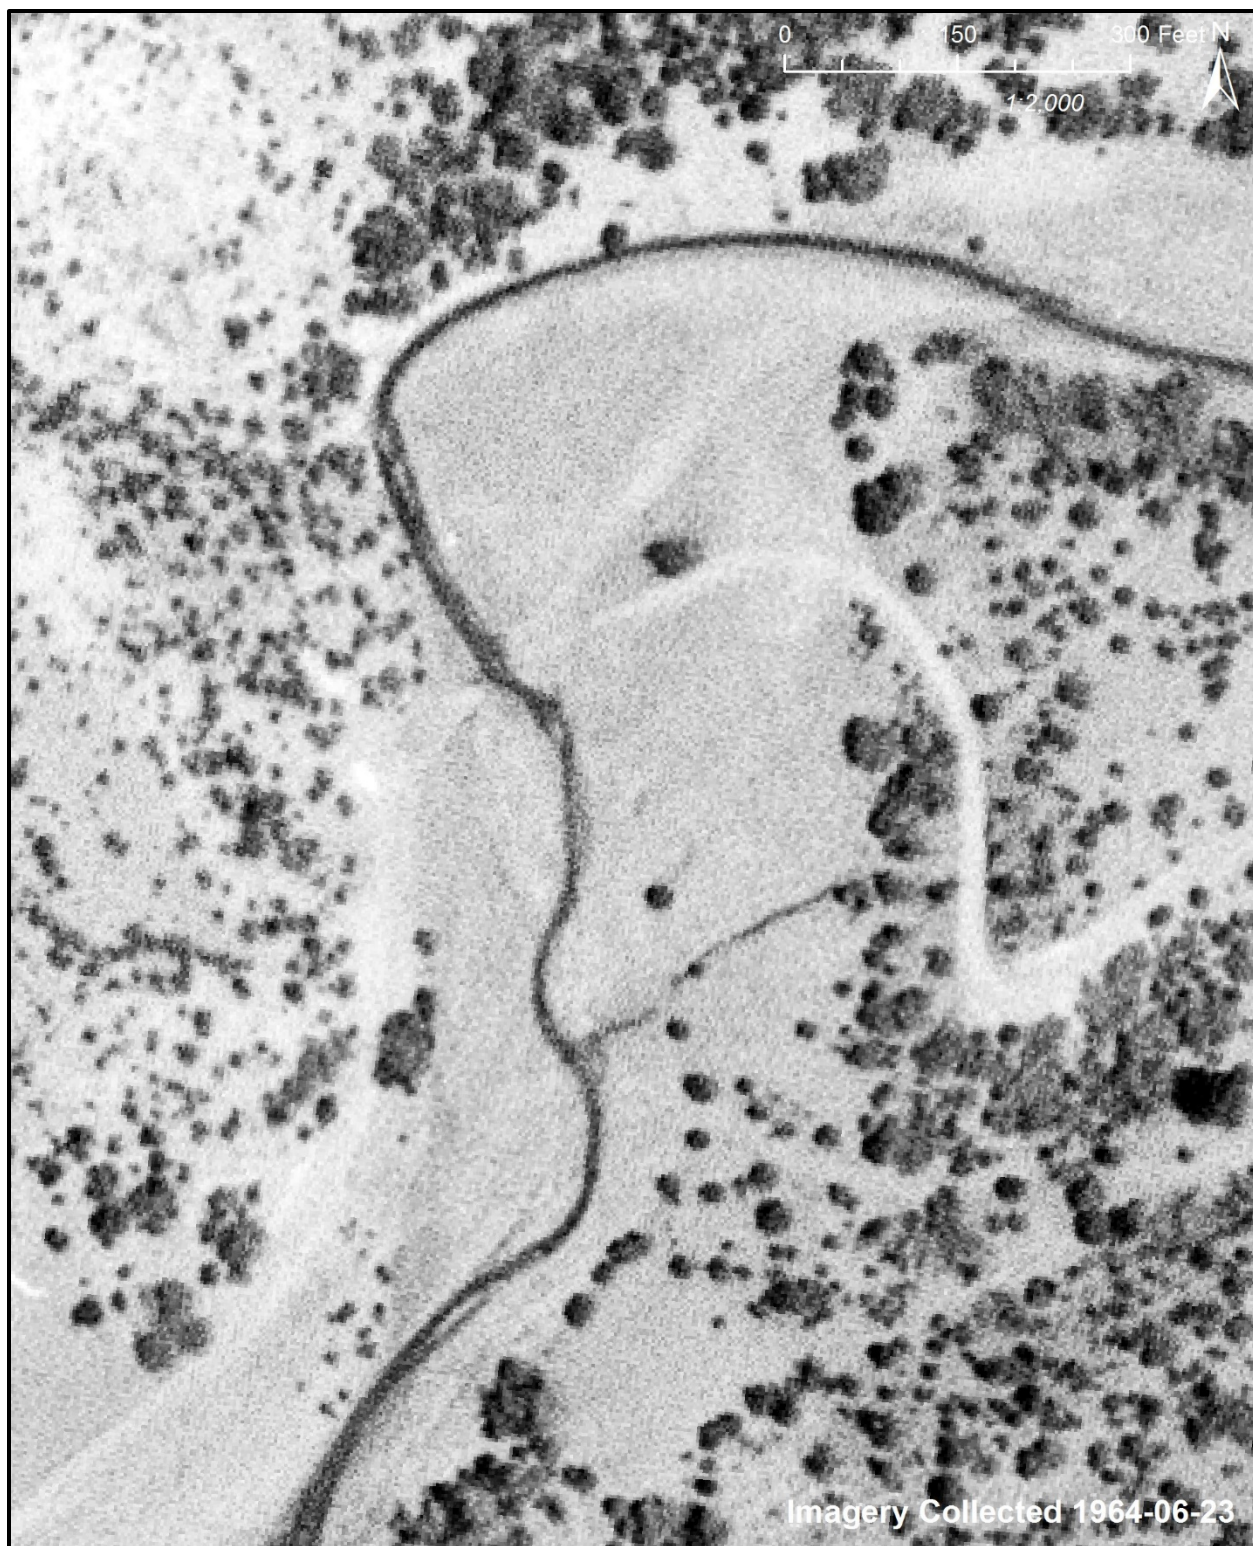
Figure A-4: Tularosa River at NFSR-233 (1964-06-23).
