**U.S. FOREST SERVICE  
NATIONAL STREAM AND AQUATIC ECOLOGY CENTER**

**WET CANYON: CONDITION and REHABILITATION POTENTIAL**

**Client:** Coronado National Forest, Safford Ranger District

**Location:** Wet Canyon Watershed, Graham County, Arizona

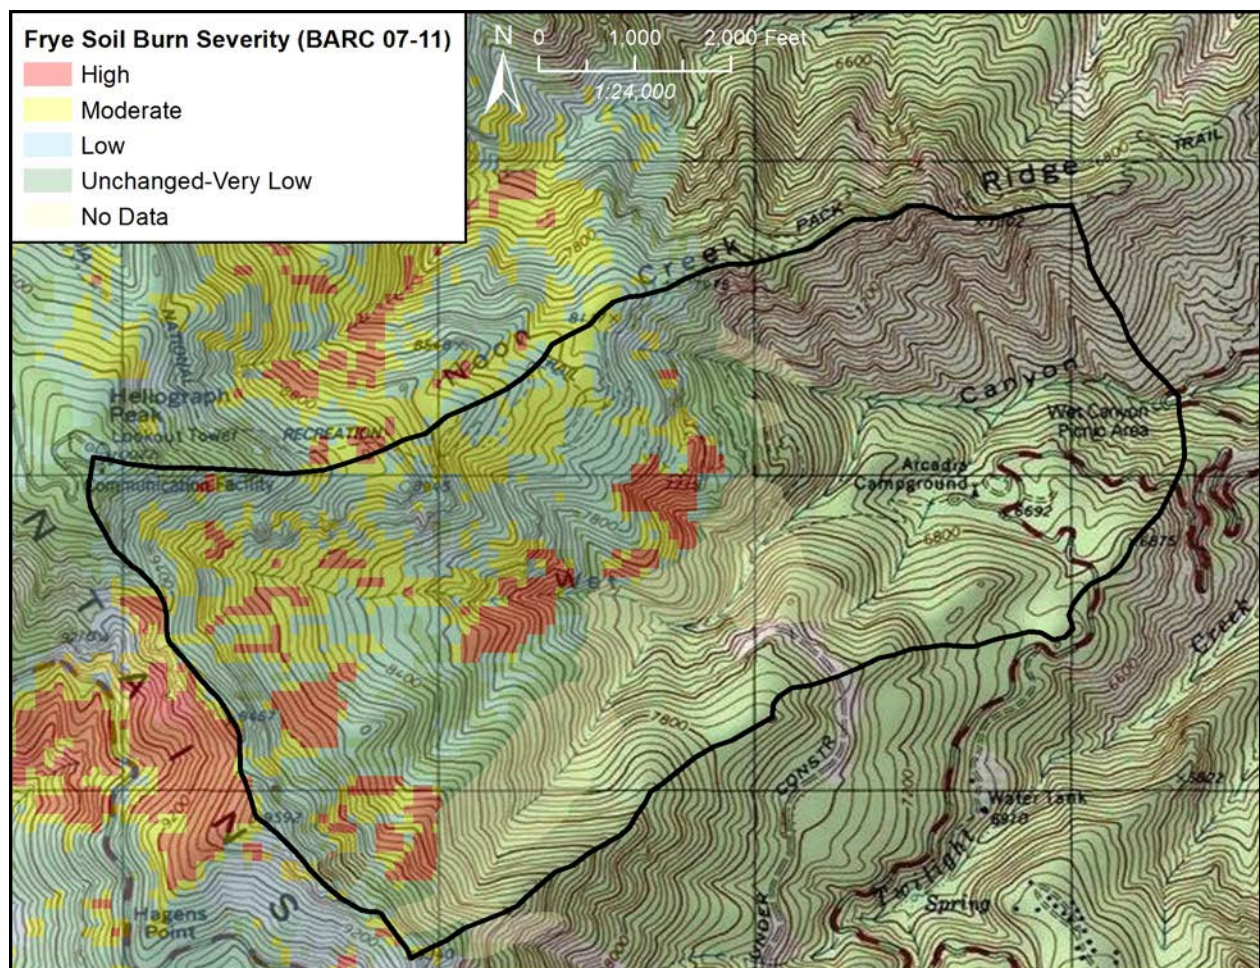
Wet Canyon, a tributary to Jacobson Creek (in the Gila River basin), was evaluated for rehabilitation needs after its watershed was impacted by the 2017 Frye Fire. This watershed is upstream of the town of Safford, Arizona. Low, moderate, and high soil burn severity fire conditions were experienced (Figure 1), resulting in debris flows and floods during the 2017 monsoon season. These flows negatively impacted AZ Route 366 in the summer of 2017, with there being additional potential for negative impacts as floods and debris flows are expected for several years while watershed conditions recover from the fire. This

**Figure 1:** Wet Canyon at Arizona Rt. 366 watershed, with 2017 Frye Fire soil burn severity as determined using Burn Area Reflectance Classification techniques (2017-7-11).

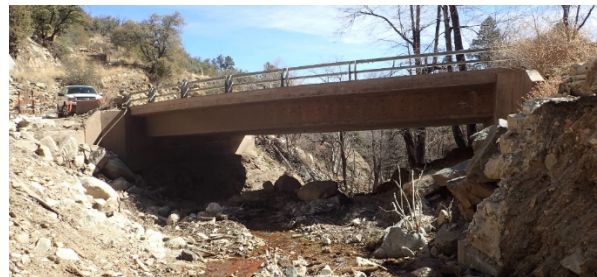
As communicated by Salek Shafiqullah and Walter Keyes, the flooding and debris flows obstructed the opening of a historic (Civilian Conservation Corps) arched culvert that had been left in place after a new highway bridge (Figure 2) was constructed over Wet Canyon, forcing flow and debris over AZ-366. Several emergency measures were taken in response to the wildfire-enhanced monsoon flooding, including sediment and large wood removal, and the removal of the historic culvert. At the time of the visit both approaches were still in place but the structure has been largely removed and flow capacity through

**Figure 2:** Arizona Rt. 366 over Wet Canyon.

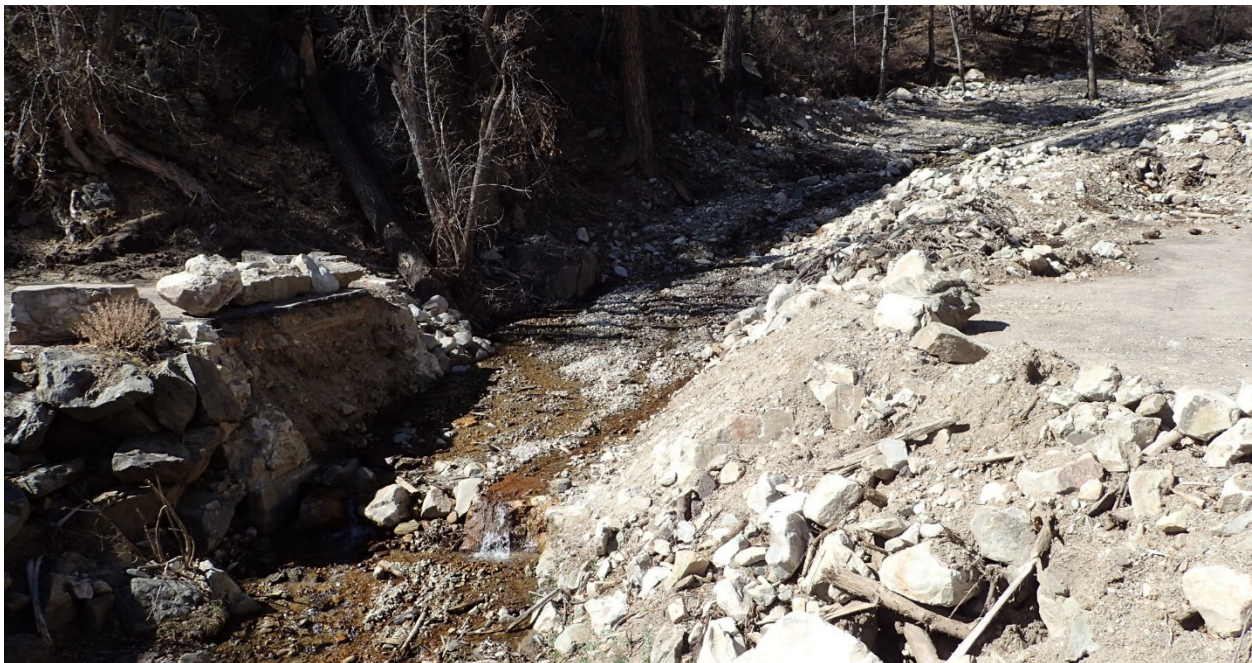
the opening is now relatively unobstructed (Figure 3).

The sediment and wood removal performed as an emergency measure has left the stream in a contrived and deficient form, with an irregular and somewhat ineffective floodplain and insufficient channel flow resistance. These conditions, if left in their current state, may result in continued negative impacts to infrastructure for the next few years (with the enhanced post-fire runoff conditions), and the current form is not stable and does not provide an appropriate basis for ecological recovery over the long term.

**Figure 3:** Wet canyon creek passing through the approaches of the (removed) historic arched culvert. Note the gravel-sized material in the streambed and the asphalt parking lot. The average channel slope upstream of AZ-366 is ~20%.

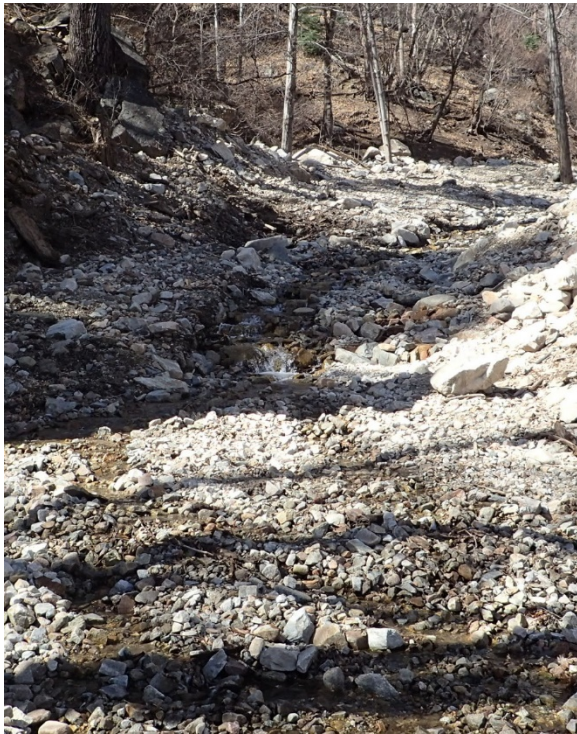
The slope of this channel was not measured, though the USGS topography indicates that Wet Canyon upstream of the bridge has about a 20% slope. Bed material within the manipulated channel consists of gravel and cobble size material (Figure 4). Boulders are largely not present and the longitudinal profile is primarily plane bed, though shallow step-pool and cascade features are forming with the available (small) clast sizes.

**Figure 4:** Excavated channel condition, with gravel and cobble size material comprising the bed surface.

- Introduction of boulders (and large wood) to the machinery-impacted channel to, in combination with the gravel and cobble size material already present, allow development of the step pool and cascade bedforms needed to increase flow resistance required for stability in a ~20% slope channel.

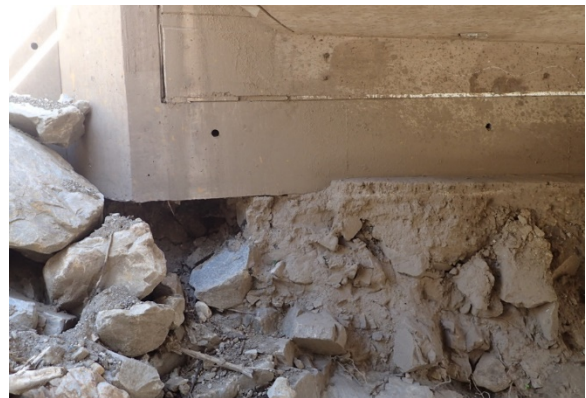
Scour of the north AZ-366 bridge abutment was noted (Figure 5). It was reported by Walter Keys that this abutment is a concrete beam on reinforced concrete drill shafts set into bedrock. Captured flow by the parking lot may likely increase this scour.

**Figure 5:** Erosion at the north abutment of the AZ-366 bridge over Wet Canyon.

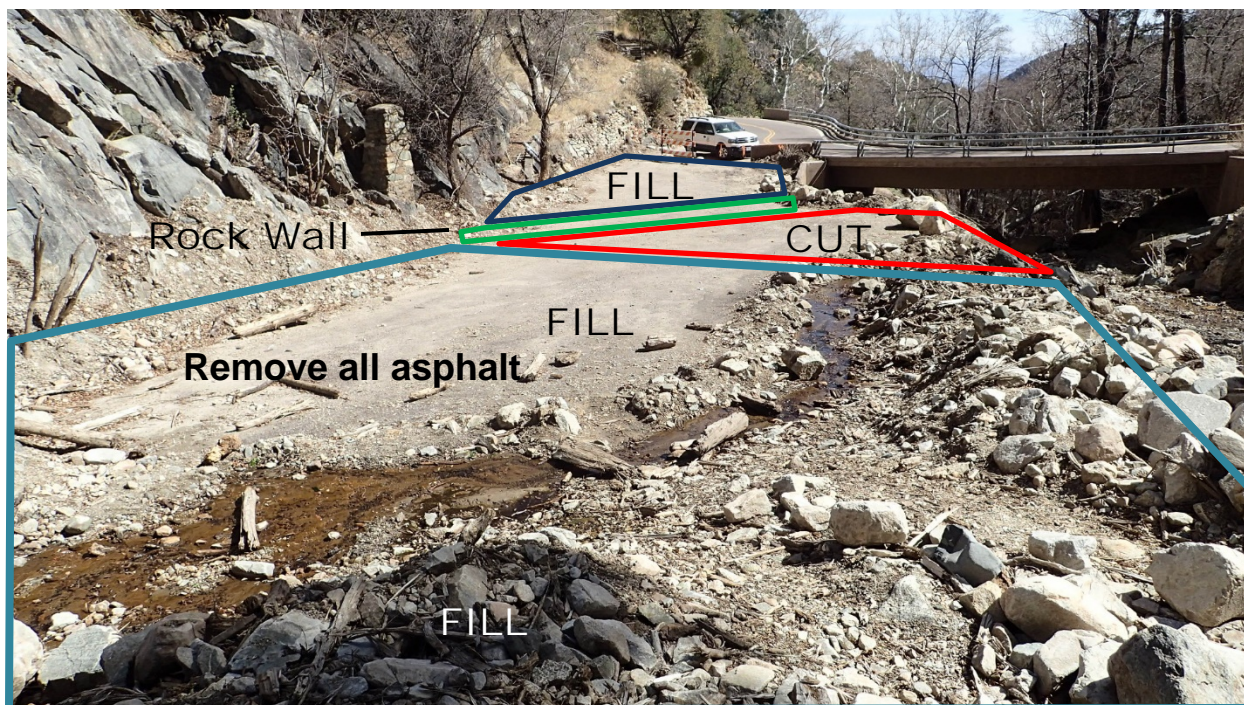
The “floodplain” on the north side of the excavated channel is currently in such a form so that, when large discharges are next yielded from the wildfire-impacted watershed, the remaining parking lot can be expected to capture a substantial portion of the flow and entrained material, with this flood flow having the potential to be diverted once again away from the bridge opening and across the highway surface.

Over the short term (before July 2018), at a minimum a portion of the old parking lot for the picnic area as well as the north “stump” of the masonry culvert should be excavated (Figure 6) to provide a conveyance path for floodplain flow captured by the parking lot to pass through the bridge and prevent floods from passing discharge and debris across AZ-366.

through this historic culvert, as well as to correct the contrived form left by the emergency measures. Figure 6 and Figure 7 provide graphic representations of some of this proposed work. This work would be intended to provide the basis for ecologic recovery and opportunities for future recreational use. This work is recommended to include:

**Figure 6:** Downstream portion of emergency action area, with proposed cut and fill locations. It is recommended that all the asphalt be removed, a floodplain created with fill in the parking lot area, cut of the north culvert abutment (stump) and a flow path to divert flood flows from passing over AZ-366, and a rock wall to protect fill placed for a small parking lot.
