## U.S. FOREST SERVICE NATIONAL STREAM AND AQUATIC ECOLOGY CENTER

### WINDY PARK: STREAM RESTORATION ASSESSMENT

Client: Ashley National Forest Location: Windy Park, Utah Date of Visit: 8/25/2015

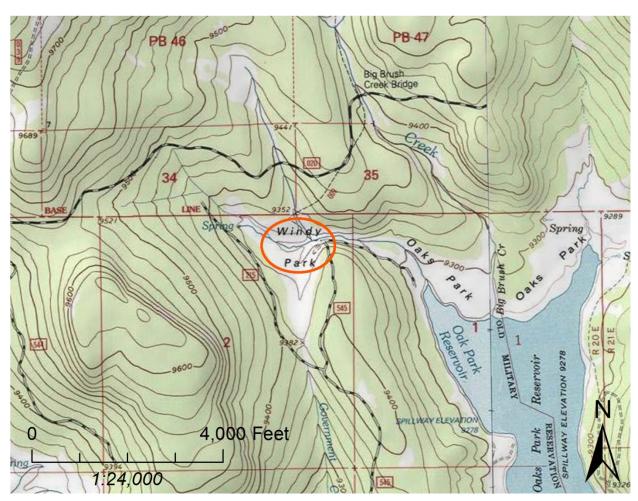
Figure 1: Area of concern in Windy Park (circled).

The catchment (Figure 1) consists of 0.9 square miles at the point of impairment, a parallel sequence of headcuts. Average annual precipitation ranges from 27 to 29 inches, from PRISM (Daly et al., 2008). The aerial photo in Figure 3 shows the primary area of concern. The locations and directions of the photographs collected during this field visit and presented in this report are illustrated in these figures.

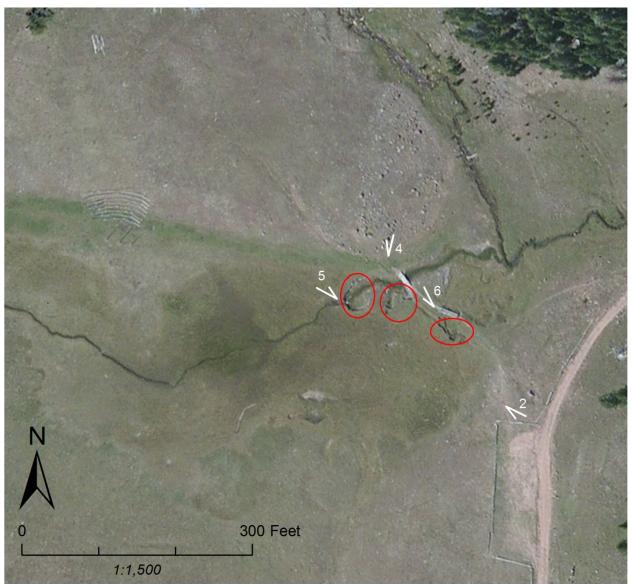
**Figure 3:** Aerial imagery illustrating Windy Park (6/27/2010). The annotated arrows indicate figure numbers of presented photographs, with directions. The red ellipses indicate points of incision.

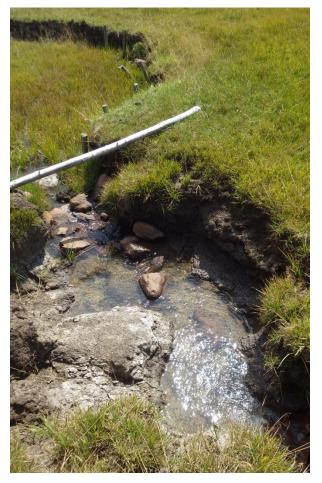
Figure 5: Active headcut at upstream end of scarp.

Figures 4 and 5 show the low scarps and headcuts that have formed at the downstream end of the wet meadow. Both the scarps and a point headcut are evident. The elevation drop is approximately 2 feet. It appears that the soil movement is through both bank failure and soil piping as the meadow soil horizons are drained. The headcut, as shown in the foreground of Figure 5, is extending into the wet meadow along the E-type stream channel (Rosgen classification), creating a linear

drawdown of the water table. It appears that this headcutting is continuing to propogate upstream, causing a gradual increase in the wet meadow impairment.

Historic aerial imagery was obtained to understand the rate of headcutting and scarp progression, and hence the rate of wet meadow loss. The scarp is not visible in aerial imagery collected in 1965; the impairment may have started before this date. However, the scarp is present in imagery collected in 1993. Using this latter imagery, it appears that rate of scarp translation is about 1 foot per year. The point headcut may be progressing at a more rapid rate.

Fortunately, these scarps and headcuts are relatively low (~2 feet in height), and can be arrested with a reasonable amount of confidence for success. The amount of eroded material is low and could be relatively easily replaced. The sedge mats that have formed below the headcuts should be removed and placed on the newly filled surface. A restoration could be performed in combination with restoration activities in Government Park, providing a source for borrow material. Using such a regraded approach, combined with grade control structures, the riparian corridor has the potential for restoration to a sustainable wet meadow in Windy Park.

Combining grade control structures and fill with livestock exclusion would likely be a successful strategy for retaining and restoring the wet meadow. The relatively low drop of each headcut combined with low stream power in such a headwater stream provide conditions for durable grade control structures, though periodic maintenance will be needed. Grade control structures could consist of numerous types (this is elaborated on in the Restoration Details section). Log structures would probably be the best fit for Windy Park. Existing sedge mats present below the headcuts should be transplanted on top of the new filled surface, to restore the wet meadow.

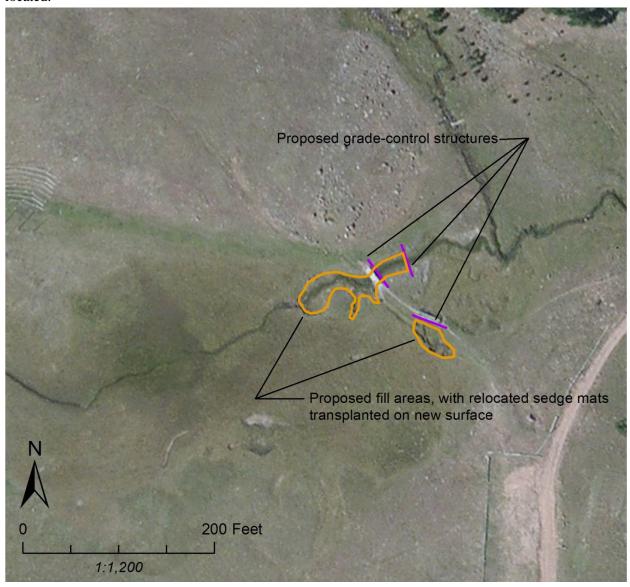
Figure 7: Alternative 3 proposal, with grade-control structures to arrest headcuts and fill (with sedge mat relocations) to restore the lost wet meadow area.

A few details regarding key features of Alternative 3 is provided below, specifically on grade control structures for arresting the headcuts and on fill locations (and sedge mat relocations). Details are also provided for the sedge mat transplants. A summary of the recommended features is presented in Figure 7.
