Kearney Reservoir

Dam Breach Analysis

Johnson and Sheridan Counties, Wyoming.

Kearney Reservoir Dam Breach Analysis

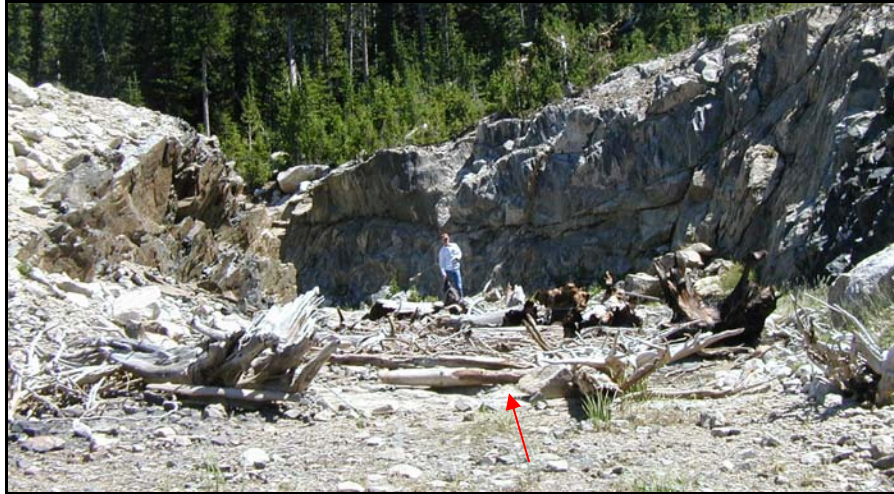
Figure 2: Emergency spillway entrance, facing downstream. Flow capacity is approximately 1800 cfs with water-surface-elevation at the dam crest.

Figure 1 provides a plan view of the reservoir and watershed. Figures 2 and 3 are background photos of the dam and emergency spillway.

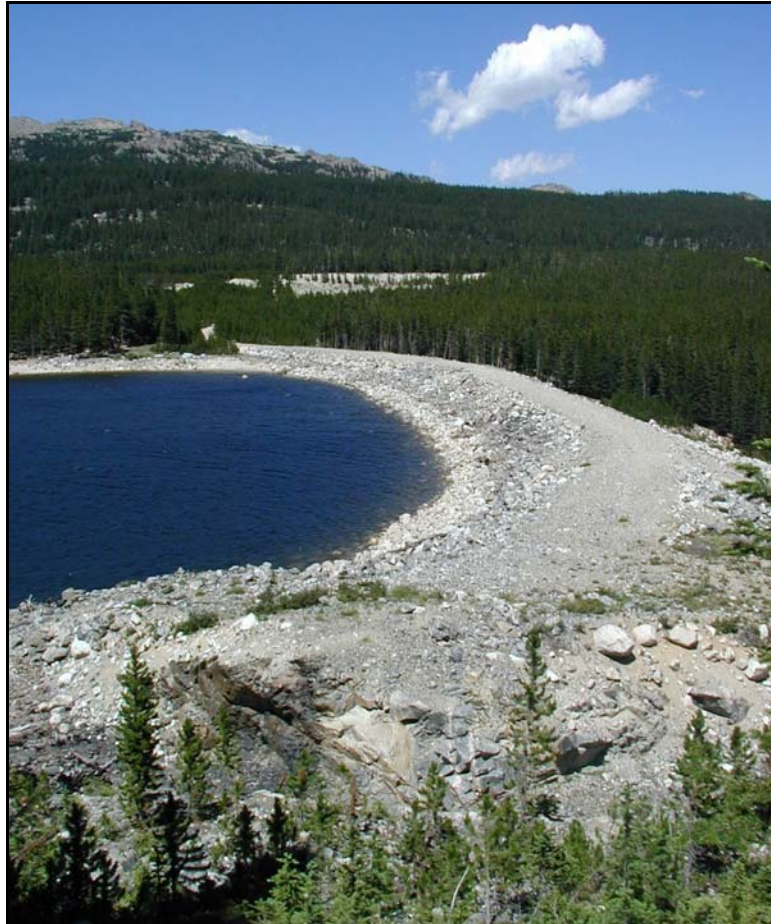
Figure 3: Kearney Dam, with emergency spillway in foreground.

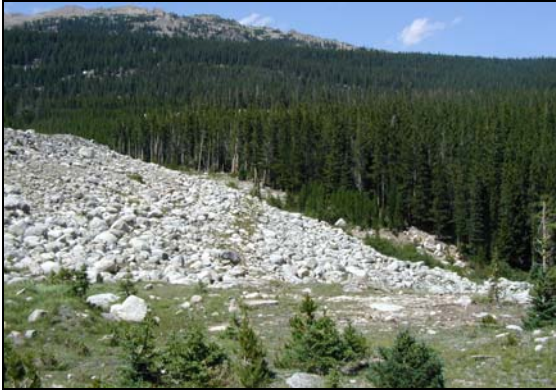
Figure 4: Downstream face of Kearney dam.

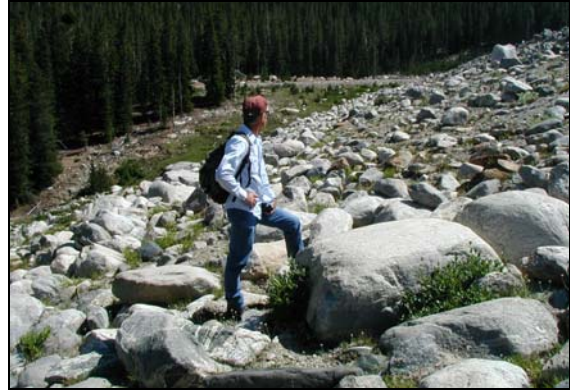
Figure 5: Armoring detail, on downstream face.

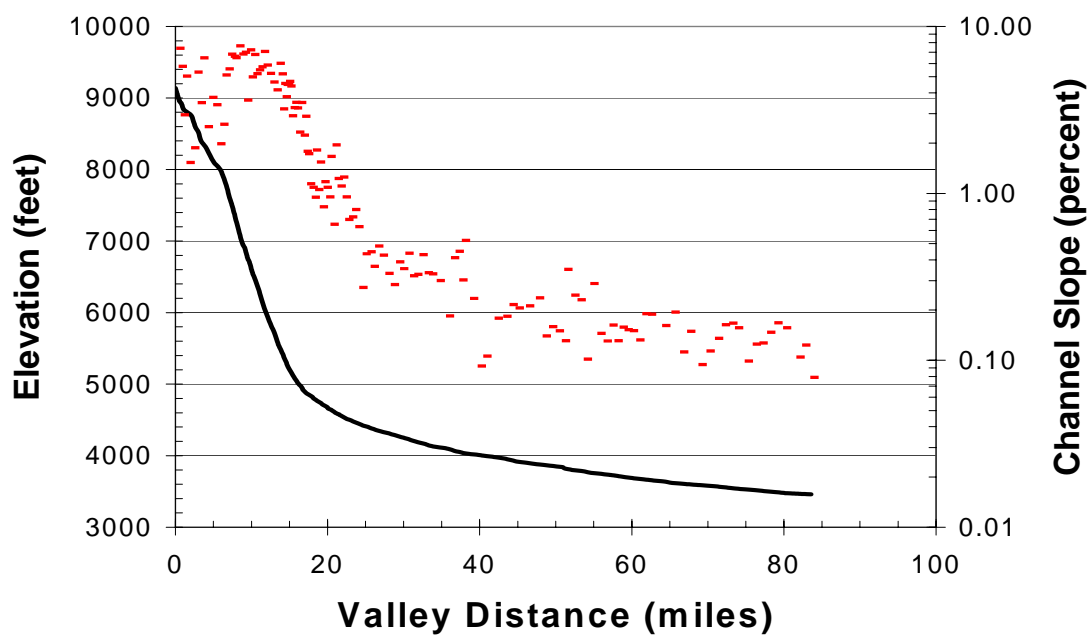
Figure 7: Stream profile, with channel slopes.

Due to the large number of required cross-sections for model stability on supercritical slopes and the extensive model length from little attenuation in the steep, narrow reaches, the hydraulic analysis was broken into 9 separate but linked analyses: Kearney Creek, South Piney Canyon; South Piney Creek in Story; Piney Creek from Story to I90; Piney Creek from I-90 to US-14; Piney Creek from US-14 to Clear Creek Confluence; Clear Creek from Piney Creek to Clearmont; Clear Creek from Clearmont to Buffalo Creek; Clear Creek from Buffalo Creek to Powder River; and Powder River. The entire model length is illustrated in the plan and profile provided in figures 6 and 7.

This reach, with slopes ranging from 1.0 to 2.9 percent (figure 7) and significant riparian but less floodplain vegetation (figure 14), has fairly broad floodplains and provides opportunity for additional floodwave attenuation, especially behind the I-90 roadway embankment. The steep slopes and available vegetation indicate that significant debris load will be carried and generated. However, most of the debris load will likely drop out of transport at the bottom end of this reach in the vicinity of I-90, within the backwater induced from the highway embankment and reduced valley slopes.

This reach, with stream slopes ranging from 0.3 to 1.2 percent (figure 7), is significantly shallower, with a broad flat floodplain with side slopes of 0 to 2 percent. Cottonwoods and willows line the stream banks forming a vegetated riparian corridor but upper floodplain slopes are lightly vegetated. Figures 19 and 20 provide photographs of typical channel and floodplain conditions.

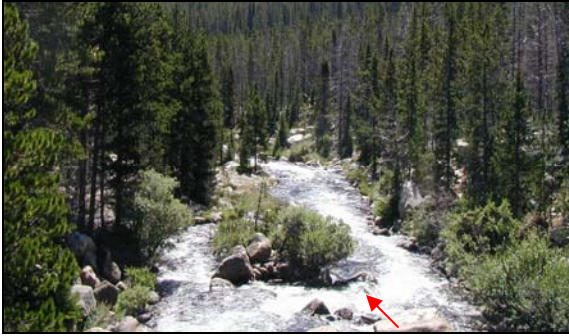
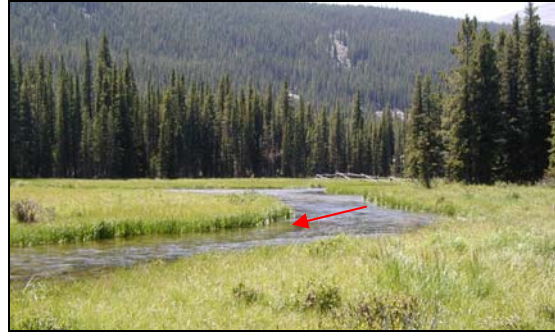
Figure 8: Typical narrow, steep reach and wider less steep reach on Kearney Creek.

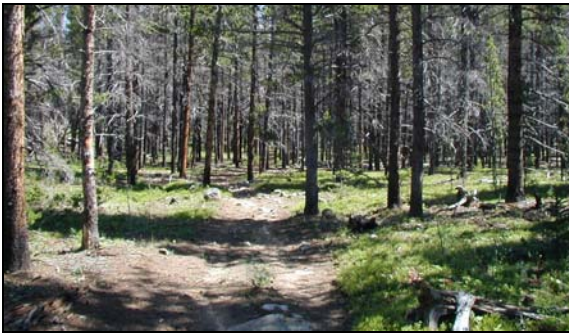
Figure 9: Typical wooded floodprone zone on Kearney Creek.

Figures 8 through 10 are provided to document general reach characteristics.

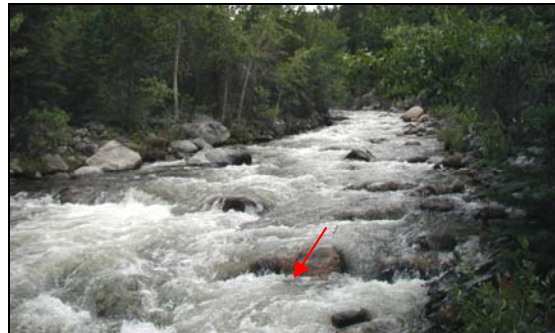
Figure 10: Typical reach in South Piney Canyon.

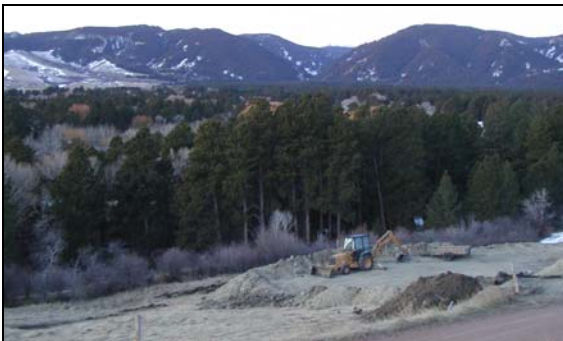
Figure 11: The alluvial fan of Story. The mouth of South Piney canyon is evident in the top, center.

Due to little attenuation of the flood wave in South Piney Canyon, most to all of the alluvial fan of Story will be inundated in the event of a catastrophic breach. A portion of the mass of debris that will be stripped from the upstream canyon will likely be deposited in debris dams as the flow expands on the alluvial fan in Story. Additionally, the dense vegetation (figures 11 and 12) and steep slopes (figure 7) in Story will provide an additional source of debris. Hence, flow paths are unpredictable and it can only be said that a probable inundation zone is at likely risk of flooding.

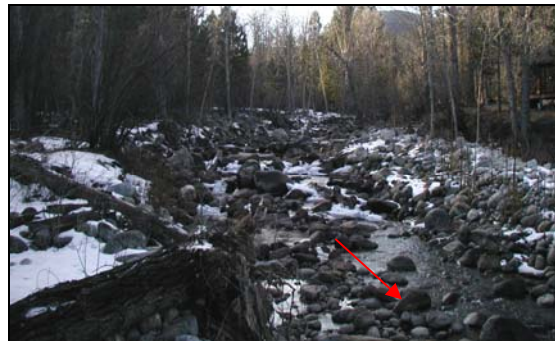
Figure 12: Typical reach of South Piney in Story.

Modeling is simplified by using cross-sections approximated with a typical stream cross-section (figure 12) and a relatively flat floodplain to generate a composite cross-section. These simplified cross sections allow modeling in Story with limited data but while still appropriately modeling storage and floodwave attenuation.

Field determined Manning's roughness was estimated from visits to numerous sections within the reach. With Manning's values estimated at 0.045 for the channel (fairly clean, winding, some pools and shoals with weeds and stones, figure 12) and 0.15 for the dense vegetation of the overbank (brush, trees, with flow into branches, figures 11 and 12), the resulting HEC-RAS model again predicts a flood wave with sustained supercritical flow. Manning's "n" was calibrated to maintain a Froude number close to critical for most of the reaches. Overbank roughness was maintained at 0.15 and calibrated channel roughness ranged from 0.1 in upper sections of the reach to 0.07 in lower sections.

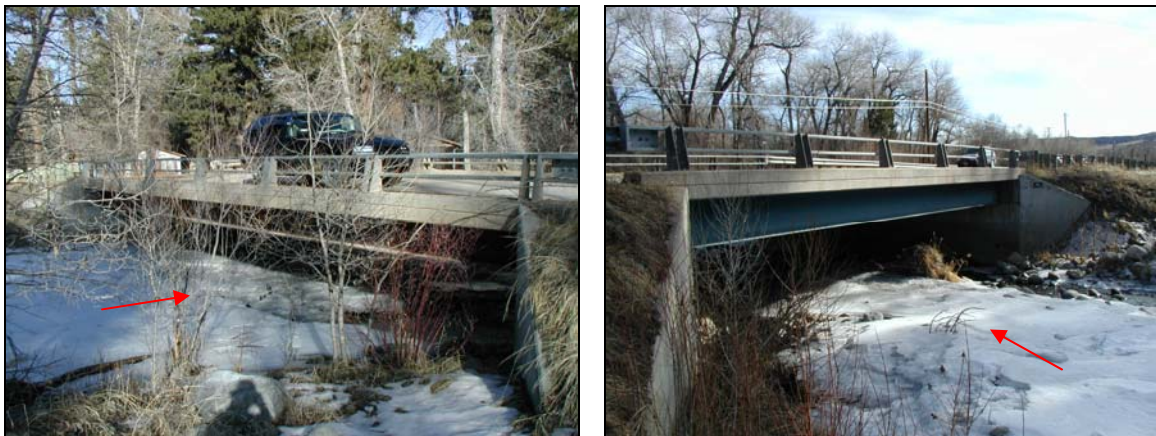
Figure 13: County road (left) and WY193 bridges on South Piney in Story.

Two bridges exist on this reach and are shown in figure 13. However, these bridges are not modeled since they will very likely be filled with debris and insignificant to flow conveyance during a breach event.

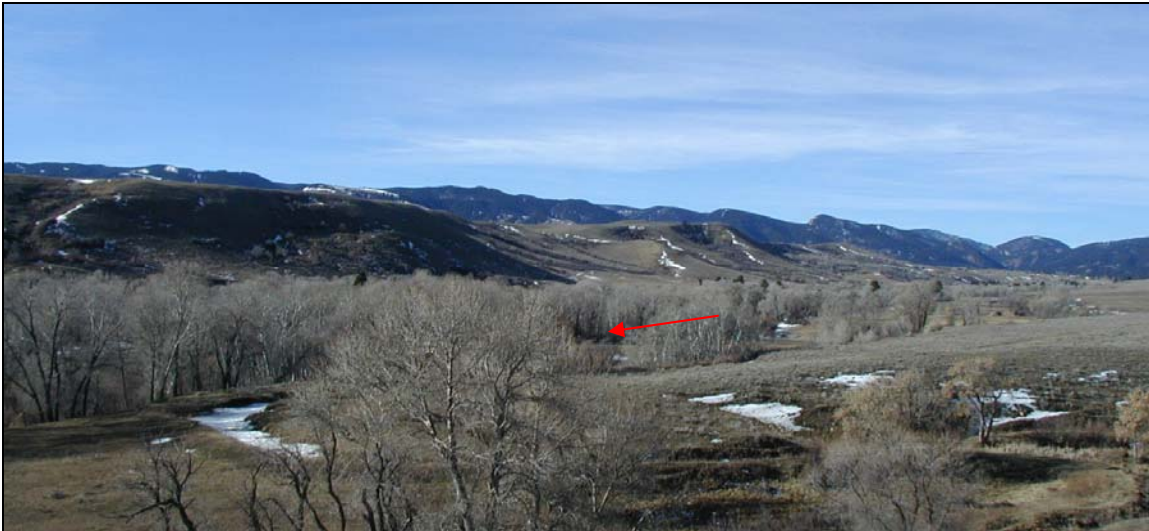
Figure 14: Piney Creek, from Story to I-90.

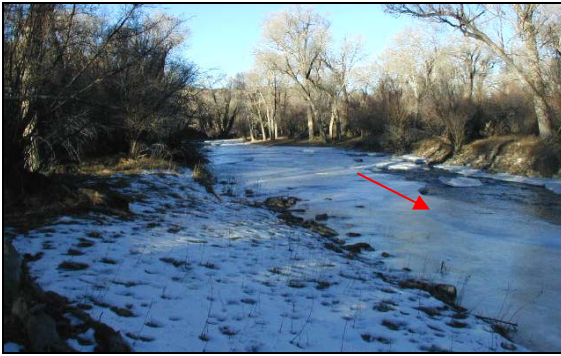
Figure 15: Typical section for Piney from Story to I-90.

Cross-sections were generated using USGS topography supplemented with field-measured floodplain slopes and a typical stream cross-section (figure 15). Twenty cross-sections were developed and additional interpolated cross-sections were generated for model stability, for a total of 625 sections for this 5.2 mile reach.

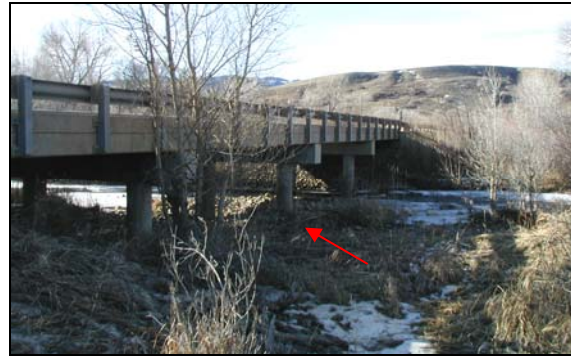
Figure 16: WY-193 crossing of Piney Creek.

Three bridges exist on this reach and are shown in figures 16 through 18. Neither the WY-193 nor US-87 bridges are modeled since they will likely be insignificant to flow conveyance due to debris. However, the I-90 bridge, with much greater possible conveyance, is modeled. For simplicity in this analysis, the true vertical alignment of the highway is not modeled. Ineffective flow areas were stipulated at both the adjacent upstream and downstream sections, for non-overtopping flows (less than about 40,000 cfs).

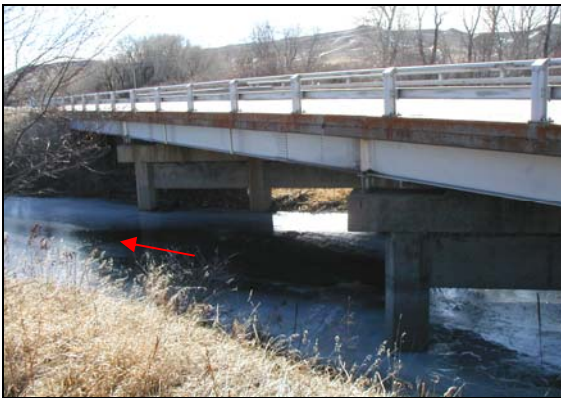
Figure 17: US-87 crossing of Piney Creek.

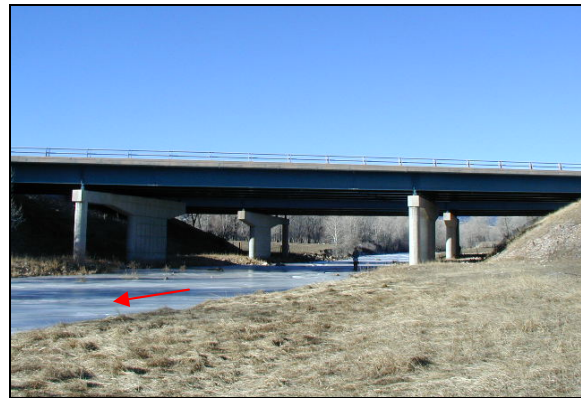
Figure 18: I-90 crossing of Piney Creek.

Due to the extreme magnitude of this event, flow over the I-90 bridge and embankment is expected. Storage from backwater behind the embankment is expected to reduce the peak flow to **50,400 cfs**, with at least 10,000 cfs passing over the highway. Bridge failure due to abutment or pier scour is also a possibility. Danger exists to any vehicles (and occupants) caught in this overflow or failure.

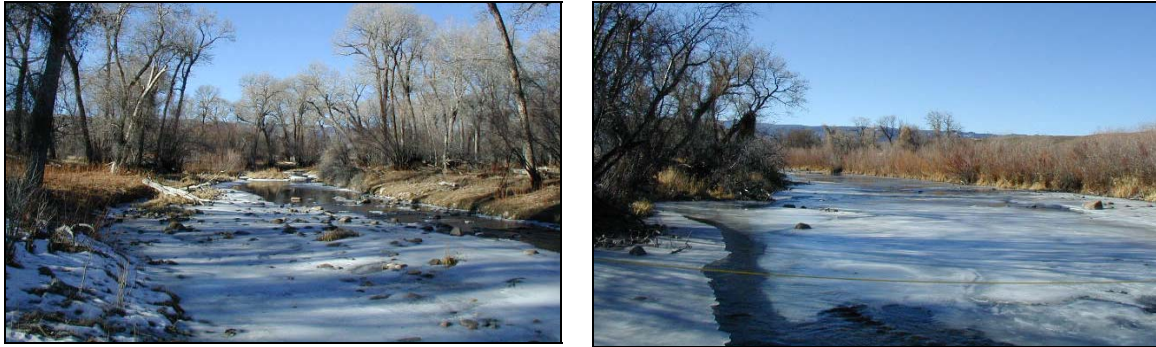
Figure 19: Typical sections used in I-90 to US-14 reach.

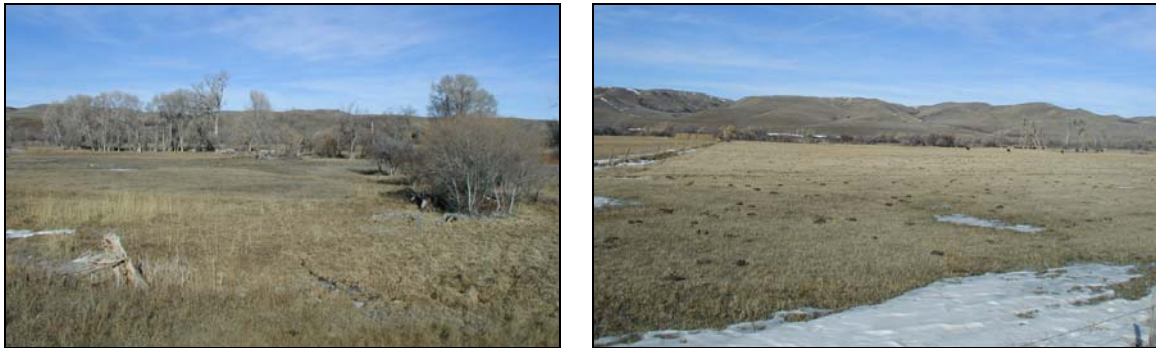
Figure 20: Typical floodplain in I-90 to US-14 reach.

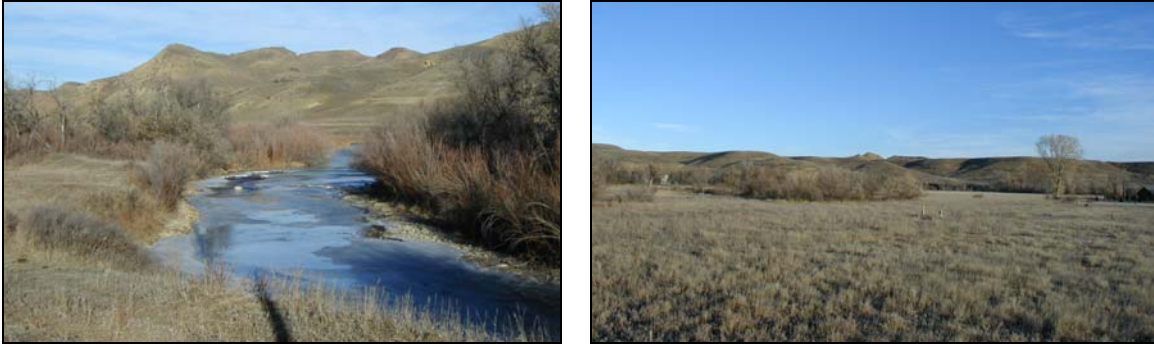
Figure 21: Typical channel and floodplain in the US-14 to Clear Creek reach.

Cross-sections were generated using USGS topography supplemented with field-measured floodplain slope and typical stream cross-sections, as well as terrace locations from aerial photography. Thirteen cross sections were developed and additional interpolated cross-sections were generated for model stability, for a total of 385 sections for this 14.8 stream mile (9.2 valley mile) reach. Figure 21 provides photographs of typical channel and floodplain conditions.

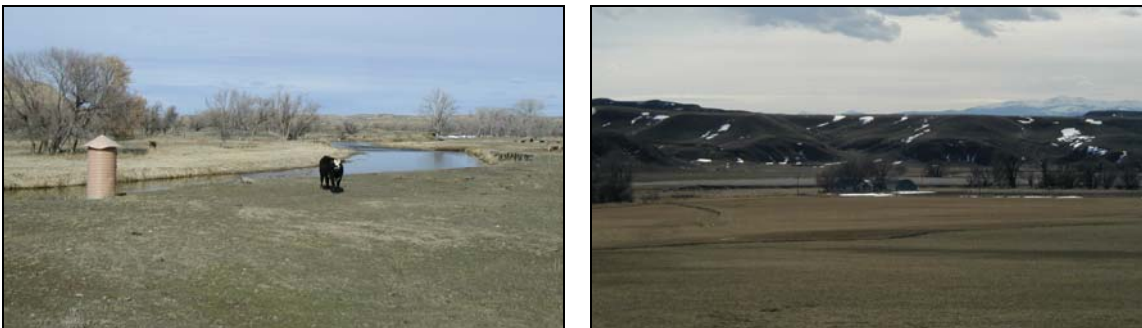
Figure 22: Typical channel and floodplain in the Piney Creek to Clearmont reach.

Cross-sections were generated using USGS topography combined with stream channel cross-sections provided by Cheryl Harrelson of Steady Stream Hydrology in Sheridan, Wyoming. These data were supplemented by locating terraces and floodplains with aerial photography. Ten cross sections were developed and additional interpolated cross sections were generated for a total of 307 sections in this 16.0 stream mile (9.3 valley mile) reach. Figure 22 provides photographs of typical channel and floodplain conditions.

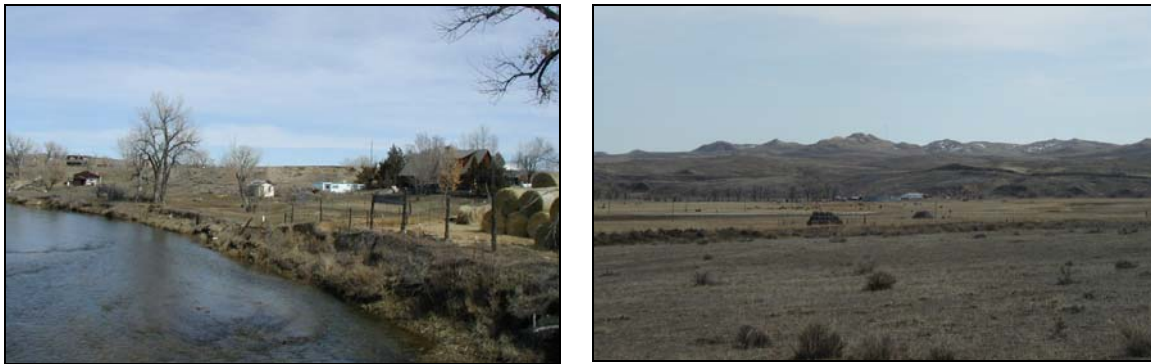
Figure 23: Typical channel and floodplain in the Clearmont to Buffalo Creek reach.

Cross-sections were generated using USGS topography combined with a typical channel section. These data were supplemented by locating terraces and floodplains with aerial photography. Thirty-one cross sections were developed and additional interpolated cross sections were generated for a total of 695 sections in this 38.4 stream mile (24.8 valley mile) reach. Figure 23 provides photographs of typical channel and floodplain conditions.

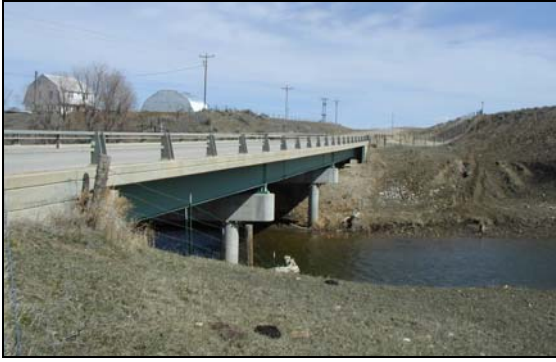
Figure 24: US-14/16 crossing of Clear Creek.

Two county bridges and several private bridges within this reach are not modeled due to insignificant effects that they will have upon the breach routing. However, the US-14/16 and the Burlington Northern Railroad bridges (figures 24 and 25) were included in the model.

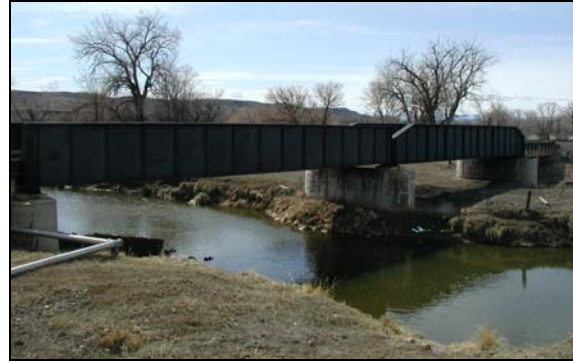
Figure 25: Burlington Northern Railroad crossing of Clear Creek.

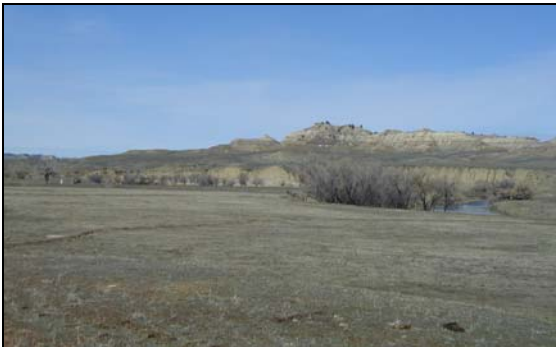
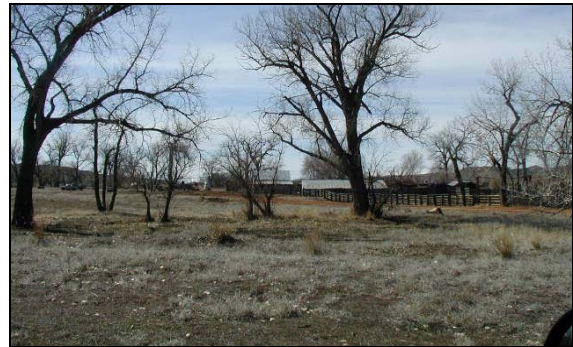
Figure 26: Typical channel and floodplain in the Buffalo Creek to Powder River reach.

Cross-sections were generated using USGS topography combined with a typical channel section. These data were supplemented by locating terraces and floodplains with aerial photography. Seven cross sections were developed and additional interpolated cross sections were generated for a total of 179 sections in this 9.3 stream mile (6.9 valley mile) reach. Figure 26 provides photographs of typical channel and floodplain conditions.

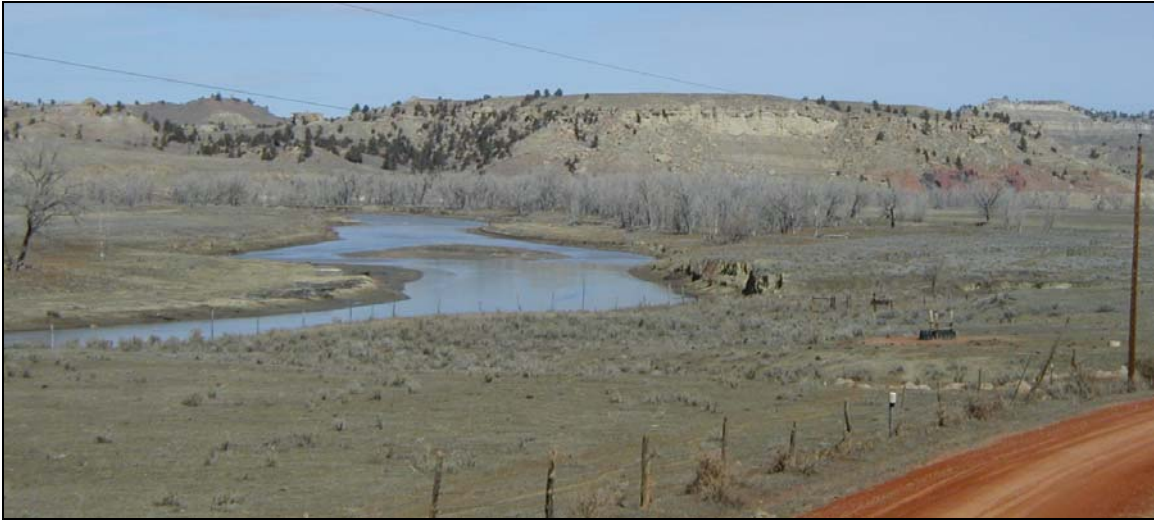
Figure 27: Powder River near the Clear Creek confluence.

Cross-sections were generated using USGS topography supplemented with a typical stream cross-section that was generated from USGS streamgage information (063245000, Powder River at Moorhead, MT), which notes a bankfull width of 215 ft and an average depth at bankfull of 9 ft. This information was retrieved from <http://montana.usgs.gov/freq>. The floodwave was routed from the Clear Creek confluence to Moorhead, Montana however only the uppermost 6.1 stream miles (5.7 valley miles) of this reach is addressed in this report. Figure 27 provides a photograph of the Powder River a few miles downstream of the Clear Creek confluence.

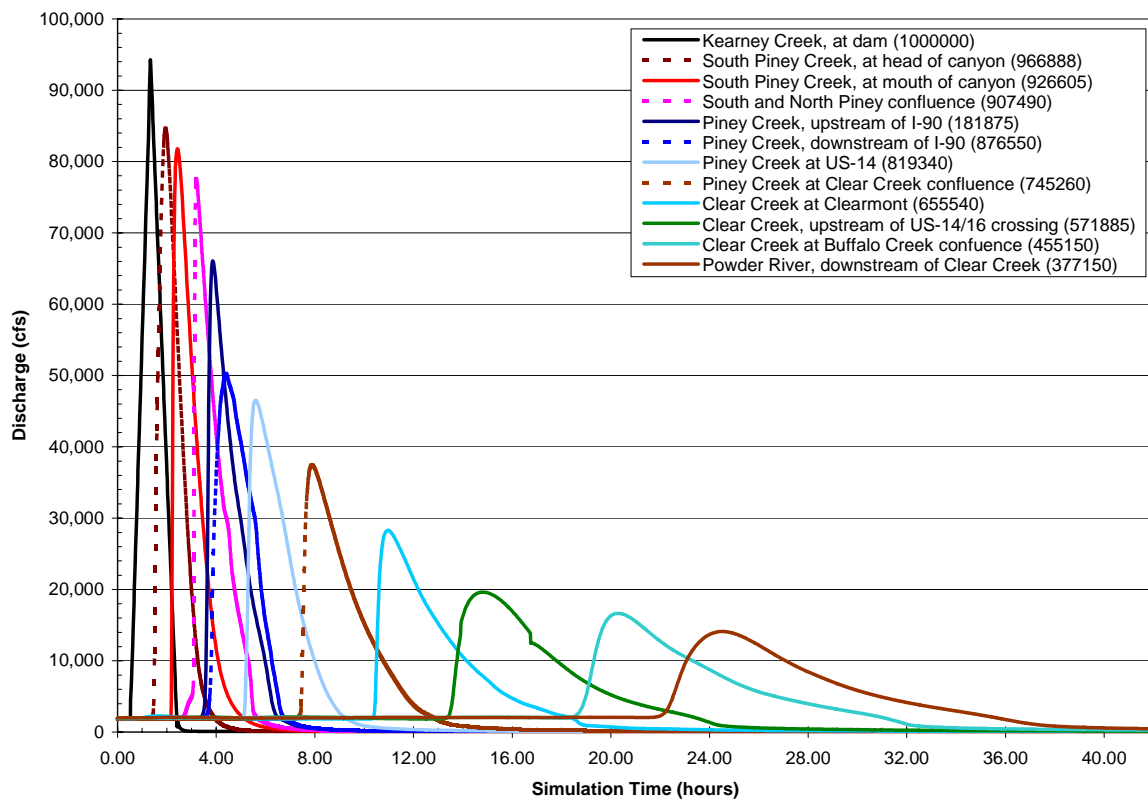
Figure 28: Breach hydrographs.

A catastrophic breach of Kearney Dam, with an initial peak flow of about 94,400 cfs, will inundate the floodplains of 84 miles of stream valley of Kearney Creek, South Piney Creek, Piney Creek, and Clear Creek before finally attenuating to about 14,100 cfs in the Powder River near the Clear Creek confluence. This is a 10-year event for this point on the Powder River (see discharge-frequency computations in Appendix C). Figure 28 provides the routed breach hydrographs at 12 points within the analysis zone. In the case of such a breach, hundreds of homes and businesses will be threatened with damage or destruction, several highways and one interstate will be inundated, bridges may be damaged, and many lives could be lost. This potential for harm is why the Wyoming State Engineer's office rates this structure as a "1", a high hazard, and requires the development of an Emergency Action Plan (Wyoming State Engineer's Office, 2000). Identification of the extent and timing of a floodwave is the first part of an Emergency Action Plan.
