U.S. FOREST SERVICE
NATIONAL STREAM AND AQUATIC ECOLOGY CENTER
October 25, 2016
MOGOLLON RIM STREAM INSTABILITY ASSESSMENTS

Client: Coconino National Forest

Location: Mogollon Rim Ranger District, Arizona

Date of Visit: 9/20/2016

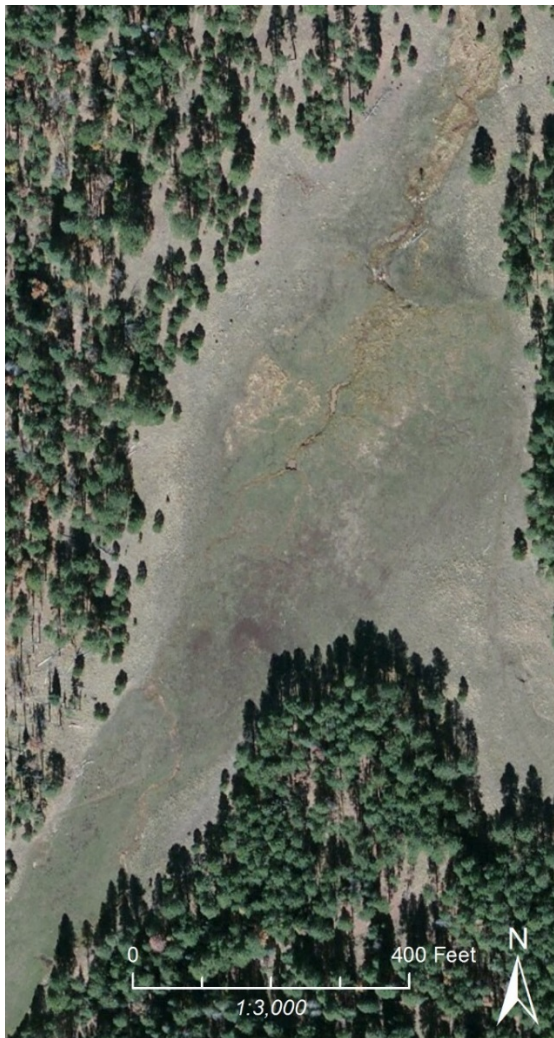
The Buck Springs channel and riparian zone (Figure 2) is a wet meadow system that has incised in a number of locations, with prior restoration activities to counteract this incision consisting of rock and wood structures, and exclusion fencing. The watershed extent is 1.18 mi², with average annual precipitation varying from 33 to 36 inches (PRISM; Daly et al. 2008). The exclusion fencing clearly shows the impact of Elk grazing and browsing activities on the meadow (Figure 3). This watershed has been classified as “functioning at risk” in the watershed condition framework (Potyondy 2011).

Figure 2: Buck Springs wet meadow (circa 11/2010).

An alternative approach is to utilize a meadow restoration, with reestablishment of a gradually-varied longitudinal profile through earth movement from local (valley side and terrace) borrow areas. Combined with grade control structures (log-type recommended), revegetation efforts, and possibly introduction of large wood and heterogeneously-sized alluvial rock material (gravel and cobble sized; for increased flow resistance and bed armoring), a fully-restored meadow could be developed. Success potential is high for this headwater drainage due to the small watershed and relatively-low stream power. This approach would require at least a temporary exclusion fence, to allow the vegetation to be established. This sort of restoration could likely provide conditions that do not require as much inspection and long-term maintenance, and would likely be more resilient to destabilization during large floods.

If sufficient funding is available, I recommend the priority 1 restoration approach for the portions of the Buck Springs channel where more extensive headcutting has occurred. I would be available to consult on the design for such features as the log grade-control structures if it is decided to utilize a priority 1 restoration approach to addressing the impaired conditions. If a priority 2 approach is utilized, the continued use of existing methods should suffice, though with the caveats presented above.

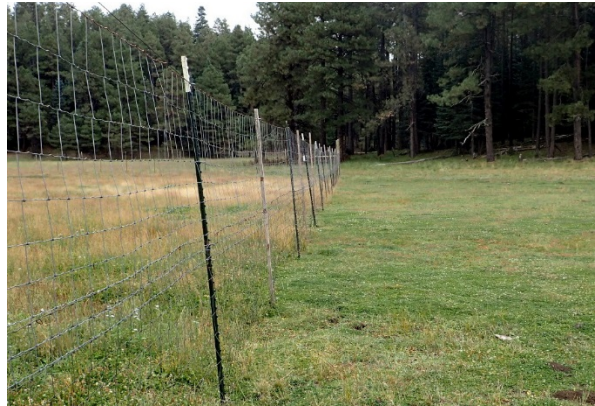
Figure 3: Exclusion fence vegetative condition contrast at Buck Springs, with the area on the right grazed by elk.

The vegetation condition within the exclusion fence is recovering well, especially compared to reaches outside the fence that are heavily impacted by elk. Willow plantings were also observed to be growing within the wet meadow, though are currently minimal in extent. The fencing, combined with a lack of livestock grazing, makes it clear that elk grazing and browsing is a fundamental impact to this meadow.

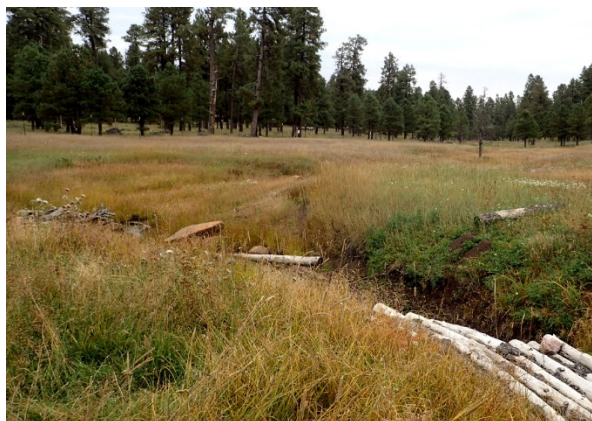
Existing rock structures to arrest headcutting include zuni bowls, within primary flow channels, and rock-mulch rundowns from side channels (Zeedyk and Clothier 2009). These structures function as rehabilitation features, to stop headcut propagation for a period, but do not restore the function of the lost wet meadow reaches. In general, these rock structures appeared to be performing well, though some maintenance activities will be periodically required. Wood structures for reducing headcut propagation were also observed (Figure 4), though appear to be ineffective as designed and constructed.

A stair-stepped longitudinal profile is apparent along the channel, with a gradually-varied slope a bit less than the valley slope for an extent, then a rapid transition to the lower grade with a steep slope at an active or arrested headcut, followed by once again a gradually-varied lower-gradient slope. The slope transitions are points of instabilities within the wet meadows, especially during large floods. Just downstream of these headcuts, the current riparian zone is much narrower than pre-disturbance conditions (Figure 4), as the channel evolves from Channel Evolution Model stages 2 and 3, to 4 and 5 (Figure 5).

Figure 4: Active headcut within the Buck Springs channel, with channel evolution occurring downstream.

The existing rock structures installed to arrest headcutting, include zuni bowls and rock-mulch rundowns, appear to be functioning well, especially within the elk exclusion. These structures will need periodic inspection and potential maintenance in perpetuity, due to the rapid drop in longitudinal profile at the stabilized headcuts being likely locations of future incision, especially during large flood events. Additionally, they maintain the current lower grade and impaired conditions (compared to pre-disturbance conditions) with narrowed riparian hydrologic and vegetative conditions. Furthermore, some of the wood structures are not effectively arresting the headcut migration, and other headcuts are present within this reach, requiring additional

rehabilitation structures in the near term to prevent additional degradation of the wet meadow.

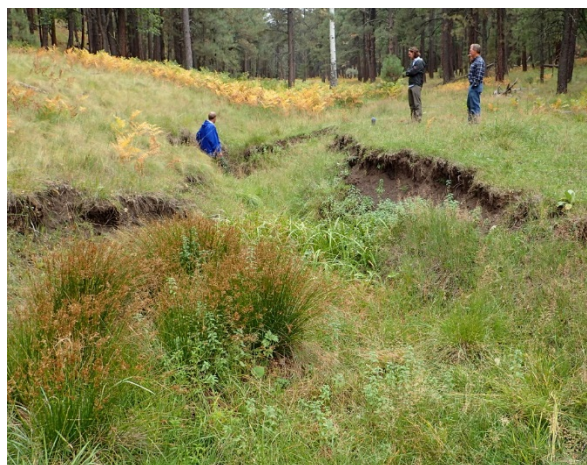
The downstream reach is relatively steep, with a slope that appears to be steep enough ($>3\%$) to be associated with transitional to step-pool bedform morphology (Montgomery and Buffington 1997), although the channel is not sediment-supply limited and has intermittent flow. A number of headcuts exist within this reach (Figure 6, Figure 7), though some armoring of headcut steps by large clasts and wood (Figure 7) may be providing a degree of stabilization in places. Generally, the channel within this reach appears to be lacking armoring and such flow resistance elements as large wood, and boulders and cobbles; this may be a fundamental reason for the propagation of instability, though the original instability may have been induced by historic livestock grazing.

Figure 6: Lower reach of Houston Draw, with multiple headcut sequences observed.

Similar to Buck Springs, either priority 1 or priority 2 approaches could be utilized to restore or rehabilitate the reaches of this channel, with both approaches having advantages and disadvantages. Both approaches could be utilized in different portions of the reaches, with priority 1 restoration recommended where there is more substantial disturbance, such as in the lower portion of the upstream reach's meadow.

With the lower reach having a higher gradient that appears to be transitional to a slope where channels typically have step-pool bedforms, providing heterogeneously-sized alluvial rock material for armoring (gravel and cobble size) may

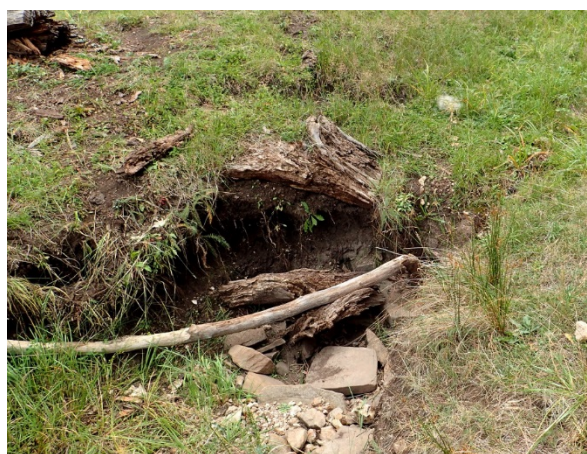
Figure 7: Lower reach of Houston Draw, with clast and wood-armored headcut.

be effective for stabilizing the bed grade. One of the existing headcuts has already formed what appears to be an armored step (Figure 7); providing the rock material will allow more of this development over time when high flows occur to sort the material. For channels greater than 2 to 3%, this armoring rock material (gravels, cobbles, small boulders) can be placed as needed to suppress erosion and allowed to sort, while in lesser gradient channels it is recommended to place heterogeneous-sized cobbles and gravel mix in riffle/crossing zones as defined by the channel planform (Figure 15). Additionally, the inclusion of large wood would also be beneficial for providing stabilization. Wood with attached root wads and lengths at least 1.5 to 2 times the channel width will be most stable.

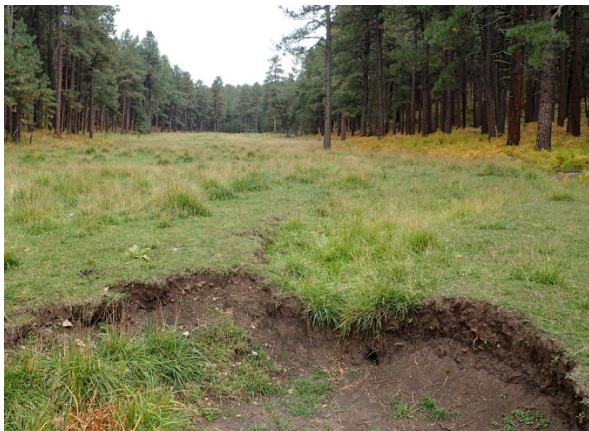
The upstream reach is also showing instability, with headcutting (Figure 8), and a relatively

This upper meadow reach is being heavily utilized by elk, which is contributing to the instability. Recognizing this, part of the upper reach has been excluded with an 8-foot fence. Interestingly, while the portion of the upper reach that is not excluded is being heavily utilized by elk (within a relatively wide valley), the lower and confined reach is not.

Figure 8: Headcut within the upper meadow reach of Houston Draw.

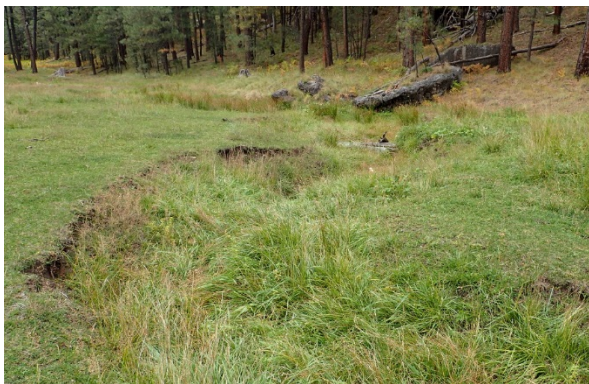
widely-developed channel and floodplain at a lower grade (Figure 9). This evolving channel appears to be in a Channel Evolution Model stages 2 & 3 (Figure 5) near the headcut, and stages 4 & 5 further downstream. Upstream of the headcut only a small channel is present within this small headwater watershed.

Figure 9: Evolved channel at lower grade, upper meadow reach of Houston Draw.

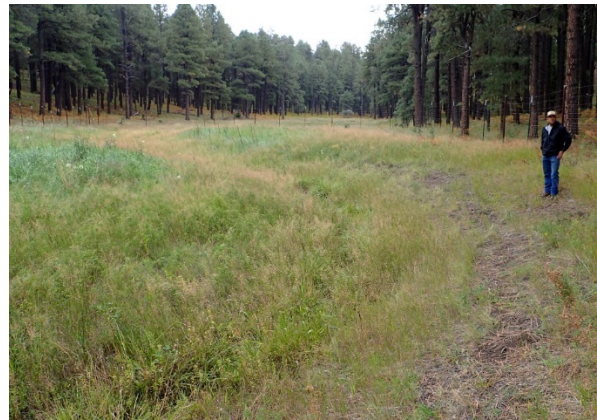
A portion of the meadow reach has had a channel rehabilitation project implemented. The term rehabilitation is explicitly used since this reach has had a channelized cross-section form constructed (Figure 10) rather than a channel and associated floodplain. This channel was constructed with sinuous planform geometry, but will have excess

unit stream power and shear stress during high flows due to the disconnected floodplain, potentially leading to incision.

Figure 10: Channel of rehabilitated reach in upper meadow portion of upper Houston Draw.

The upstream rehabilitated reach, within the exclusion zone, was constructed with a channelized cross section that disconnects the channel from its floodplain. This reach will need to be periodically inspected for stability, especially after greater than typical annual snowmelt runoff and large floods.

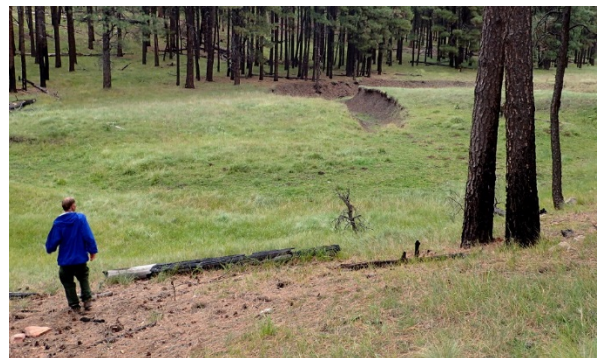
Dick Hart Draw is a dry meadow channel that is deeply incising in a fine and deep soil substrate. A number of 4 to 6 ft high berms were historically placed across the channel (Figure 11). This was presumably done to control incision, though the rationale for this is unclear since a stabilization mechanism could not be hypothesized. In any case, incised channels have been eroded through the berms and underlying substrate and this drainage is likely a substantial source of fine sediment to Barbershop Canyon, which is a tributary to East Clear Creek. Headcuts of up to about 12 feet deep are currently present (Figure 12). East Clear Creek is habitat for the Little Colorado spinedace (*Lepidomeda vittata*), a threatened species under the Endangered Species Act.

Figure 11: Dick Hart Draw, with eroded berms.

Dick Hart draw is in a poor state that is very possibly providing substantial sediment to East Clear Creek, habitat for the Little Colorado spinedace. This is a threatened species under the Endangered Species Act. The dry conditions of this intermittent stream will make restoration challenging, with a priority 1 restoration being most effective though very expensive, with large amounts of earth movement.

It is recommended that the downstream drainages are inspected (or potentially studied through research) to understand if the liberated sediment from continued deep headcutting in Dick Hart Draw negatively impacts the endangered spinedace.

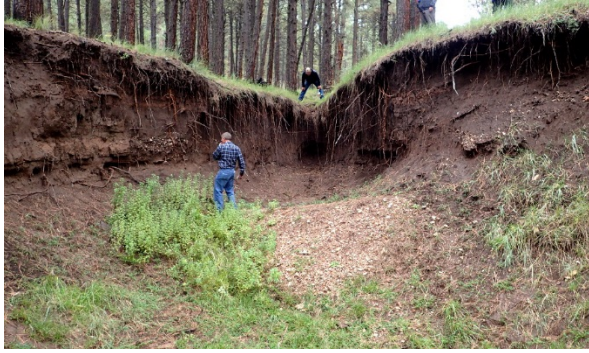
Figure 12: Deep headcut in Dick Hart Draw.

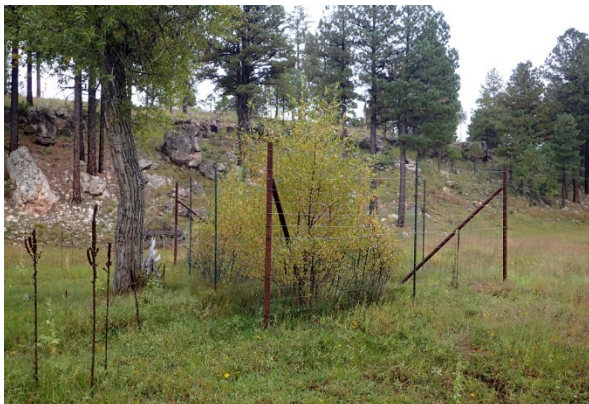
This reach of the valley has small exclusion fences to promote cottonwood recruitment (Figure 13), though considering where new growth is occurring, the best conditions for recruitment appear to be outside of the exclusion fences at a lower grade, along the margins of what appears to be an incised channel (Figure 14). This reach is grazed by cattle.

Figure 13: Small exclusion fence along the intermittent stream channel in Willow Valley.

Willow Valley's channel appears to be incised in vicinity of the remnant cottonwood populations. It is likely not reasonable to restore this channel to previous grade within this limited reach due to the large watershed imposing high stream power during floods, as well as the need for providing a gradually varied longitudinal profile. This would require restoration over a much longer extent than the remnant cottonwoods reach. Because of this, I recommend that exclusion fences be installed to protect the current areas of the channel edge (Figure 14) and terrace that currently have cottonwood growth.

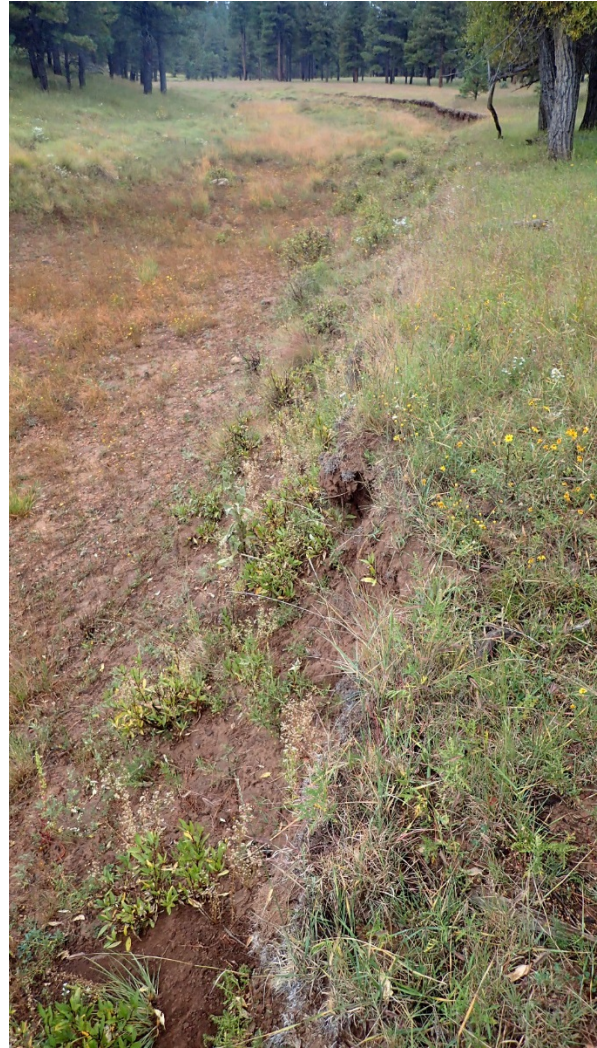
Figure 14: Cottonwood recruitment along the incised channel margin of Willow Valley.
