Willow Creek Stream Restoration: Planning Study

Mineral County, Colorado
April 2007

Willow Creek Stream Restoration: Planning Report

Summary: A plan detailing current conditions and proposed restoration options of the Willow Creek stream and floodplain downstream of Creede has been developed and is presented in this report.

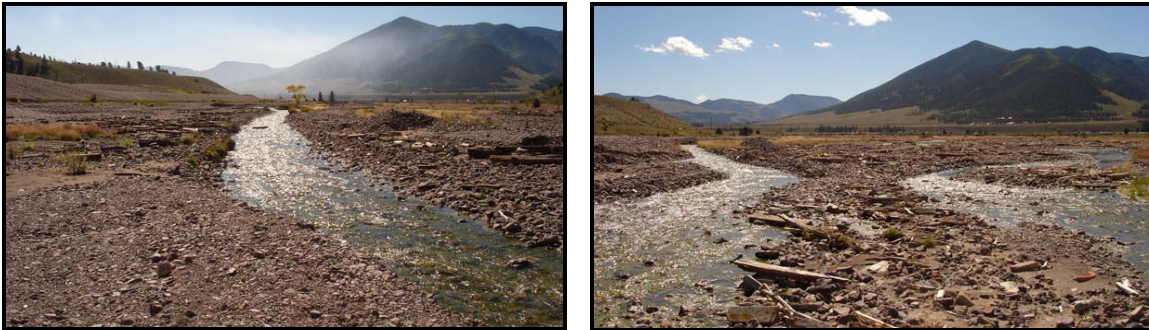
Figure 1: Current condition of Willow Creek floodplain.

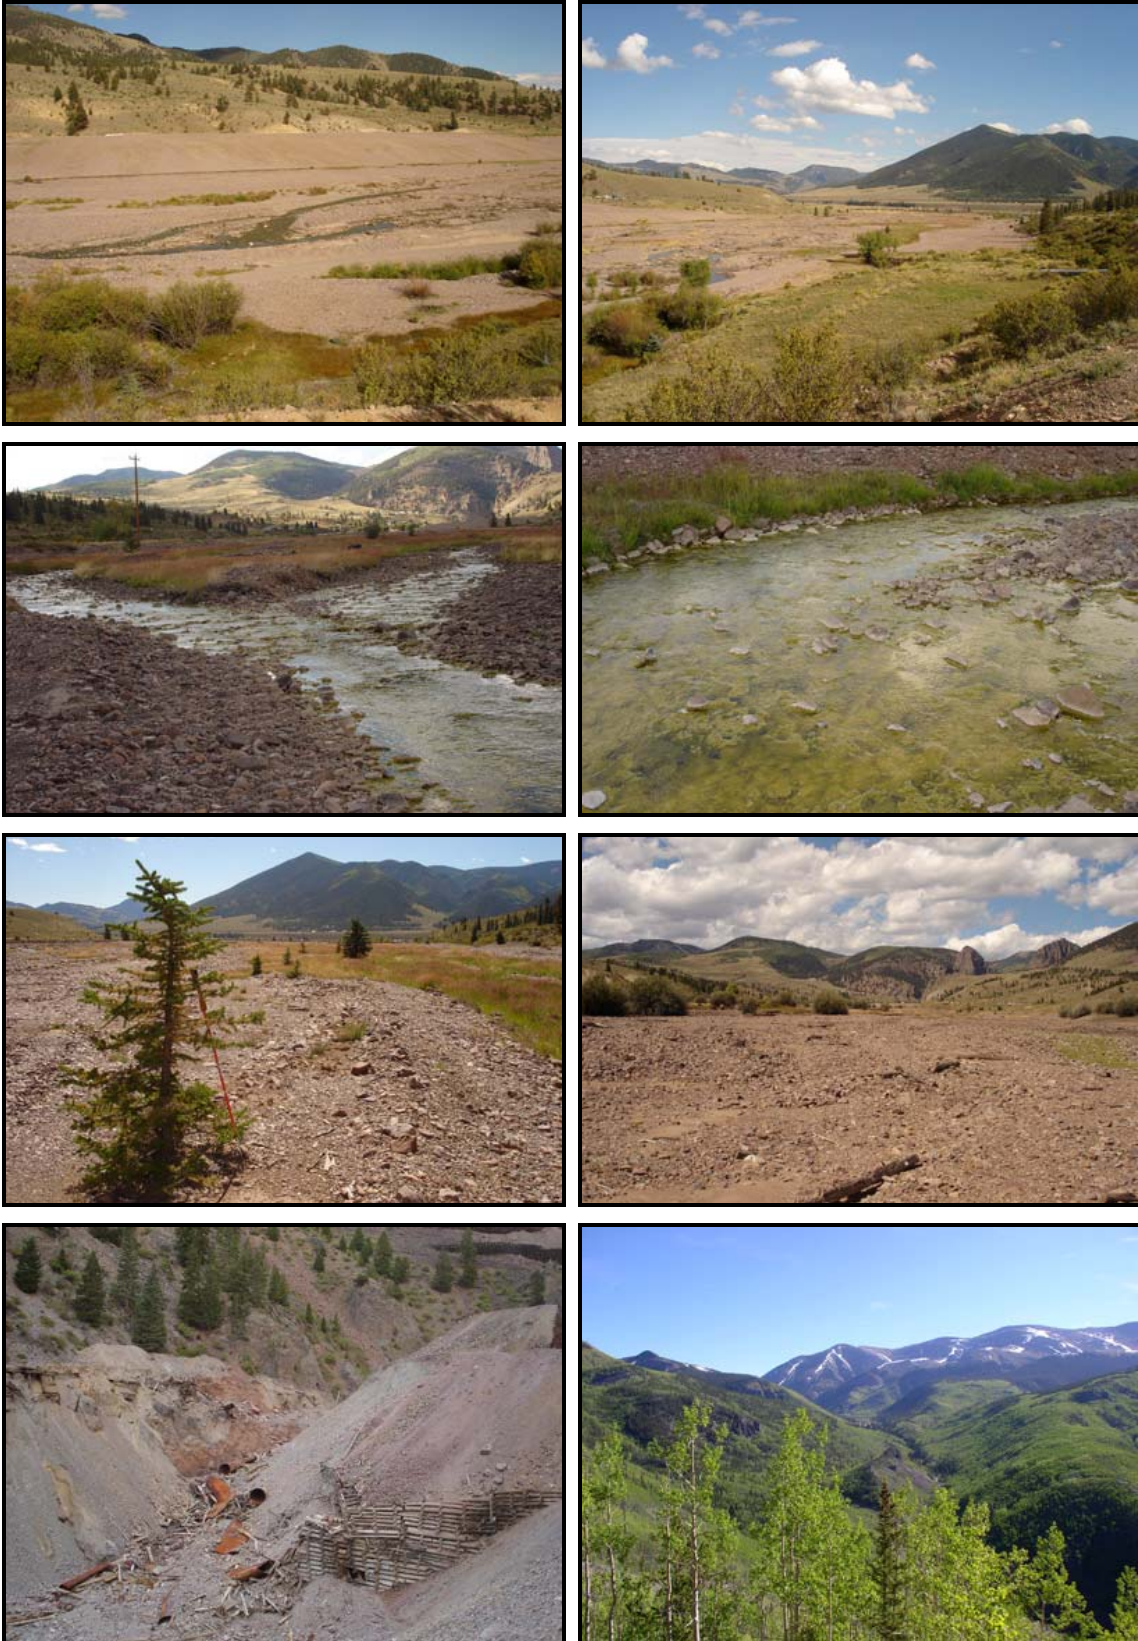
Figure 2: Current condition of Willow Creek floodplain and watershed.

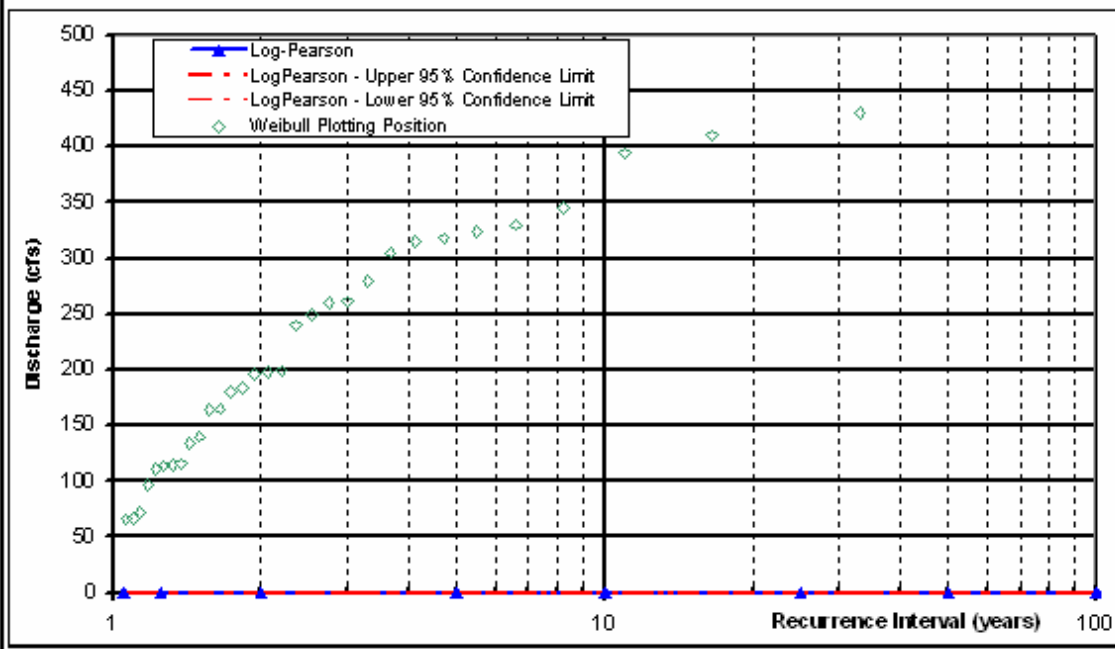
Figure 19: Frequency analysis (B) of streamgage 08216500.

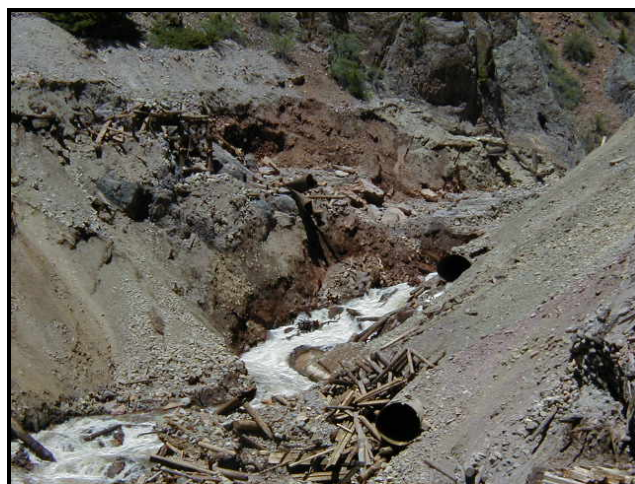
A snowmelt-related flood occurred in late May of 2005. This flood caused extensive damage on West Willow Creek, causing the failure of a large culvert and eroding mine waste and tailings and other mining-related material (Figure 55). Much of this debris was deposited in the Willow Creek floodplain, downstream of Creede within the proposed stream restoration area. As of late 2006, this reach on West Willow Creek has yet to be stabilized.

Figure 55: West Willow reach of instability, on 5/25/2005.

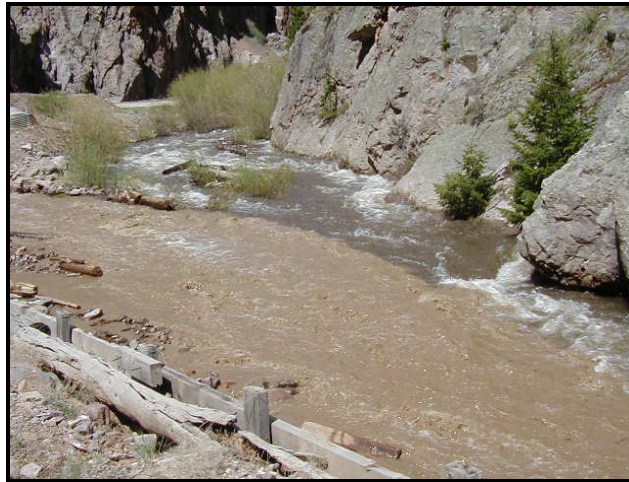
Substantial material was eroded during the May of 2005 flood event. A photograph of the confluence of West and East Willow Creeks, dated 5/25/2005, is provided in Figure 56.

Figure 56: Confluence of West (left) and East (right) Willow Creeks on 5/25/2005.
