**U.S. FOREST SERVICE
NATIONAL STREAM AND AQUATIC ECOLOGY CENTER**

FIRST CREEK: STREAM RESTORATION ASSESSMENT

Client: Routt National Forest

Location: Headwaters of Elkhead Creek in California Park, Colorado

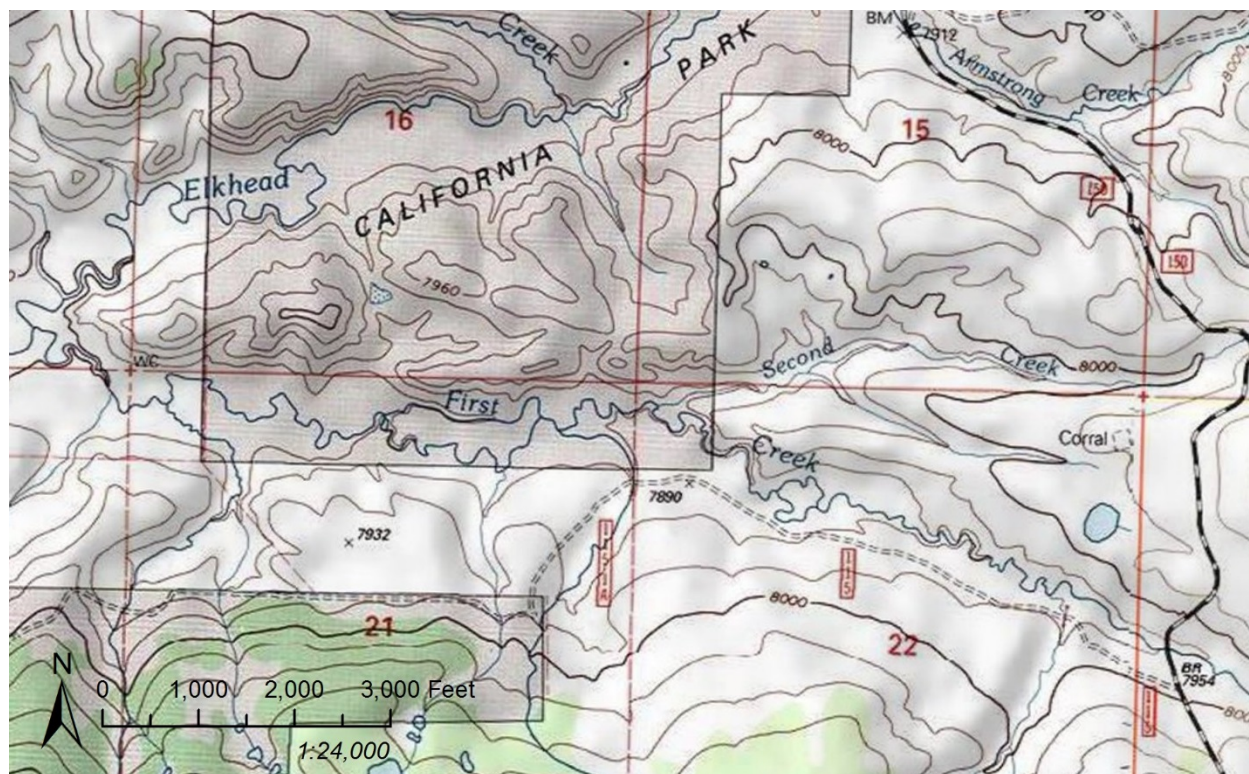
Figure 1: First Creek reach of concern, from County Road 150 to the confluence with Elkhead Creek.

Currently, First Creek between County Road 150 and the confluence is incised up to about 3 feet, with the amount of incision varying throughout the overall reach. No headcuts were observed, though aerial imagery indicates that multiple meander bends have been cut off and that lateral erosion in some locations is active and may likely be accelerated compared to pre-settlement conditions. Elkhead Creek at the confluence was also observed to be incised. Several terraces and hillslopes were actively eroding at their toe. These high eroding banks combined with active bank erosion at many locations are contributing to turbid conditions. Specific observations of conditions along First Creek, as well as a short section of Elkhead Creek downstream from the First Creek confluence, are presented below.

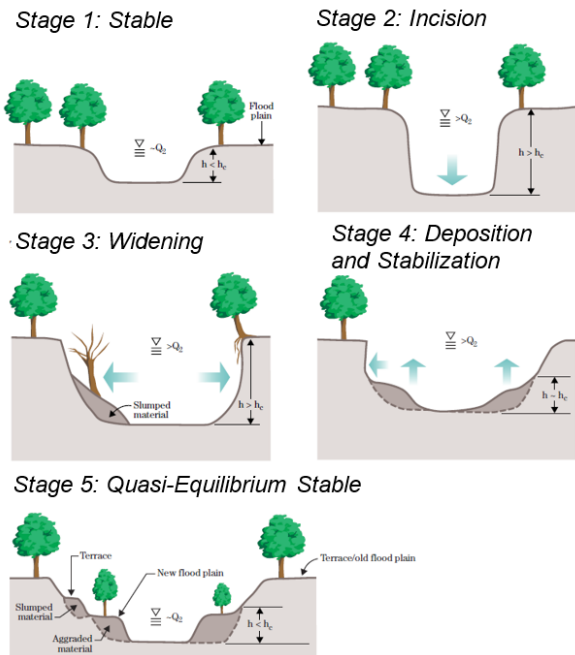
Elkhead Creek below the First Creek confluence (44.3 mi² catchment size; Figure 2) is incised, and appears to be in Channel Evolution Model (Schumm et al. 1984) stages 3 and 4 (Figure 3).

Figure 3: Channel evolution model, with channel cross sections illustrating the 5 channel stages (modified from NRCS 2007).

The Channel Evolution Model (CEM) is a valuable tool for understanding how channel form adjusts over space and time due to a disturbance that causes incision. At a specific location the channel evolves from an initial stable state (stage 1) through incision (stage 2), widening (stage 3), deposition and stabilization (stage 4), and once again stable (stage 5). Stages 2 and 3 are the most challenging stages of the evolution model for managers; this is the stage where sediment supply is highest and restoration options are limited. Over time, the incision moves upstream, forcing incision of the valley bottom on successive upstream reaches. With this reach of Elkhead Creek being in stage 3 within part of the observed reach, the stream appears to still be transitioning to a stable form (stages 4 and 5), with a sufficient floodplain width at the lower base level (oval, Figure 4).
