**U.S. FOREST SERVICE
NATIONAL STREAM AND AQUATIC ECOLOGY CENTER**

September 17, 2015

GOVERNMENT CREEK: STREAM RESTORATION ASSESSMENT

Location: Government Creek, in Government Park, Utah

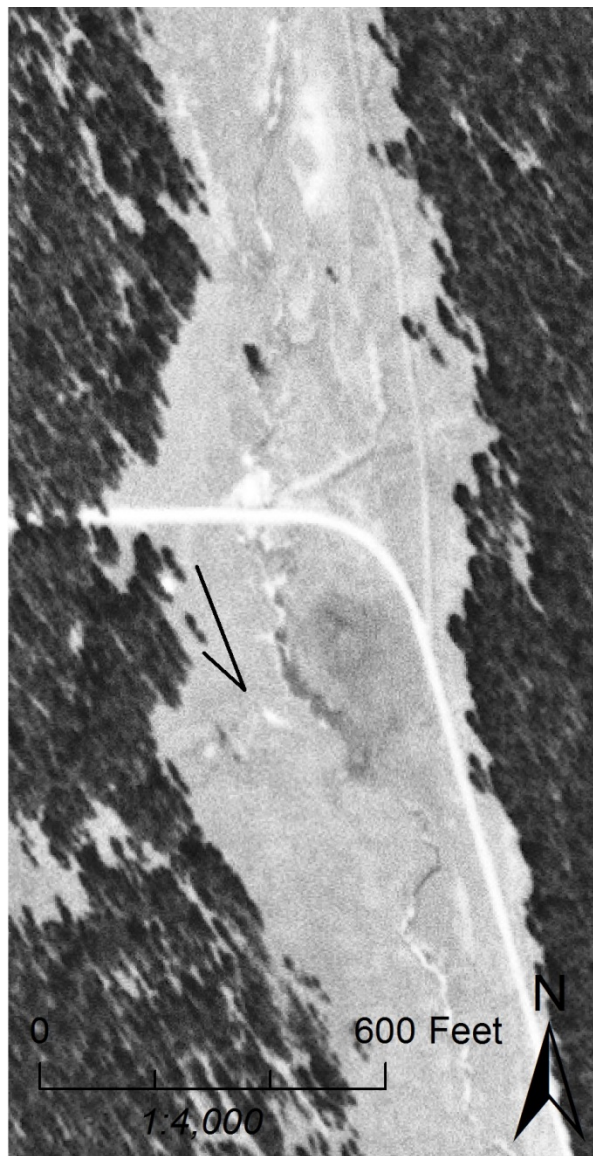
Historic aerial imagery was obtained for 1949, 1953, 1959, 1965, 1976, and 1993. Figure 16 provides imagery from 1959. Using this 1959 image, as well as the 1953 image, an average headcut propagation rate of the primary headcut of concern (Figure 3) is 4 to 5 feet/year. If this rate has been more or less consistent, then this particular headcut initiation may have started in the 1870s, 1880's, or 1890's.

Figure 16: Historic aerial photograph of Government Park (9/2/1959).

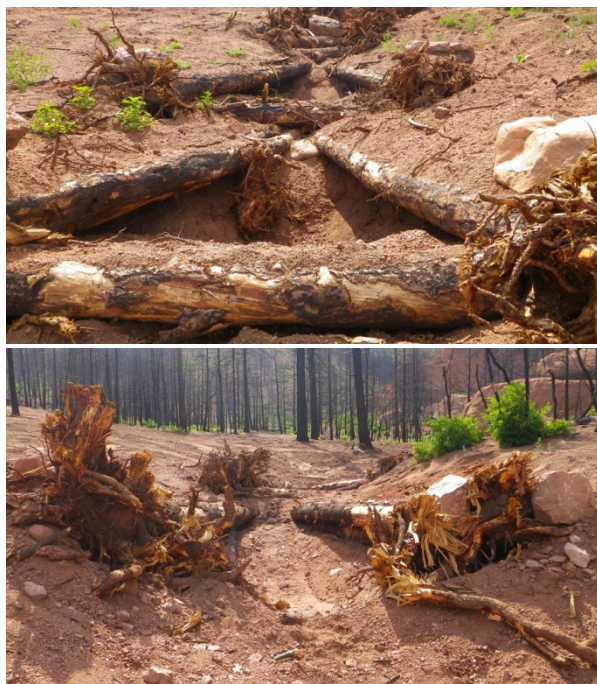
Figure 20: Log grade control structures implemented downstream of the Waldo Canyon Fire (2012), Colorado.

Numerous types of grade-control structures have been used to provide grade control to arrest headcuts and retain constructed channel beds and floodplain surfaces. The best type for this situation is likely a log structure, similar to the structures presented in Figure 20. There are numerous approaches to constructing a log grade-control structure; the National Stream and Aquatic Ecology Center can help adapt a design for use in Government Park. Periodic maintenance may be needed for these structures, though less maintenance is expected for the full meadow restoration (Alternative 4) compared to the headcut arrest approach in Alternative 3.

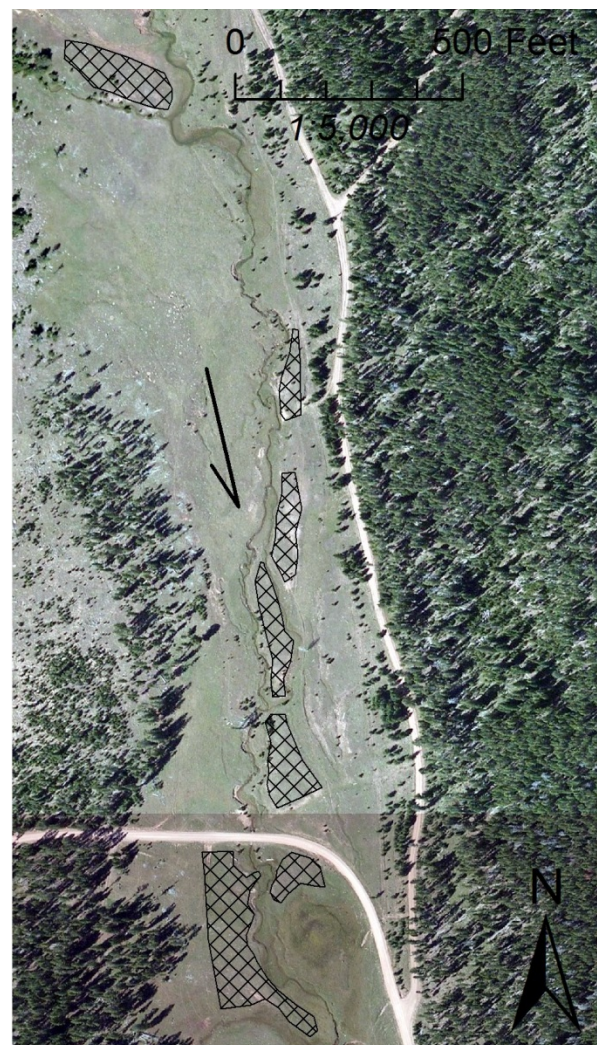
Terraces (abandoned historic floodplain surfaces) that could be utilized for this borrow material (if this material and source areas are deemed suitable) are illustrated (Figure 21). Removing this borrow can potentially widen the wet meadows in these reaches. If all of these areas were utilized for borrow, an excavation depth of roughly 13 inches would be needed, though deeper excavation in some areas would likely be preferable, to widen the extent of wet meadow.

Figure 21: Potential borrow areas (cross hatched) in Government Park.

It is roughly estimated that 1400 cubic yards of fill would be required to fill the incised stream channel downstream of the road crossing, reestablishing the wet meadow. This was computed by assuming a 2 foot elevation drop throughout the delineated incised areas that are in a stage IV of the Channel Evolution Model (Figure 6). Additionally, roughly 2900 cubic yards of fill would be required to fill the most recent incised stream segments upstream of the road crossing. Portions or all of these segments could be restored. As a design is developed, it
