**U.S. FOREST SERVICE
NATIONAL STREAM AND AQUATIC ECOLOGY CENTER**

PICKEL MEADOW: STREAM CONDITION and RESTORATION POTENTIAL

Client: Humboldt-Toiyabe National Forest

Location: Pickel Meadow, West Walker River, Mono County, California

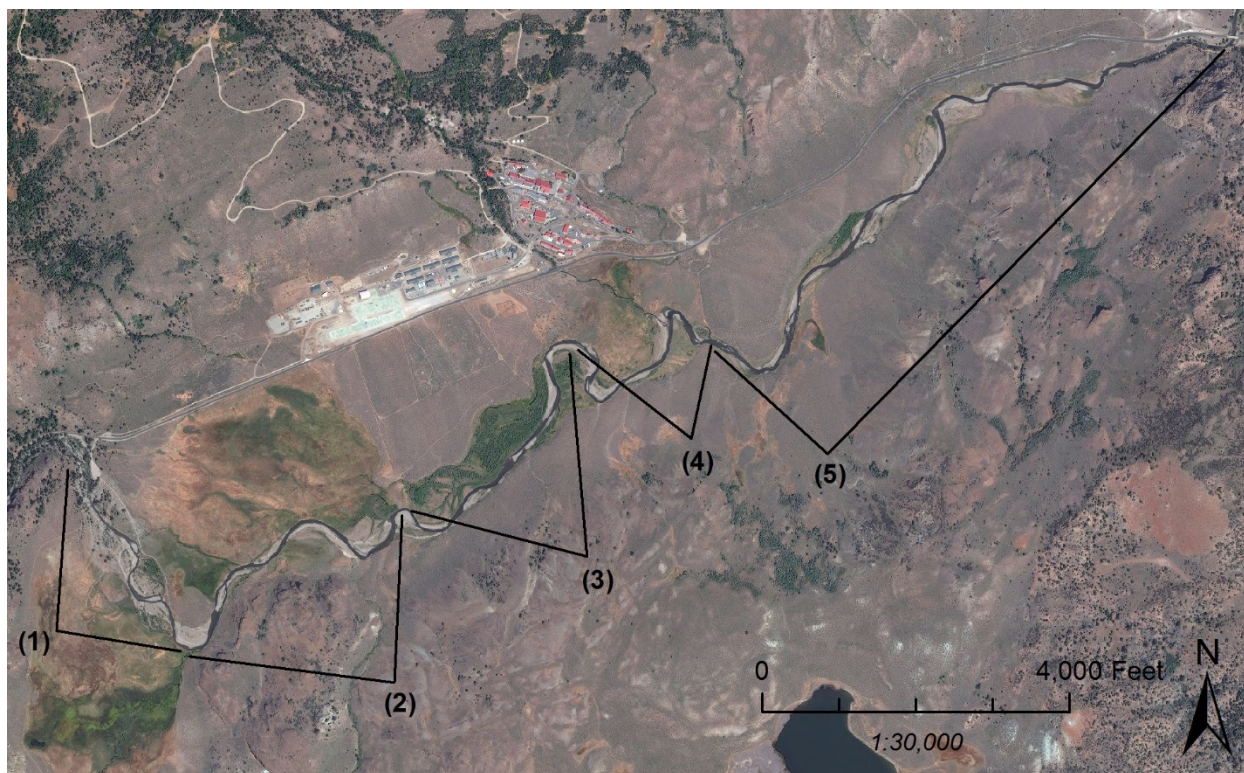
Figure 2: Geomorphic subreaches of the West Walker River in and downstream of Pickel Meadow. Aerial imagery: 8-28-2016.

Based upon general geomorphic processes and stream confinement, the overall Pickel Meadow restoration reach was divided into five subreaches of the West Walker River (Figure 2). Specifically, these are:

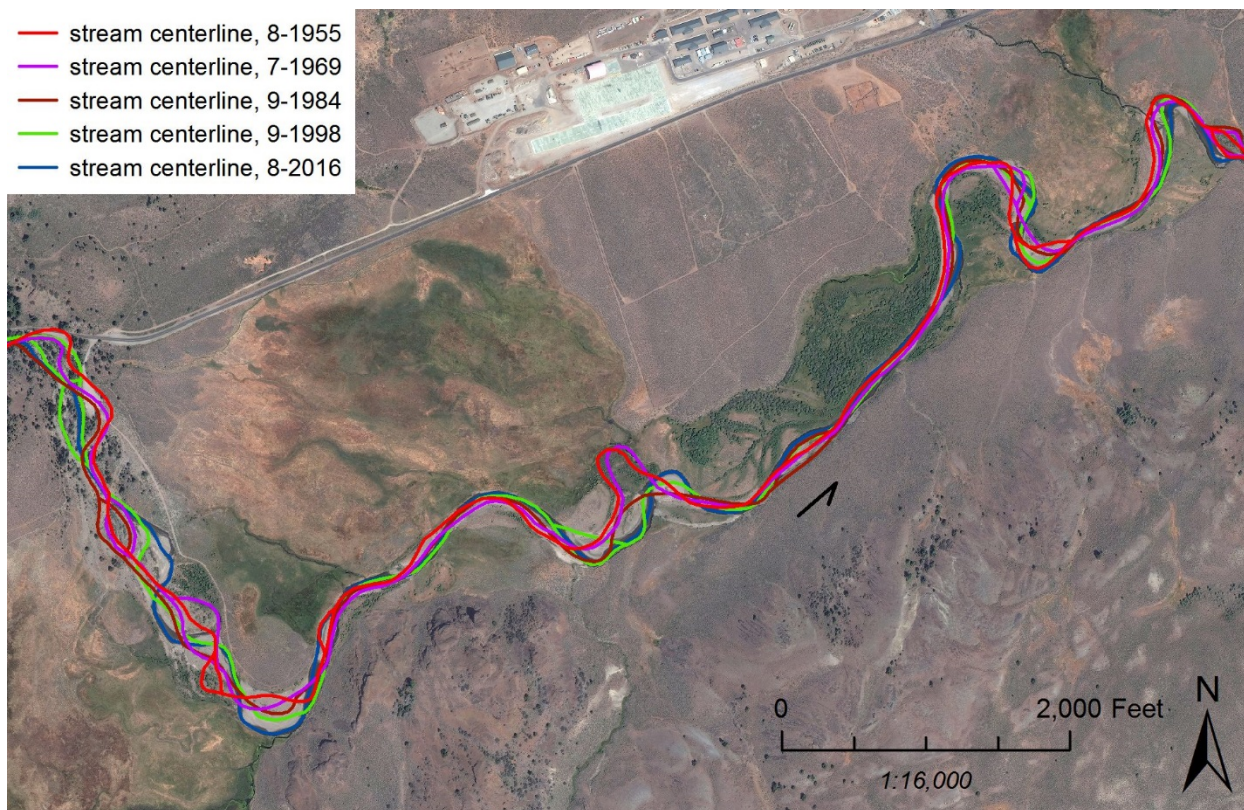
Figure 3: Stream centerlines (1955 through 2016), upstream portion of the West Walker River in Pickel Meadow.

In reach 1 (Figure 3), the transitional reach with a remnant alluvial fan, the stream has alternated between being in a single thread and multi-thread form, though has occupied a narrow footprint as the slope and valley confinement changes from canyon to meadow. Terrace features, a parking lot, and a primitive road have limited the development of a more extensive fan since at least 1955, with the widest portion of Pickel Meadow, to the east (reach 2), being isolated from this reach. Reach 1

has been more connected with the Poore Creek portion of Pickel Meadow to the south, with at least two connected lesser stream channels being consistently maintained by fluvial geomorphic processes from 1955 through 2016.

The West Walker River in reach 2 (Figure 3) has had a consistent form from 1955 to 2016 for most of this unconfined portion of Pickel Meadow. Despite the meadow being up to 2500 ft wide within this reach, the stream has consistently flowed in the far southern portion of the meadow. An 1877 survey of the area shows the West Walker River also in this same general location. A small amount of downstream meander migration, as well as a meander bend cutoff as this reach transitions to being semi confined in reach 3, has occurred from 1955 through 2016. This cutoff occurred between 1969 and 1984. More substantial side channel connectivity also existed for a portion of this reach in 1955, but has since been gradually lost.

Reach 3 of the West Walker River in Pickel Meadow (Figure 3) is more confined, with terraces limiting active floodplain widths from 550 to 750 ft within the majority of this reach. The meadow widens again in reach 4, to 1600 ft as Silver Creek flows towards its confluence with the West Walker River. The stream has had a consistent form from 1955 through 2016 within reaches 3 and 4, with minimal detected meander migration, though side channel connectivity appears to have been reduced since 1955.

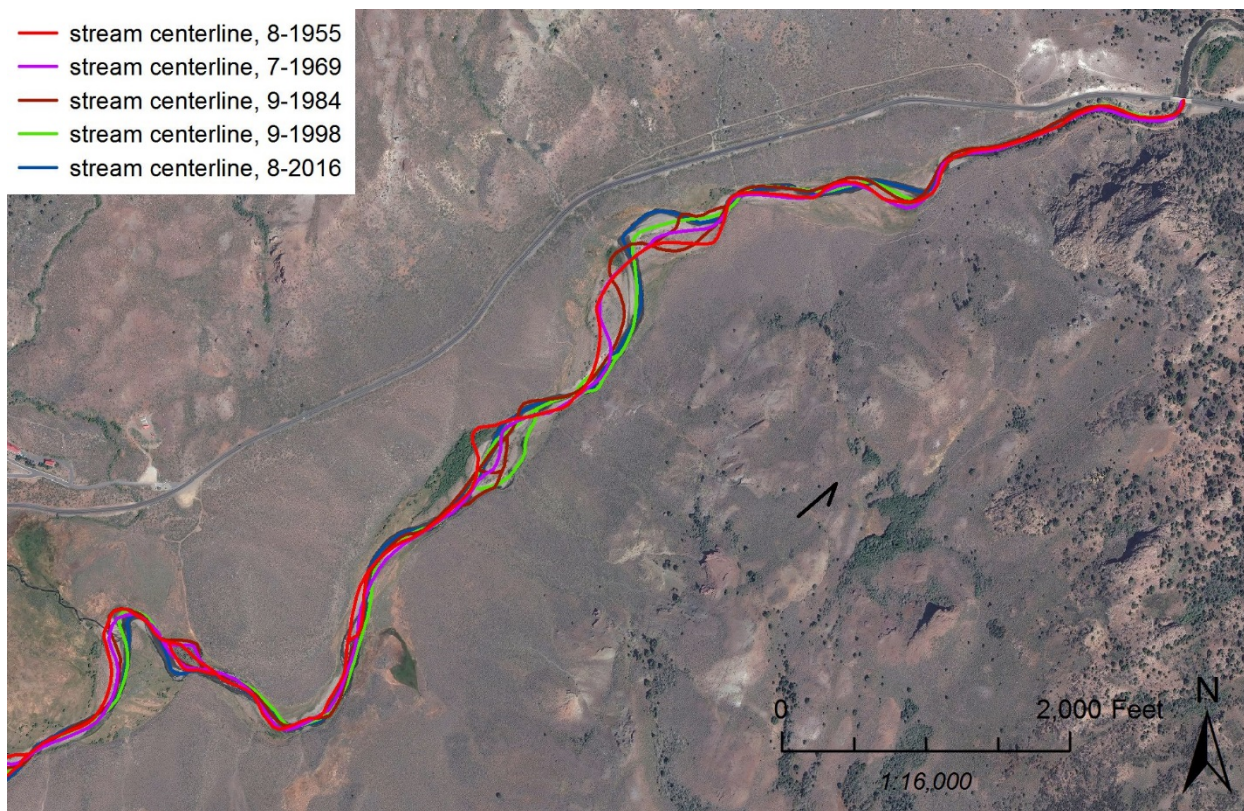
Figure 4: Stream centerlines (1955 through 2016), downstream portion of the West Walker River in Pickel Meadow.

Reach 5 (Figure 4) is substantially more confined by high terraces than the upstream reaches, with floodplain widths ranging from 150 to 500 ft. In the most confined portions of this reach the channel has remained in the same planform, though substantial channel migration has occurred where the channel is less confined, with most of the floodplain in these locations being host to the channel since 1955.

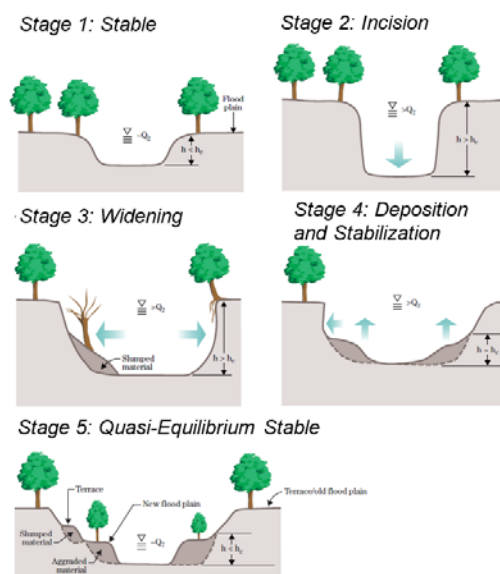
Figure 18: Channel evolution model, with channel cross sections illustrating the 5 channel stages (modified from NRCS 2007).

The West Walker River in reach 2 has incised at some point in time and fully developed a new floodplain at a lower grade. Hence, this stream is in stage 5 of the channel evolution model (Figure 18). In these areas, the current substantial floodplain extent has reduced unit stream power and sediment transport conveyance capacity; it is considered relatively recovered from a historic incision episode, but with hydrologic consequences to the adjacent meadow due to the lowered groundwater table elevations.
