**U.S. FOREST SERVICE
NATIONAL STREAM AND AQUATIC ECOLOGY CENTER**

RIO SAN ANTONIO: STREAM CONDITION and RESTORATION POTENTIAL

Client: Carson National Forest, Tres Piedras Ranger District

Location: Rio San Antonio watershed, Rio Arriba County, New Mexico

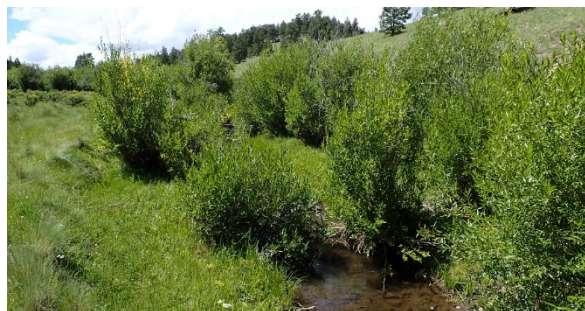
Figure 3: Reach of Canada Tio Grande with more vegetation cover.

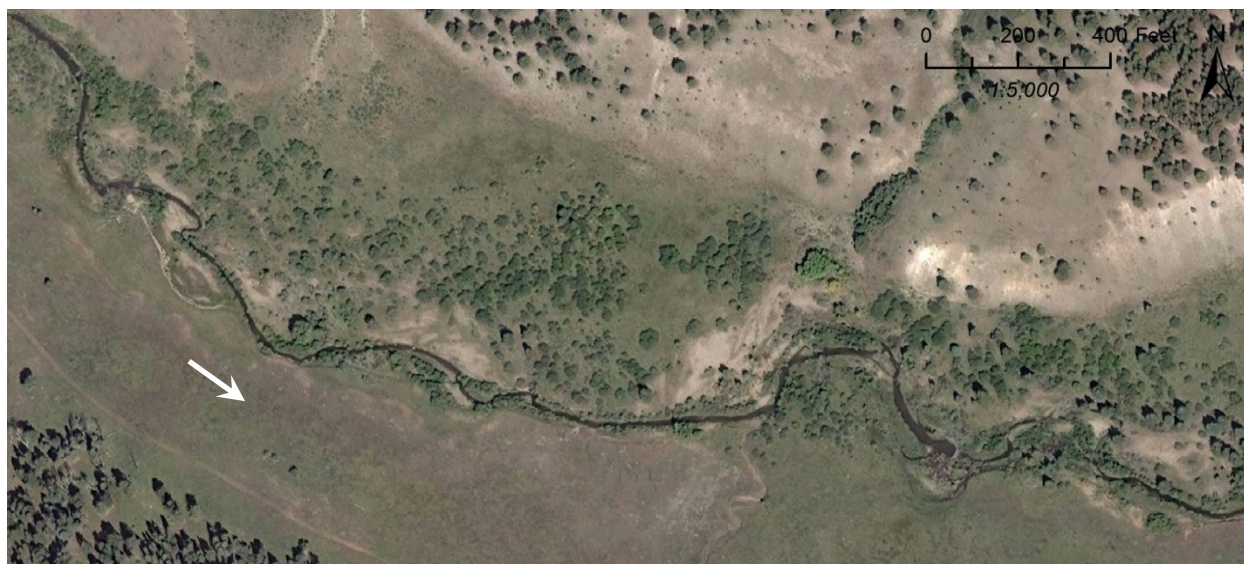
The proposed lower Rio San Antonio restoration reach is located between two private inholdings (Figure 1), between a large tract downstream and small tract upstream. The downstream portion of this reach is a beaver pond dominated meadow (Figure 7), while beaver activity is less prevalent upstream (Figure 8). The upstream portion of this reach was not visited during this trip.

Figure 8: Lower Rio San Antonio proposed restoration reach (2016-10-4), upstream.

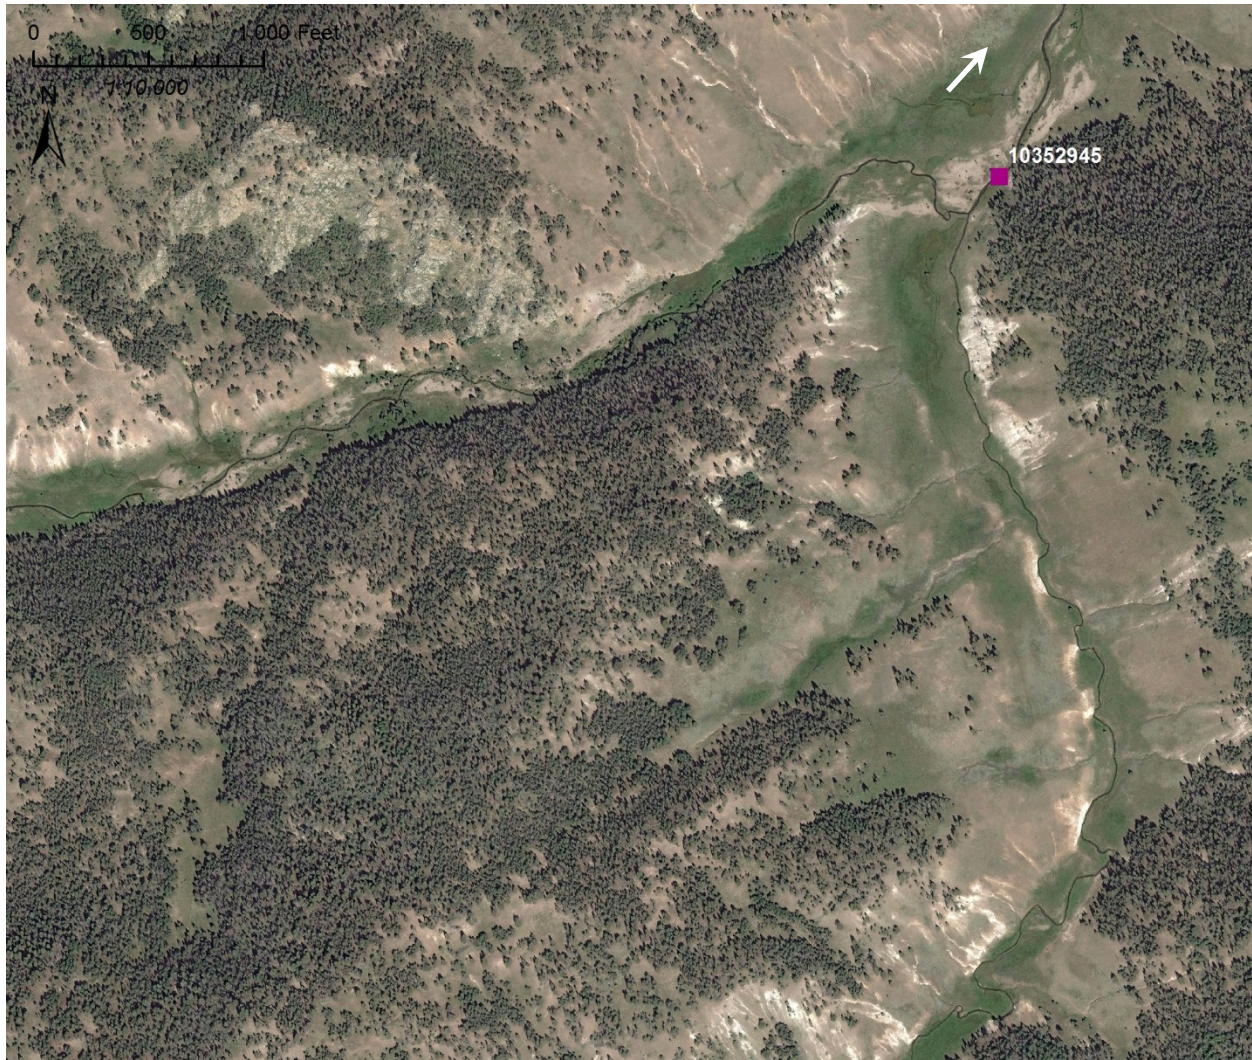
Figure 14: Upper Rio San Antonio proposed restoration reach (2016-10-4), upstream.

Numerous small alluvial fans are present along this reach (Figure 13), from small and a moderate-sized tributary (Canon Largo). Erosion of the terraces that are former floodplain surfaces that were abandoned with incision are evident, as is erosion of higher terrace surfaces, including portions of alluvial fans.

Knox (2016) documents two temperature monitoring stations within this reach (Figure 13, Figure 14), in addition to the monitoring station in the lower Rio San Antonio reach (Figure 7). Mean and peak temperatures for July 1 through July 7, 2013 are provided in Table 1, with a plot of the data for the three stations illustrated in Figure 18.

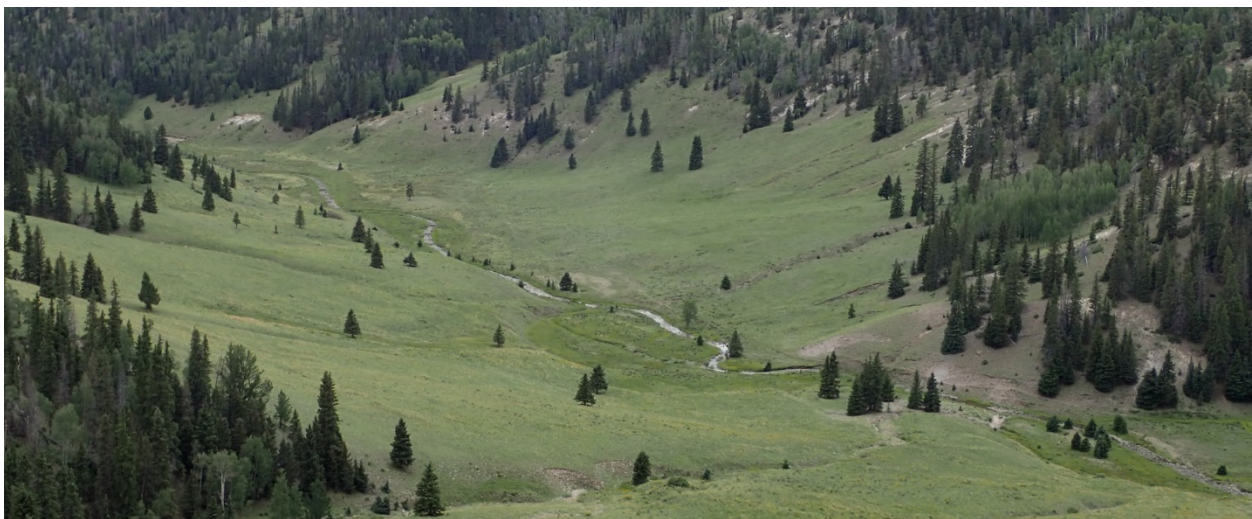
The upper Rio San Antonio Reach (Figure 13, Figure 14, Reaches 4-upper, 5 and 6 in Knox 2016) was not directly assessed on 8/15/2017, but was evaluated from an overlook (Figure 15) and was visited in 8/2017 by Michael Gatlin. A number of photographs documenting conditions were collected, which were utilized in this condition assessment.

Figure 15: Downstream portion of the Upper Rio San Antonio proposed restoration reach.

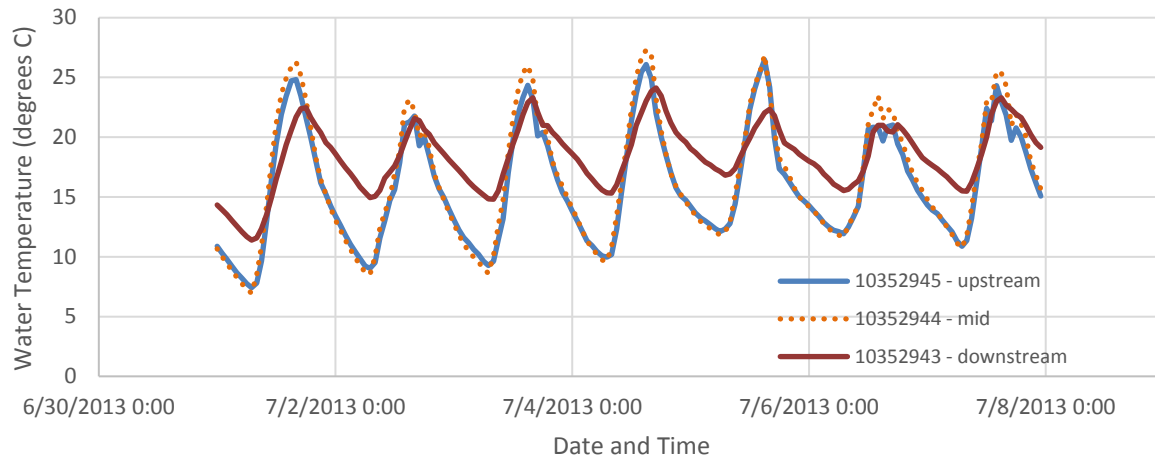
The upstream stations have lower averages but increased diurnal variations, while the downstream station has higher average temperatures but lower maximum temperatures. This may likely be the result of the poor shading and riparian vegetation conditions upstream, forcing higher high temperatures (from solar

radiation) and lower low temperatures (from a lack of microclimate zones to moderate temperature). Beaver ponds and associated increased hyporheic exchange immediately upstream of the downstream monitoring site is likely also contributing to the lesser diurnal temperature variability.

Figure 18: Plot of Rio San Antonio temperature monitoring results from Knox (2016), for July 1 through July 7, 2013.
