**U.S. FOREST SERVICE
NATIONAL STREAM and AQUATIC ECOLOGY CENTER**

TULAROSA RIVER at NFSR-233: SITE VISIT and RECOMMENDATIONS

Client: Gila National Forest, Reserve Ranger District

Location: NFSR-233 crossing of the Tularosa River, Catron County, New Mexico

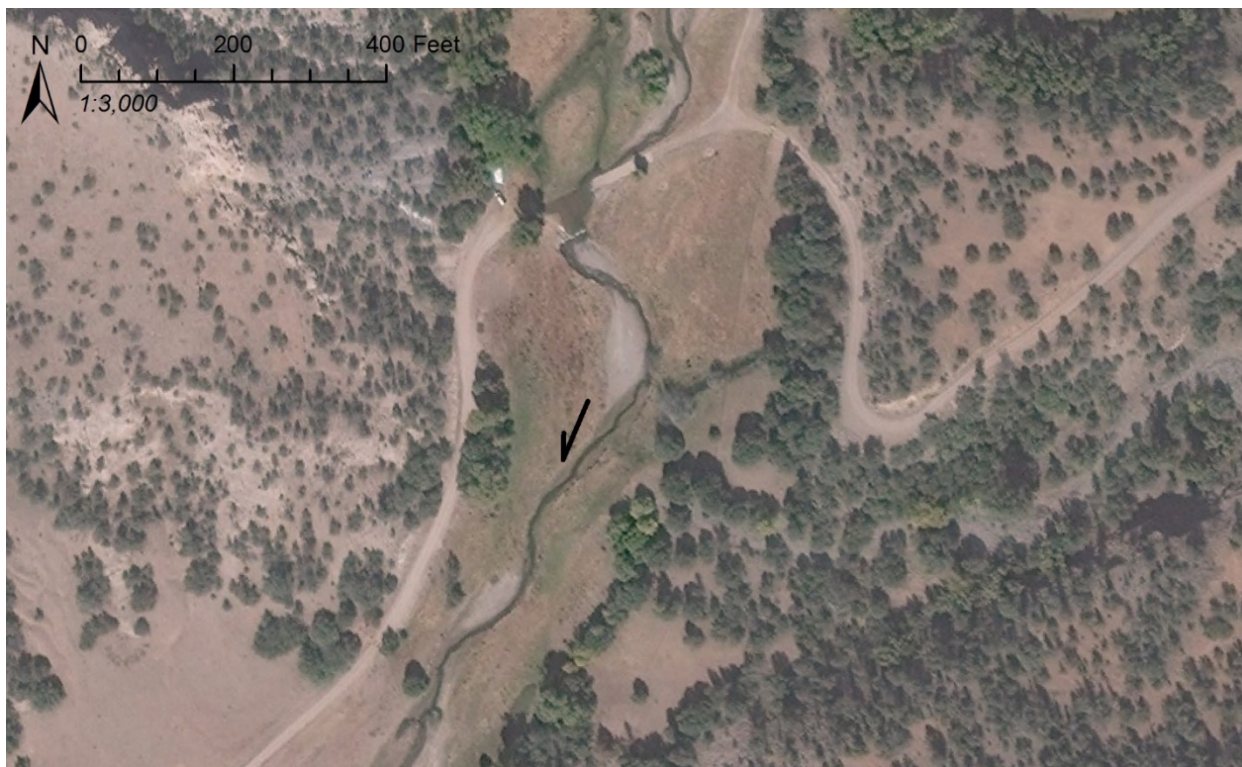
The NFSR-233 crossing of the Tularosa River consists of a concrete low water crossing (Figure 2) that spans a bit more than half of the valley width (Figure 3) at an angle to the valley profile. The 2009 addition of a concrete apron just downstream had the intent of increasing aquatic

Figure 3: Aerial imagery (2017-10-14) of the Tularosa River at the NFSR-233 crossing.

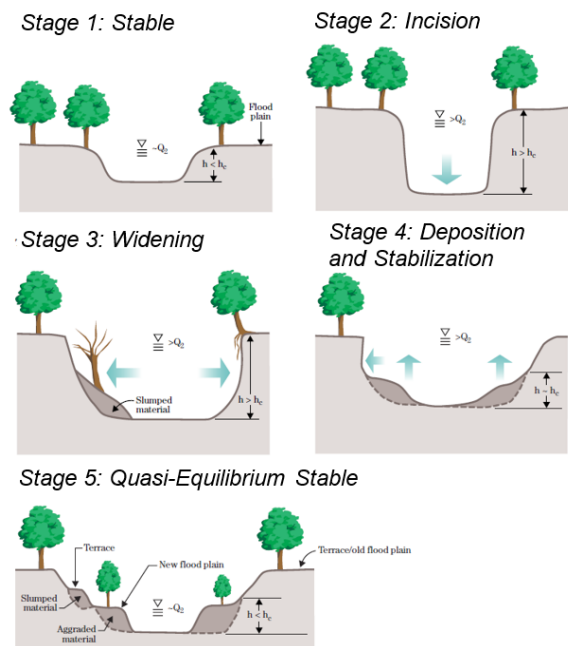
Regarding the downstream channel incision (Figure 6, Figure 7), this reach appears to be predominantly in channel evolution model stages 3 and 4 (Figure 10), with stage 2 immediately downstream of the crossing. The channel evolution model (Schumm et al. 1984) is a valuable tool for understanding the dynamics of stream disturbance and recovery processes. The method describes the movement of a headcut through a channel reach and the consequential evolution of the channel over time and space. This provides a framework for evaluating longitudinal response and restoration potential. At a specific location the channel evolves from an initial stable state (stage 1) through incision (stage 2), widening (stage 3), deposition and stabilization (stage 4), and once again stable (stage 5). Stages 2 and 3 are the most challenging stages of the evolution model for managers; this is the stage where instability and sediment supply is highest and restoration options are limited. Over time, the incision (at a knickpoint) moves upstream, forcing evolution of the valley bottom on successive upstream reaches.

At this point in time this upstream propagation has been arrested by the crossing structure. This channel evolution process is the likely mechanism for the 1000 feet of incision downstream of the crossing, though it is acknowledged that other unidentified mechanisms directly associated with the crossing structure may have also influenced this incision.

Figure 10: Channel evolution model, with channel cross sections illustrating the 5 channel stages (modified from NRCS 2007).

Restoration of the downstream channel and floodplain is recommended. This restoration would consist of filling the high unit stream power channel with borrow material from a suitable source, to eliminate the knickpoint at the downstream limit of the crossing, reconnect the channel with its floodplain (reducing unit stream power), and raising groundwater levels to

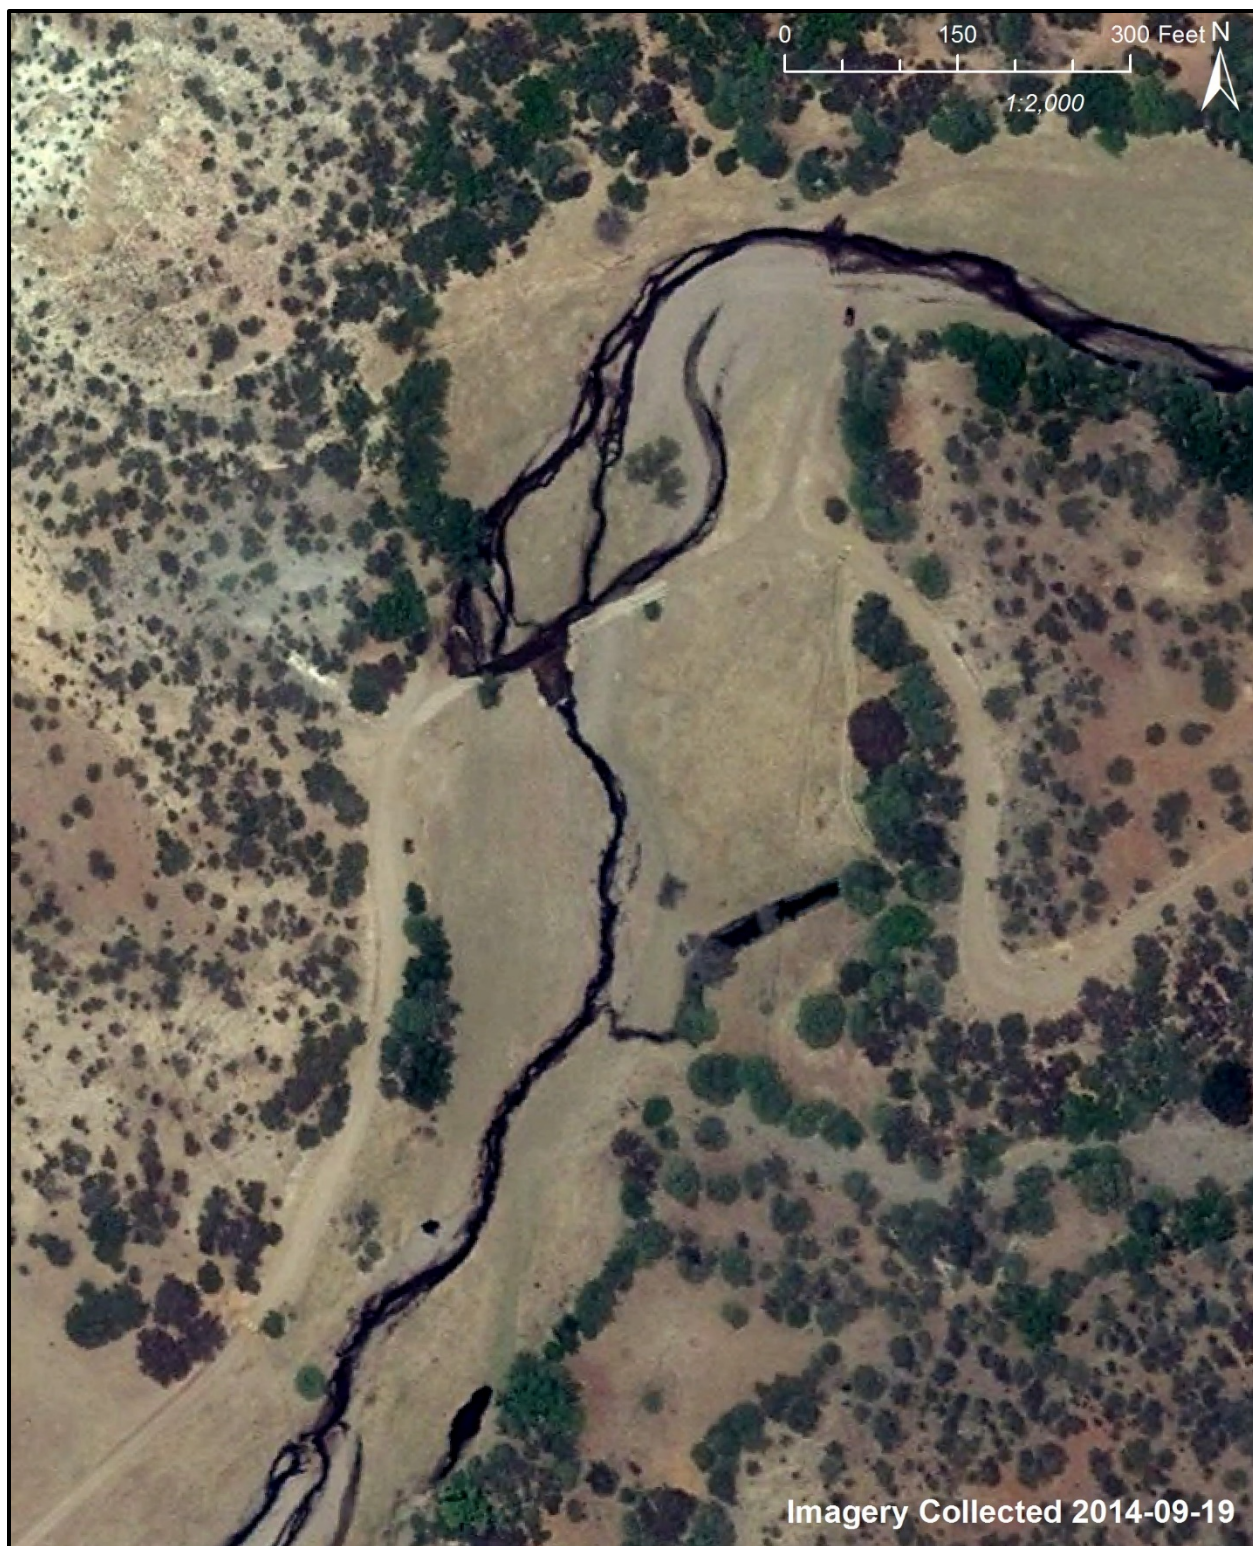
Figure A-2: Tularosa River at NFSR-233 (2014-09-19).
